ALLENSTOWN ELEMENTARY SCHOOL FEASIBILITY STUDY

Allentown, NH

FINAL REPORT

STUDY OVERVIEW

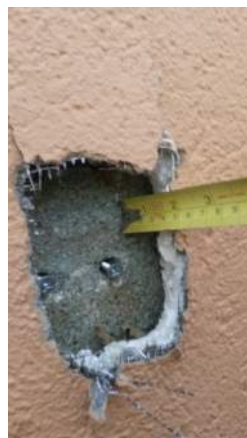
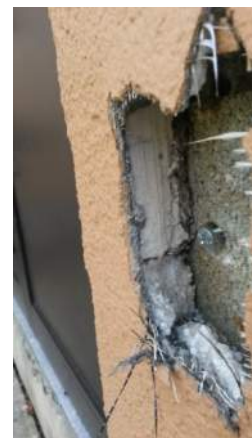
The one story area to the right of the main entrance is a masonry wall with exterior stucco insulated finish system. It is unknown if there is insulation in the walls other than the stucco insulated finish system. Based on the era of construction, little to no insulation was used in the walls on any of these masonry exterior walls.

Stucco finish with exposed 1-1/2 inch Styrofoam insulation

If a renovation is to take place the Energy Code (IEEC) will need to be adhered to. Harriman recommends furring out exterior walls with wood studs and filling the voids with spray foam insulation to seal the perimeter of the envelope and a layer of gypsum drywall. The cavity would allow for electrical and data wiring with devices.

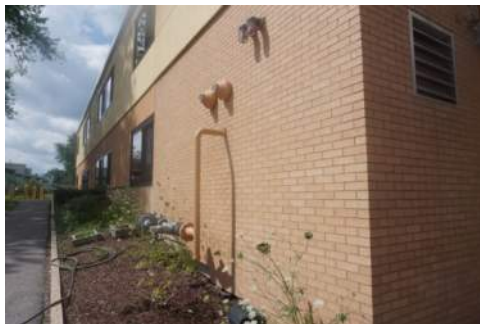
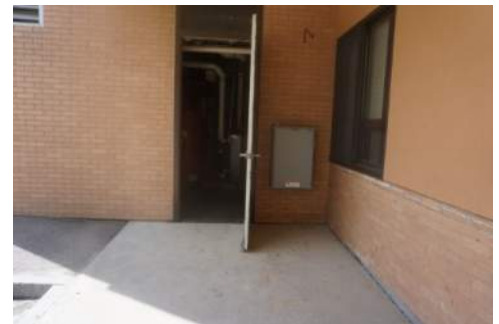
Brick at original building

By not taking on a major renovation project, IEEC does not apply. Repointing and ongoing maintenance are recommended to maintain exterior brick walls and to keep moisture from penetrating the building shell.

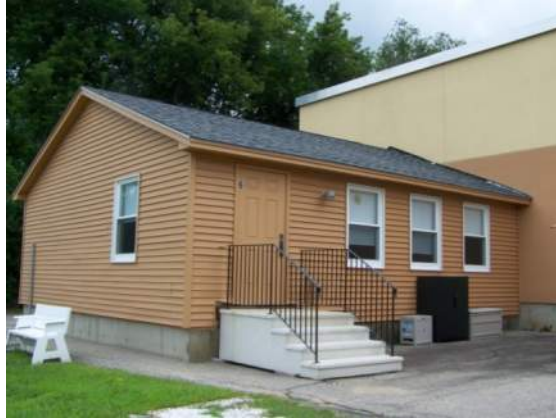
SPED addition

These two additions are wood frame construction and per building code for combustible construction. The original building and other additions are non-combustible construction. Per building code, the criteria when calculating allowable square footage would be based on the code least protected building type (combustible construction) and if the building as an automatic sprinkler system (this building as no sprinkler system). With an addition or substantial renovations we would not meet the criteria. We would recommend replacing the two additions with non-combustible construction.

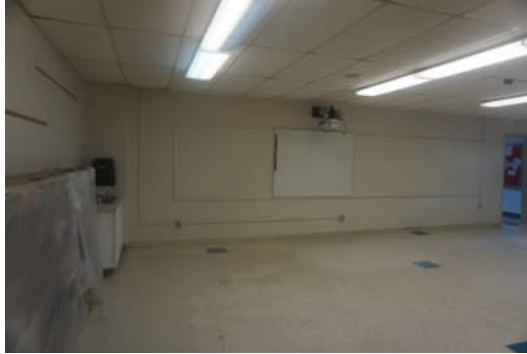
Acoustical ceiling tiles

There is suspended acoustical ceiling tile throughout most areas of the building. A variety of conditions, from poor to good, were noted. Many ceiling tiles have been discolored and stained. Plaster ceilings are located at Rooms 112, 202, 203, 204, 205, and 206. The 1972 Multipurpose space is exposed painted acoustic metal decking.

- Replace acoustical ceiling tiles.
- Add sound absorbing ceiling system at Multipurpose.

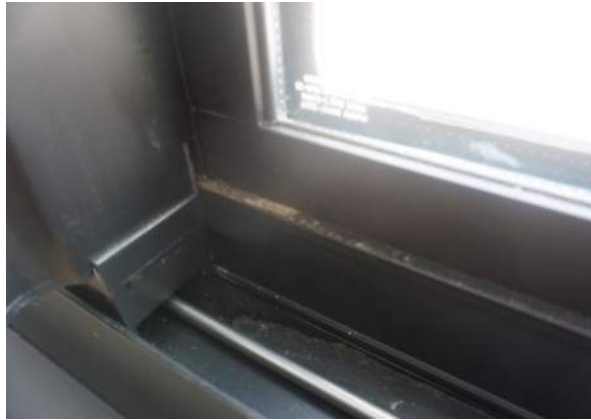
Worn out track

- Remove and replace all windows with commercial grade, thermally broken frames, exterior window system.
- System could be a combination of double hung windows or sliding style and fixed windows.
- Windows to be insulated glazing, low-E and argon filled for best performance.

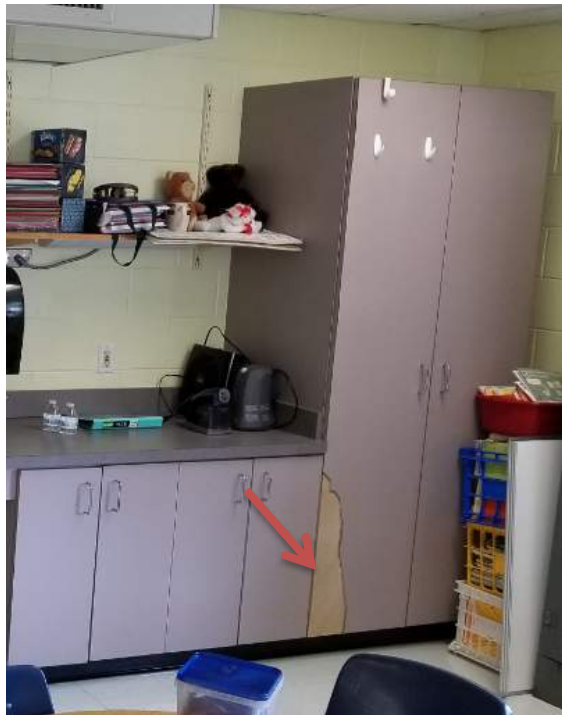
Plastic laminate delamination

- All casework to be removed.

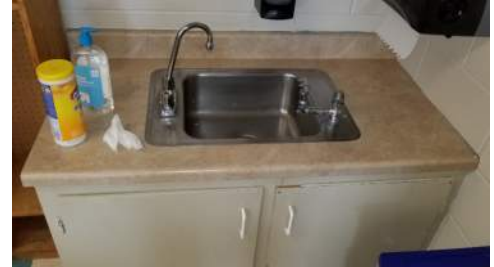
Door replaced with plywood

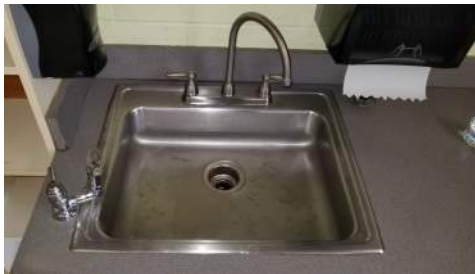
Most classroom sinks have bubbler and per code they must have a separate sink to meet hygiene standards

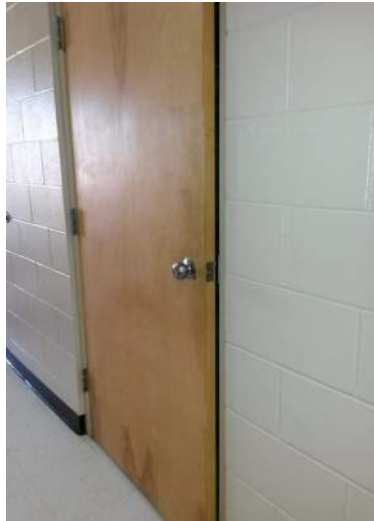
Interior doors vary and include wood doors in wood frames, wood doors in hollow metal frames, and metal doors in hollow metal frames. Hardware varies in age and quality. Some meet ADA accessibility with lever handles while others have knob sets that do not meet code.

Door handle with knob

- All exterior and interior doors to be replaced with new doors, frames, sidelights, transom, and hardware.
- Provide fire rating assemblies as required.
- Hollow metal frames in good condition can remain.

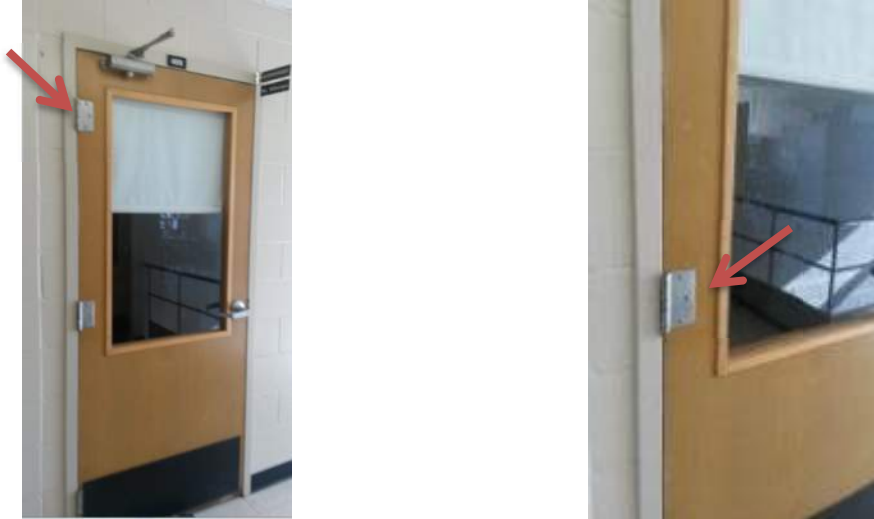
Exterior doors have a variety of maintenance repairs and finishes. Many doors are aluminum that have failed at the hinges. Typical modifications are to install hinges to the surface of frame or door, then install metal plate to reinforce hardware mounting, etc.

Door hinges modified with face mounted hinges

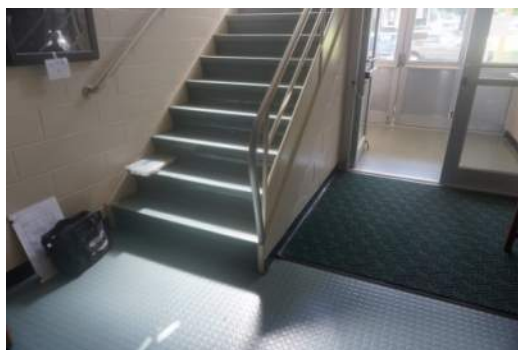
Stair A – handrail termination and guardrail/handrail along open stair does not meet code.

- Stairs A & C: along open stair and at landings to have separate handrail guardrail with balusters. Provide new wall handrails with handrail extensions. Provide guardrail with balusters to section along exterior windows.
- Stair B: provide new wall handrails with handrail extensions.
- Stairs E, F & G: provide new cast in place stairs with proper width concrete foundation below frost line.
- Stairs D, E, F & G: provide new handrail guardrail with balusters.

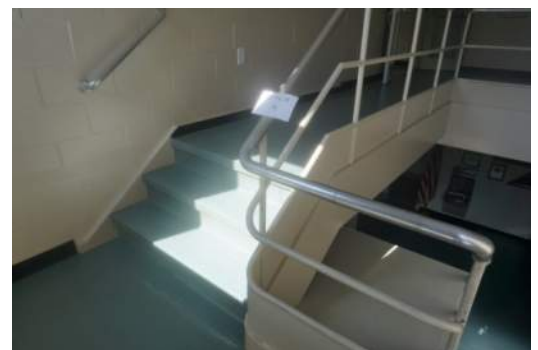
Stair A – handrail termination & guardrail/handrail at landing does not meet code.

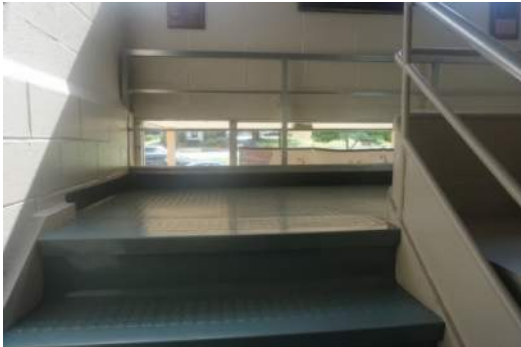
Stair A –guardrail with balusters at landing along open stair does not meet code.

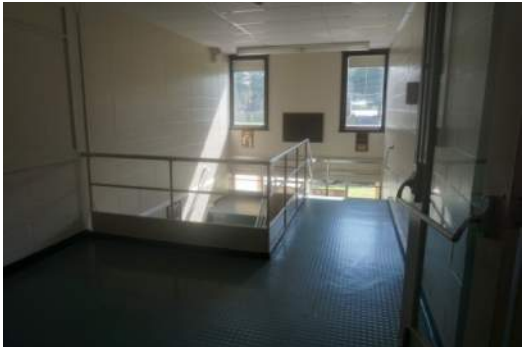
Stair A – handrail termination and guardrail/handrail with balusters along open stair does not meet code.

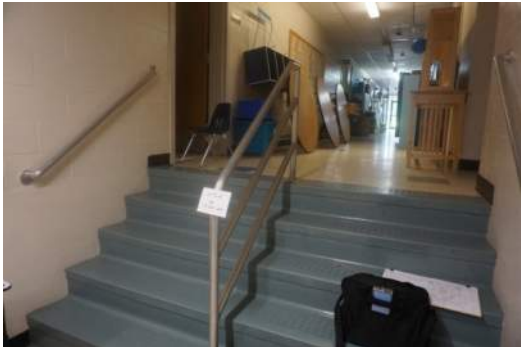
- Stair B; no handrail extensions at top and bottom run of stairs does not conform to code.
- Stair C; handrail along open stair and at landings serves as the guardrail/handrail which does not conform to code. No extension of wall handrails at bottom or top of stair runs and landings and does not conform to code. Guardrail at exterior windows does not meet height requirements or baluster spacing.

Stair B – handrail termination above and below stairs does not meet code.

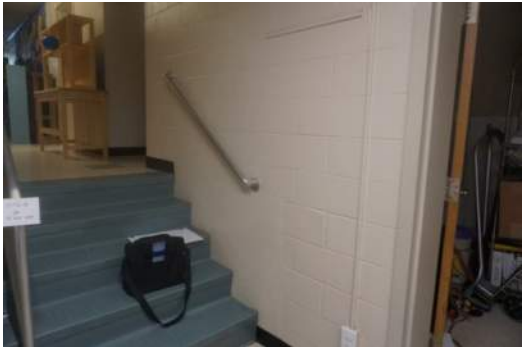
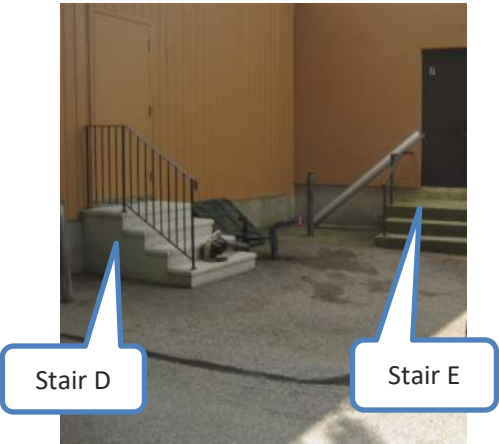
Stair D & E

- Stair D, E, F & G; have a variety of non-code compliant issues; handrail along open stair and at landings serves as the handrail and guardrail/handrail, balusters, stair width and landing at door not meeting dimensional requirements, missing handrail, bottom riser height less than other risers, latch side of door clearance require to be 18 inches, which does not conform to code. Stairs D, E & F are precast residential style stairs not set on a concrete foundation and susceptible to frost heaving.

Stairs D, E, F & G have a variety of non-code compliant issues.

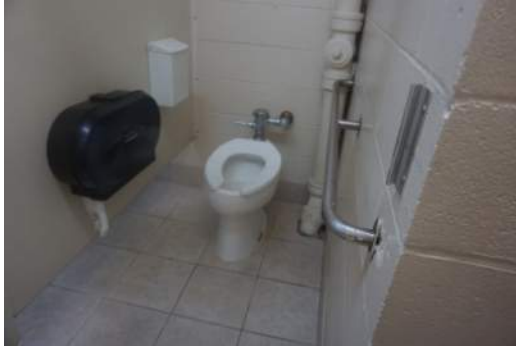
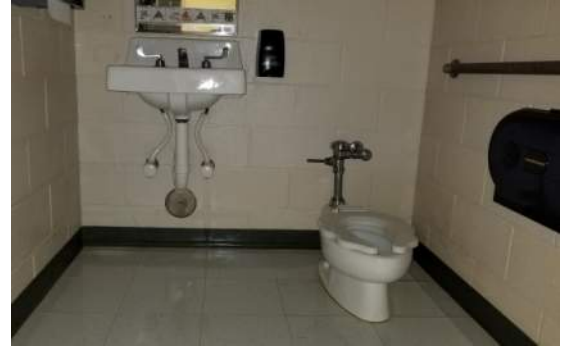
Examples of ADA toilet compartments that have no rear or vertical grab bars

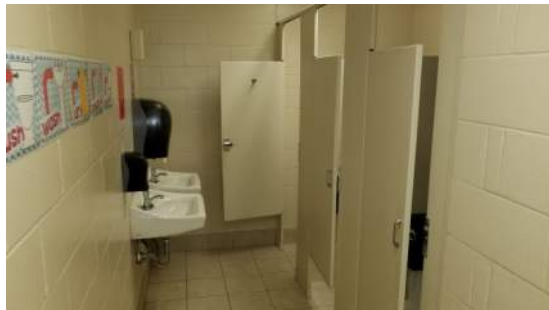
Girls 205 – width from toilet stalls to lavatory wall non-compliant. Similar condition in Girls 108 and Boys 115 and 213.

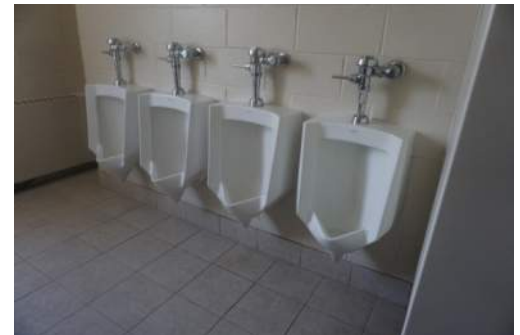
Typical Boys urinals – no ADA code compliant urinals. Require 1 ADA compliant per toilet room in Boys 115 & 213.

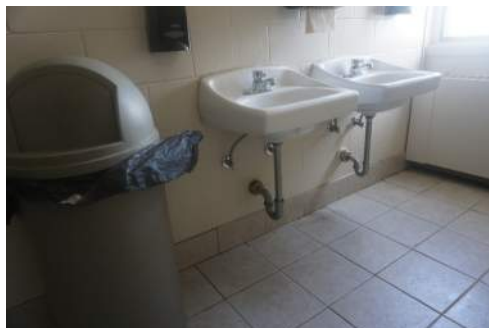
Typical Boys and Girls lavatories – no ADA code compliant lavatory. Require 1 ADA compliant per toilet room in Boys 115 & 213 and Girls

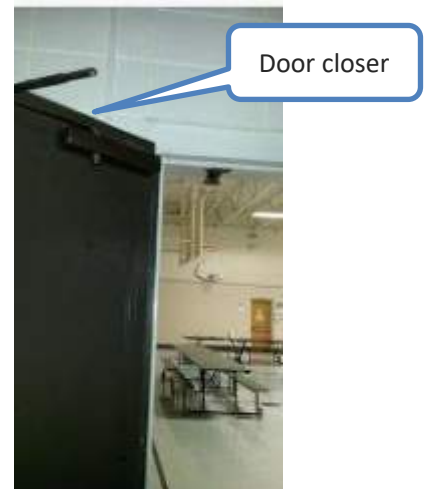
and exterior ramp view F. It is uncertain why double doors were removed; however this creates a rated and secured egress path from Multipurpose room to a public way. In its present condition this cannot be used as a means of egress. It appears this is the route to remove trash receptacles.

B - Double door viewed from Vestibule 148
Note door closer disconnected.

- Re-establish Vestibule as a rated egress path with door, frame and hardware. Verify fire rating of walls. No trash receptacles should be in the path of egress.
- Limits multipurpose room with 2 egresses. Review with local AHJ and post Maximum Occupancy allowed and remove EXIT sign.
- In both cases re-build ramp with code compliant landing and handrails both sides.

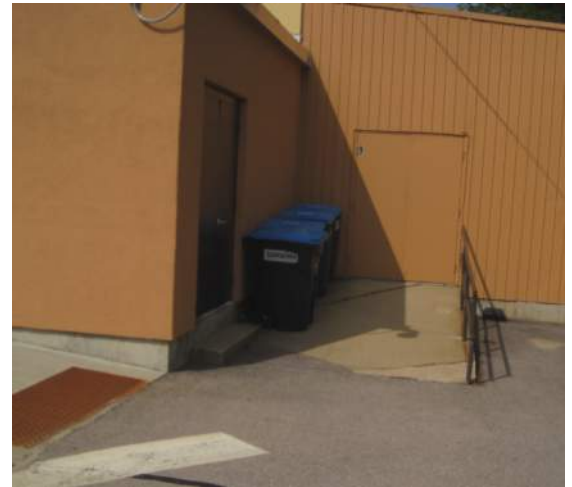
F - Double doors exterior view to Vestibule 139
No landing in front of doors or handrails both sides.
If ramp were to be extended to meet code,
requirement for landing would interfere with double
doors from Storage 138.
