ALLENSTOWN SCHOOL DISTRICT
ARMAND R. DUPONT MIDDLE SCHOOL
Allenstown, NH 03275
PROJECT # 18345

March 11, 2019

FACILITY ANALYSIS

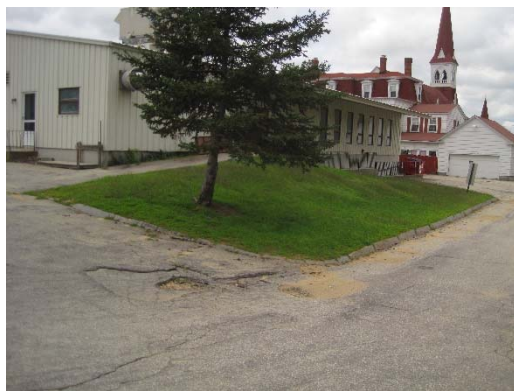
The pavement throughout these areas is generally in fair condition. Observations of the pavement included numerous potholes, large cracks, and areas of differential settlement. Vegetative growth was also observed within various large cracks within the pavement. Pavement markings were not easily visible or were non-existent. The pavement surrounding the main entrance to the eastern building (approximately 50 ft²) looks to have been recently installed.

Potholes and sediment observed along access way

- Repair pavement within the school parking lot and access way from the school lot to the church parking lot;
- Repair the areas surrounding the two catch basins, including removing the overgrown vegetation and sediments from the area;
- Reconstruct pavement that conveys stormwater to the eastern catch basin;
- Control sediment build up that was observed throughout the paved surfaces;
- Repair existing surfaces around the western perimeter fence to cover exposed concrete post foundations;
- Coordinate for ADA parking spaces and pavement markings;
- Provide additional directional signage for drivers;
- Repaint the striping within the school parking lot; and
- Reseed the existing grassed areas along the eastern perimeter drive, including repairing the erosion rills within the area.

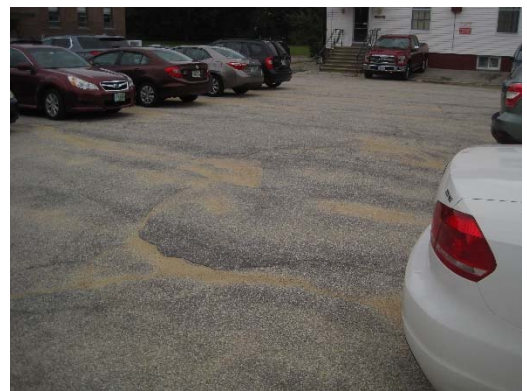
Differential settlement and sediment observed in lot

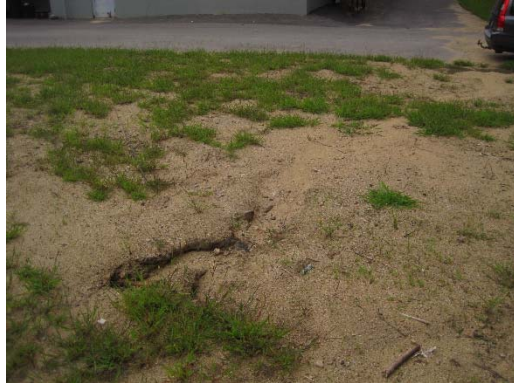
Erosion area noted to the northeast of the building

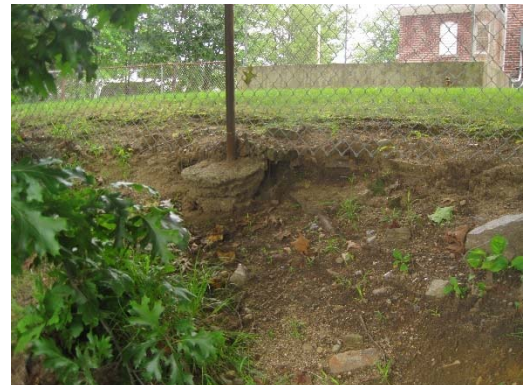
Other observations made during the site visit included perimeter fencing, signage, and ADA accessibility throughout the site. The perimeter fencing was mostly in good condition, including some fencing that appeared to be relatively new located along the northern property line. Notable issues of concern included some rusting of the perimeter fence and the exposure of some of the post foundations along the western property limit.

Exposed concrete post foundation at west perimeter

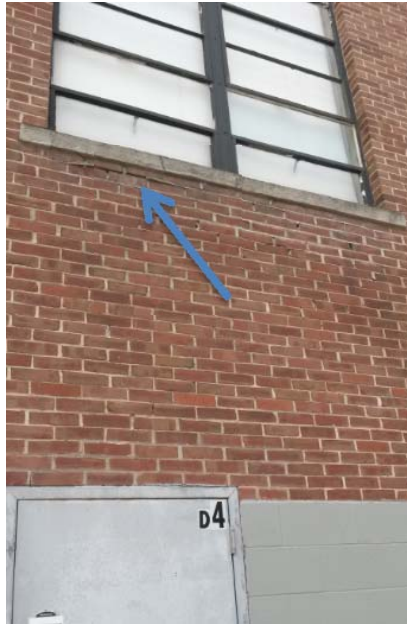
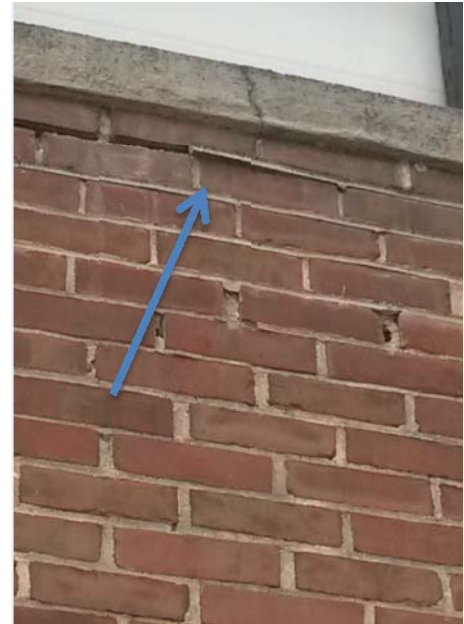
The exterior brick walls appear to have been patched and repointed several times. There is major evidence of loose mortar, bricks dislodging, and cracking. Some interior walls indicate cracks at CMU walls along Corridor #133. There have been no reported leaks at this time. The school district as obtained quotes for repointing at approximately \$100,000. Harriman recommends a structural engineer to review condition before proceeding repointing.

Exterior brick wall with loose mortar joints

- Brick exterior is deteriorating: loose mortar and bricks occur throughout the 1954 building including over walkways and doorways. Recommend structural engineer for structural integrity review before re-pointing.

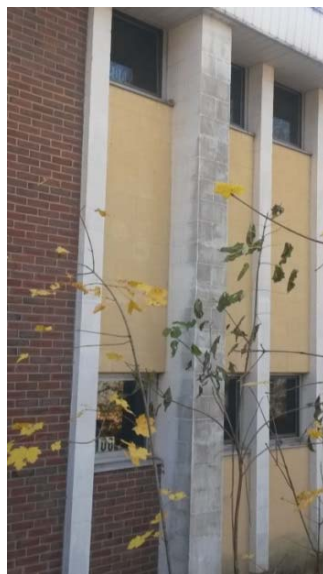
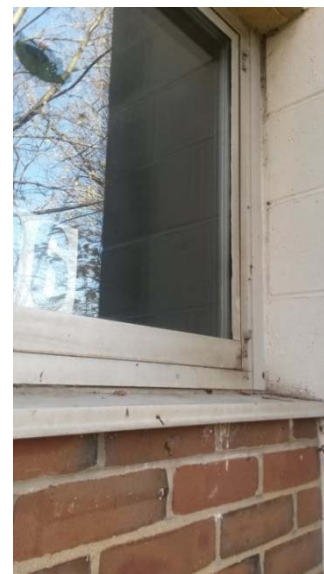
Some windows have been recently replaced such as in the locker areas and Sped office. The windows in the 1973 and 1988 buildings appear to be original and are aluminum thermal pane glazing. Most of the original 1954 building has original steel windows with single pane glass. They vary in function; slide-by, awning, and fixed. They appear to be in fair to good condition. It has been reported that many of the windows are difficult to open. Many screens are broken or missing. A commercial window's life expectancy is based on average wear-and-tear of windows. Aluminum windows are expected to last between 15 and 20 years, and can be extended with regular maintenance.

Original 1973 two story north elevation original windows

Close up view of window condition

Remove all windows other than recently replaced windows as noted above. Replace with new aluminum thermally broken with desired function and thermal pane glazing. Existing operable gymnasium windows should be reduced in size to lessen heat loss. Windows should be insulated glazing, low-E and argon filled for best performance. Also, replace window shades with clutch shades.

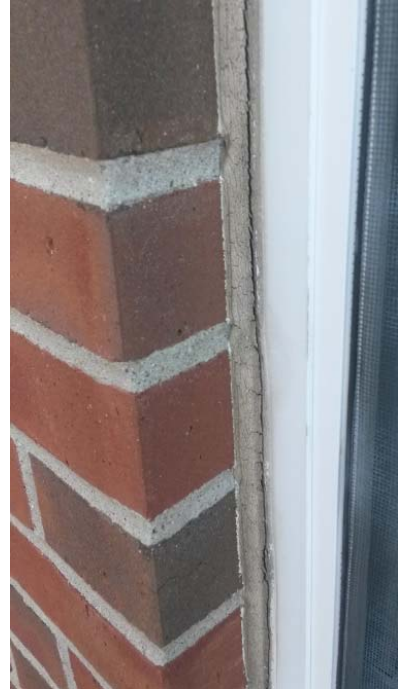
Same window, noting caulking failure.

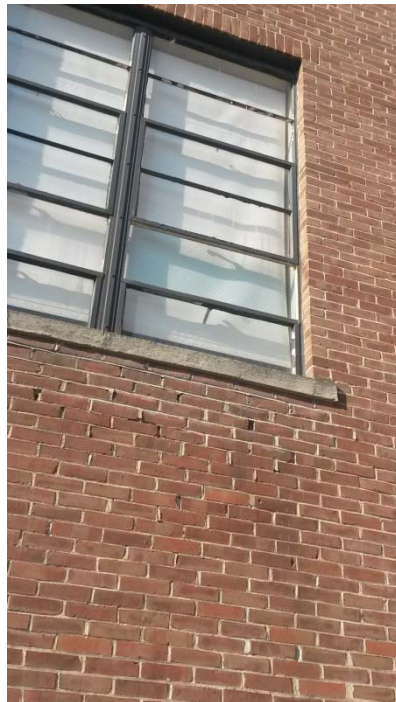
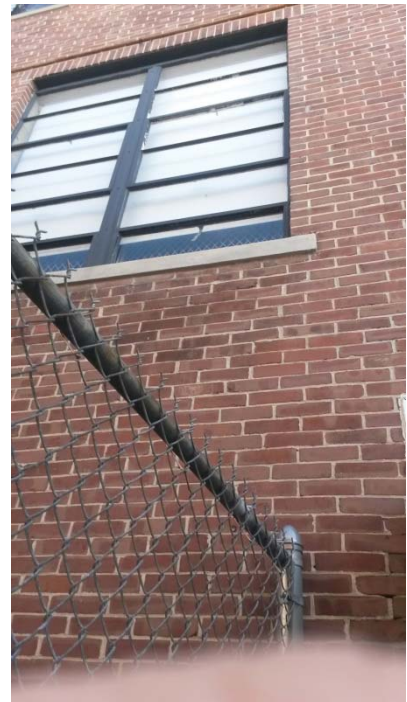
Observation of the large windows in the gymnasium noted curtains to shade the sun. The sun shining in is a typical issue with all gymnasiums. The window system should be replaced with another option that allows daylighting and there are many products that perform well. Another concern would be ventilation, and Harriman recommends exploring solutions to satisfy both daylighting and ventilation.

Original 1954 examples at Gymnasium with steel frame single pain windows

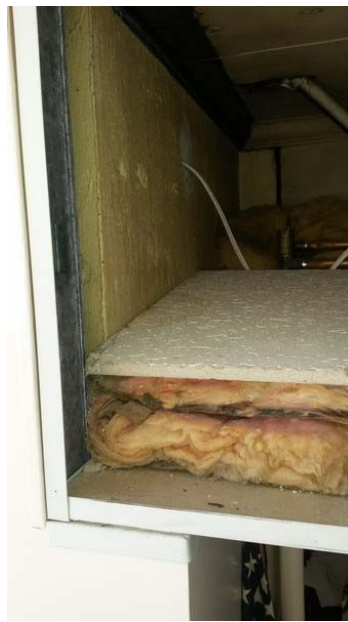
There is suspended acoustical ceiling (ATC) tile throughout most areas of the building. A variety of conditions, from very poor to good, were noted. Many ceiling tiles have been discolored and stained. Typically there is insulation above ATC. Shown below is fiberglass batt insulation with additional ATC above. This occurs in both the first and second floors. This was commonly done during the energy crisis in 1979. It is understood now that this can create an indoor air quality issue where moisture may condensate in the fiberglass insulation and ATC. Due to the amount of ceiling tile staining, it is suspected that some materials may be absorbing moisture.

First floor ceiling

- Remove all insulation above suspended acoustical tile ceilings on first and second floors.
- Replace suspended acoustical ceiling tile throughout due to most areas being in fair to poor conditions.

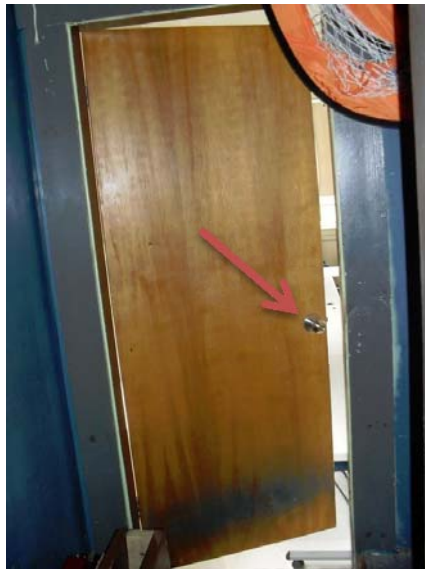
Interior doors vary and include wood doors in wood frames, wood doors in hollow metal frames, and metal doors in hollow metal frames. Hardware varies in age and quality. Most meet ADA accessibility with lever handles while some others have knob sets that do not meet code.

Typical door with knob set

- Review with Integration/Data Specialist to update with LCD projector with interactive white boards.
- All casework to be replaced.
- All interior classroom/teaching space doors to be replaced with reduce view windows into rooms.

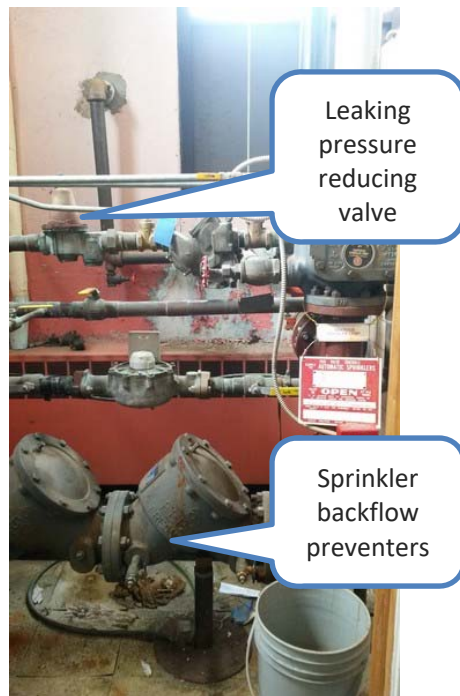
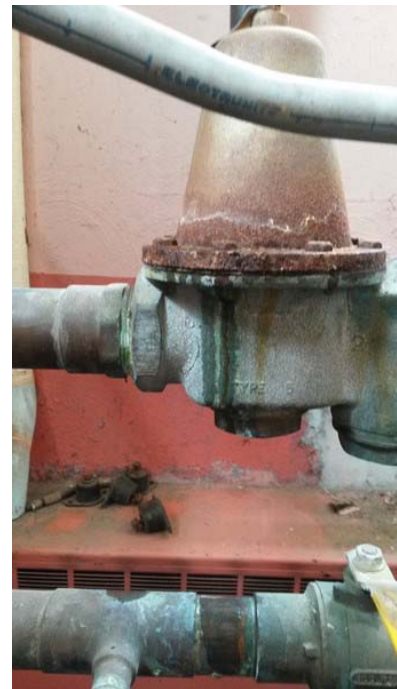
- Sprinkler backflow preventers were inspected by local Department of Public Works and passed.
- Tri State Fire Protection sprinkler maintenance contractor noted leakage on domestic line at two - 2 inch pressure reducing valves. School District is pursuing repairs.

Leaking Pressure Reducing Valve

Close-up of Water Leak

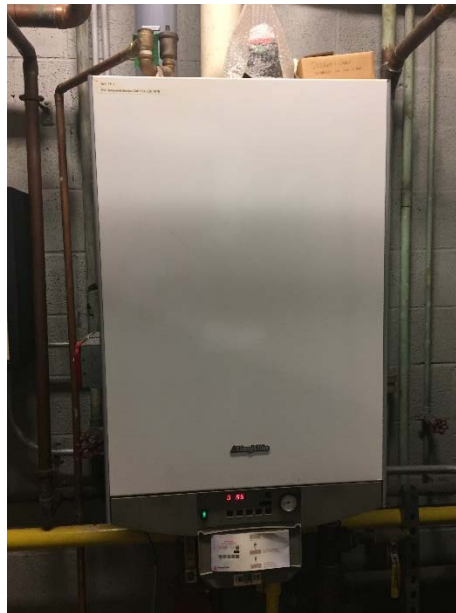
The main boiler plant consists of three Triangle Tube wall mounted boilers. Each natural gas boiler has an input of 399,000 BTUs with a max output of 330,000 BTUs. A dedicated circulation pump operates in unison with its respective boiler to inject hot water through a closed spaced tee into the central heating loop. One of the boilers is not operational and is used to scavenge replacement parts for the other boilers.

Typical Boiler

- At a minimum, the existing wall hung boilers should be replaced with new floor mounted condensing boilers that will have a longer life expectancy and be sized to provide full redundancy. The current layout of the boiler room may not allow the boilers to be located in this space, so a new location or expanding in an adjoining space will need to be considered.

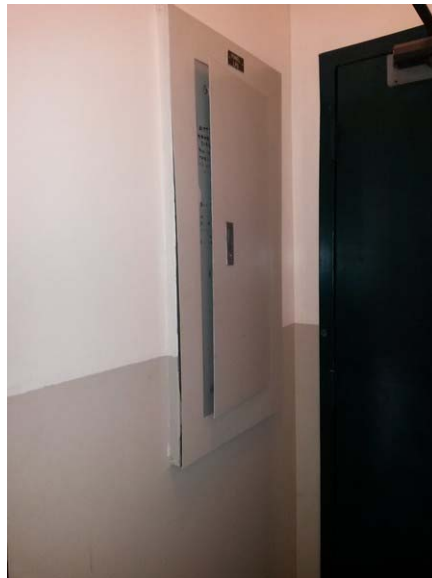
Panelboard LPG is located in an egress stair at the music classroom

- Circuits should be traced to update panelboard directories with accurate, legible, typed directory cards.
- Panelboards that are 30 years or older require replacement. Panelboards in egress stair, kitchen, and custodian closets to be relocated per code and for safety reasons.

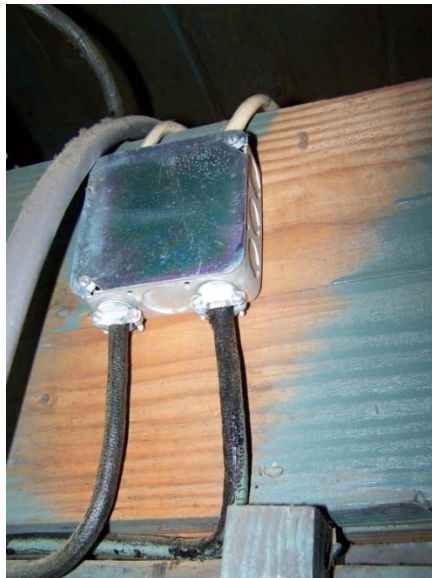
No panelboards were opened however, wiring with cloth insulation, non-metallic sheathed (Romex) and MC cable were observed above ceilings and "attic" space located above the stage.

Cloth insulated wiring (black) with non-metallic sheathed cable (white), above stage

- Wiring with cloth insulation, non-metallic sheathed (Romex) was observed above ceilings and "attic" space located above the stage. Non-metallic sheathed cables (Romex) are not permitted; should be replaced with MC.

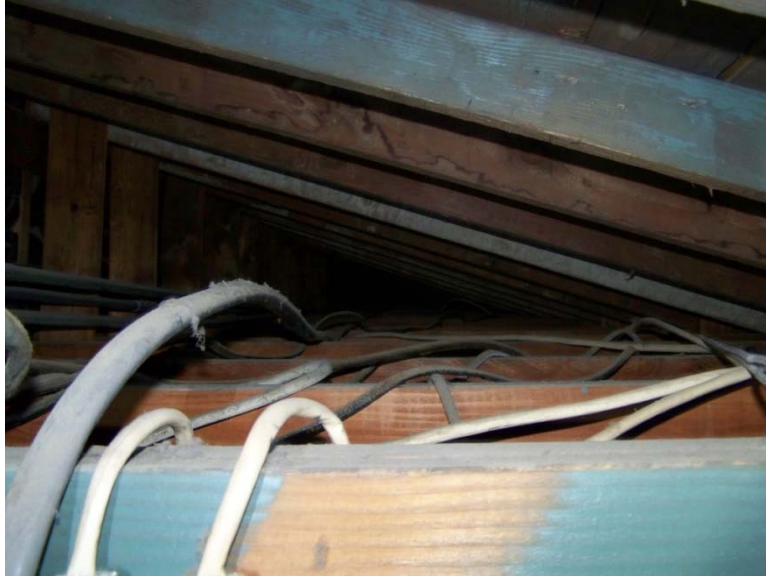
Mixture of non-metallic sheathed and cloth insulated wiring above stage

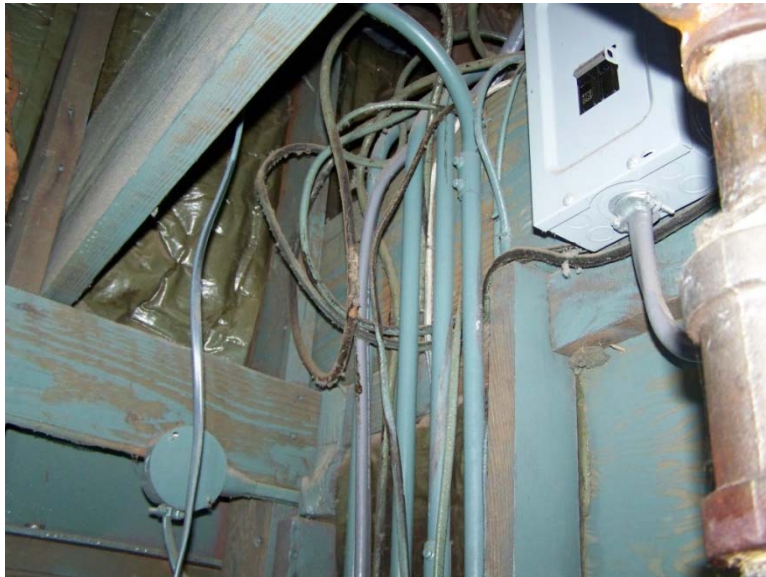
Some cloth insulation is damaged – center of picture

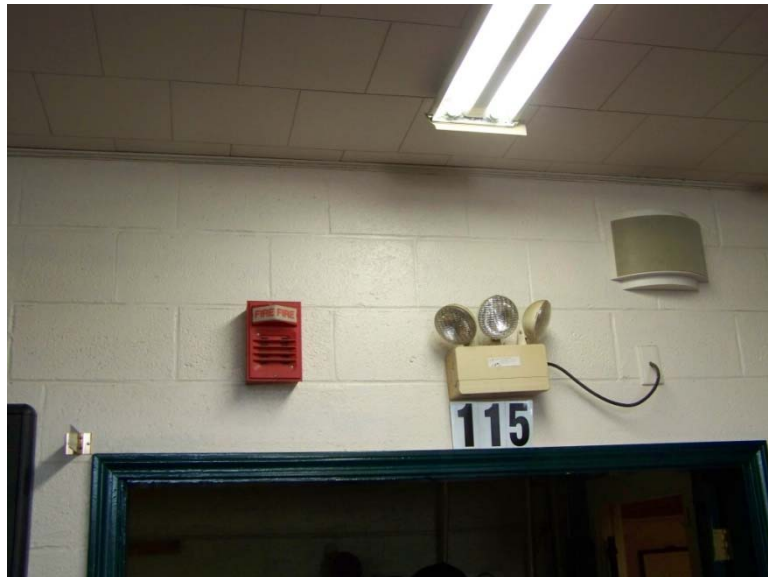
Emergency egress / life-safety lighting is provided throughout the building via emergency battery units with remote heads. A number of locations are covered by a single lamp remote head. NFPA101, 7.8 (Illumination of Means of Egress) requires that the failure of any single lighting unit does not reduce the lighting level below 0.2fc. Location of the heads does not provide adequate coverage to give the required average fc level of 1.0fc. There is no emergency egress / life-safety lighting on the building's exterior at egress doors.

Typical emergency egress / life-safety lighting battery unit

- Replace the existing fire alarm system with new system that provides voice evacuation throughout the building to comply with code.
- Replace existing emergency egress / life-safety lighting battery units with new or tie into a generator. Present spacing does not meet code for required lighting levels. There is no notification in classrooms to comply with code.
