Suncook River
Fluvial Geomorphology Assessment
Explanation Guide
Allenstown, Pembroke, and Epsom, NH

New Hampshire Geological Survey
New Hampshire Department of Environmental Services
Spring 2015

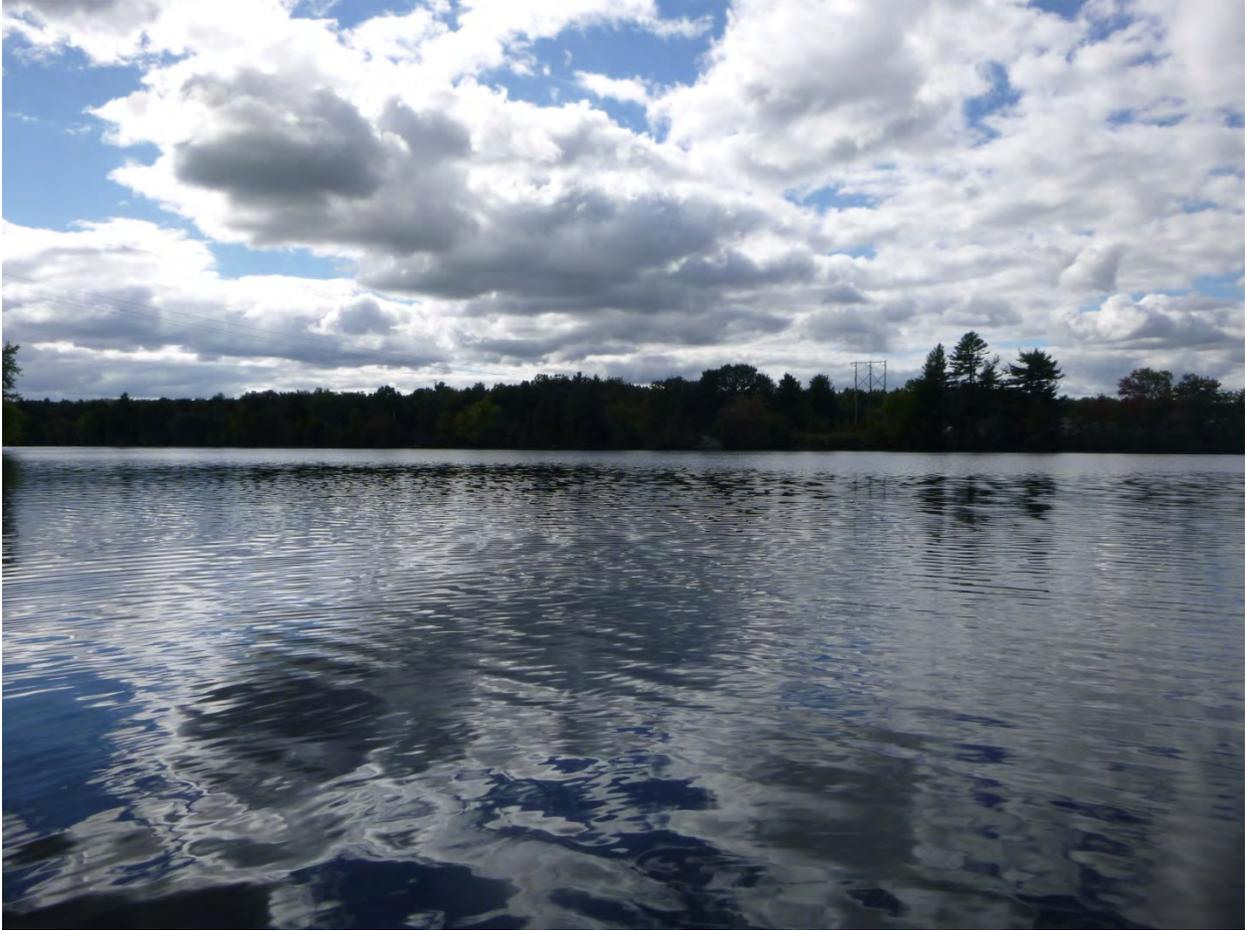
Figure 1. Confluence of the Suncook and Merrimack Rivers, looking from the mouth of the Suncook to the opposite west bank of the Merrimack.

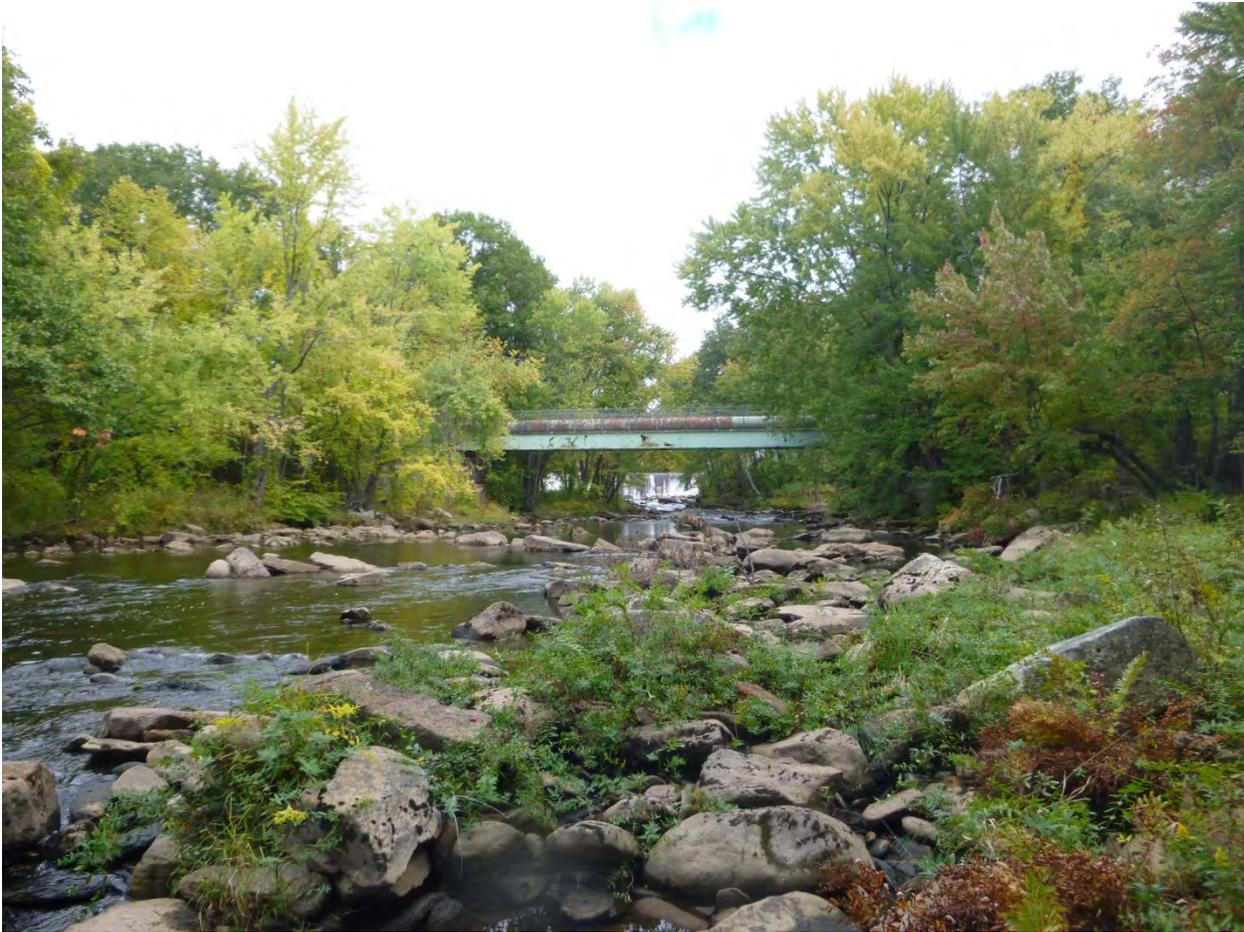
Three bars (one each of mid-channel, point and diagonal) were assessed, with three islands present, in addition to one flood chute and one steep riffle. The entire length of the channel has been straightened and modified in the past, as evidenced by the presence of the mill and related works (Figure 2).

Figure 2. Example photo looking upstream. Note the pipe crossing the channel, with the dam at the head of the reach in the distance. Also note the coarse nature of the bed material through much of this reach.

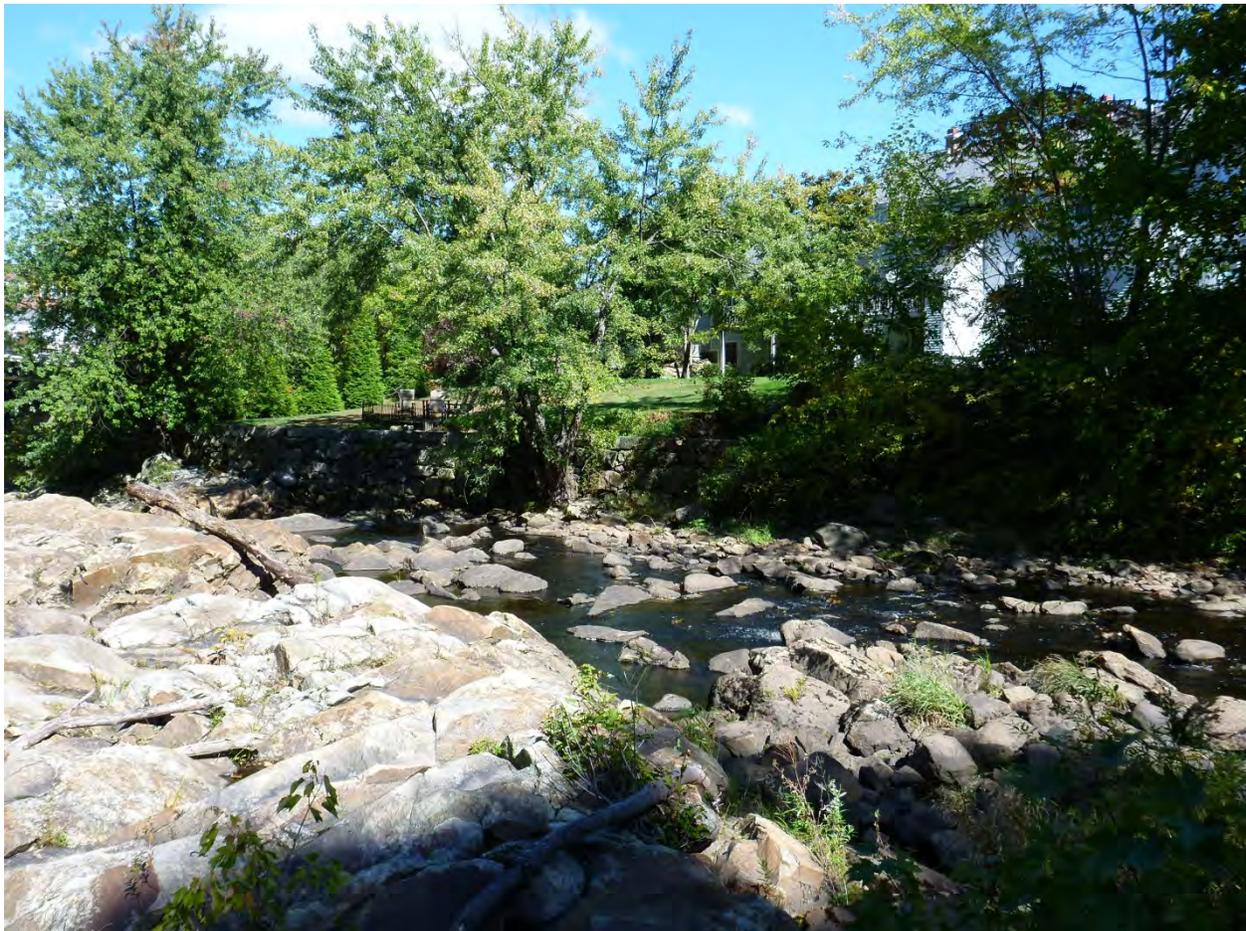
Channel bank slopes are typically steep, and are comprised of boulders at the bases and overlain by sand, though bank erosion is not present in the reach. However, much of the reach length on both banks have had bank revetment placed, extending for a total of 1105 feet on the south bank (boulder armoring) and 718 feet on the north bank (stone wall) (Figure 3). The channel canopy is open. The adjacent vegetation primarily consists of deciduous trees, both on the banks and in the adjacent floodplain, with the water works and buildings directly adjacent to the channel on the north.

Figure 3. Example of the stone wall armoring on the north bank in Reach 3.

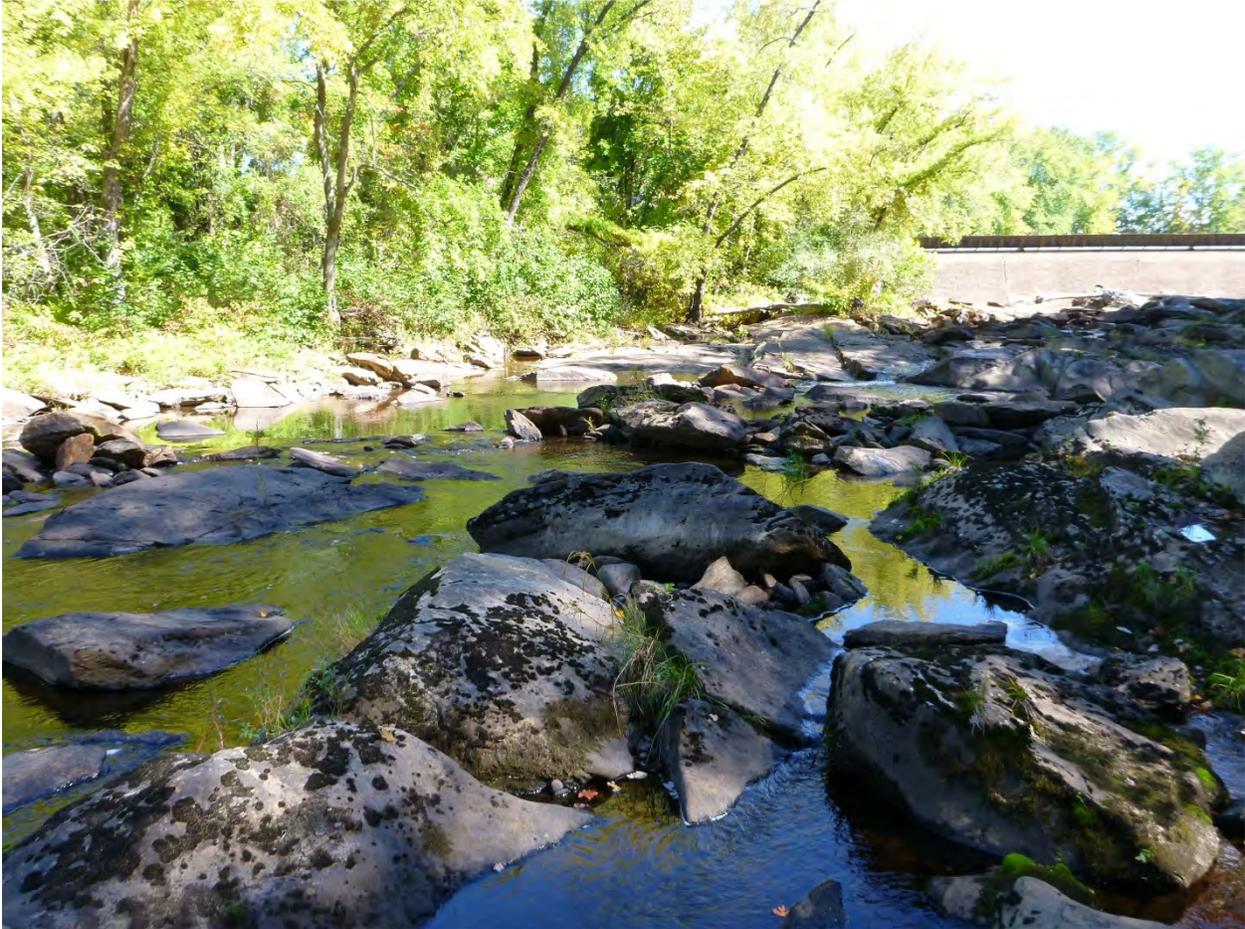
Figure 4. Looking upstream at the Suncook River Reservoir dam within Reach 3. The bedrock nature of the bed can be seen here.

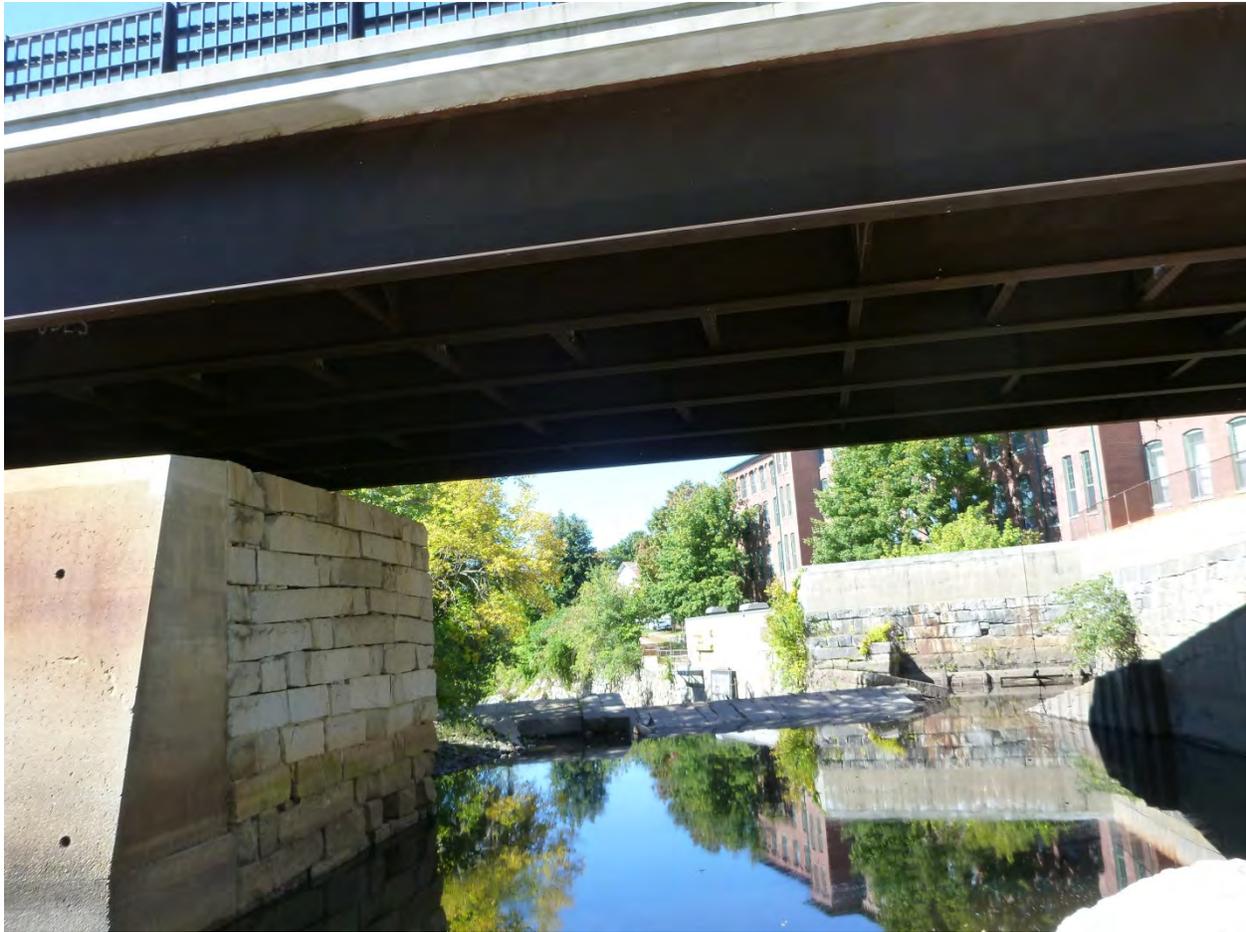
Figure 5. View of the large and deep pool just upstream of the spillway at the lower end of Reach 3 (seen in distance) at the Main Street crossing.

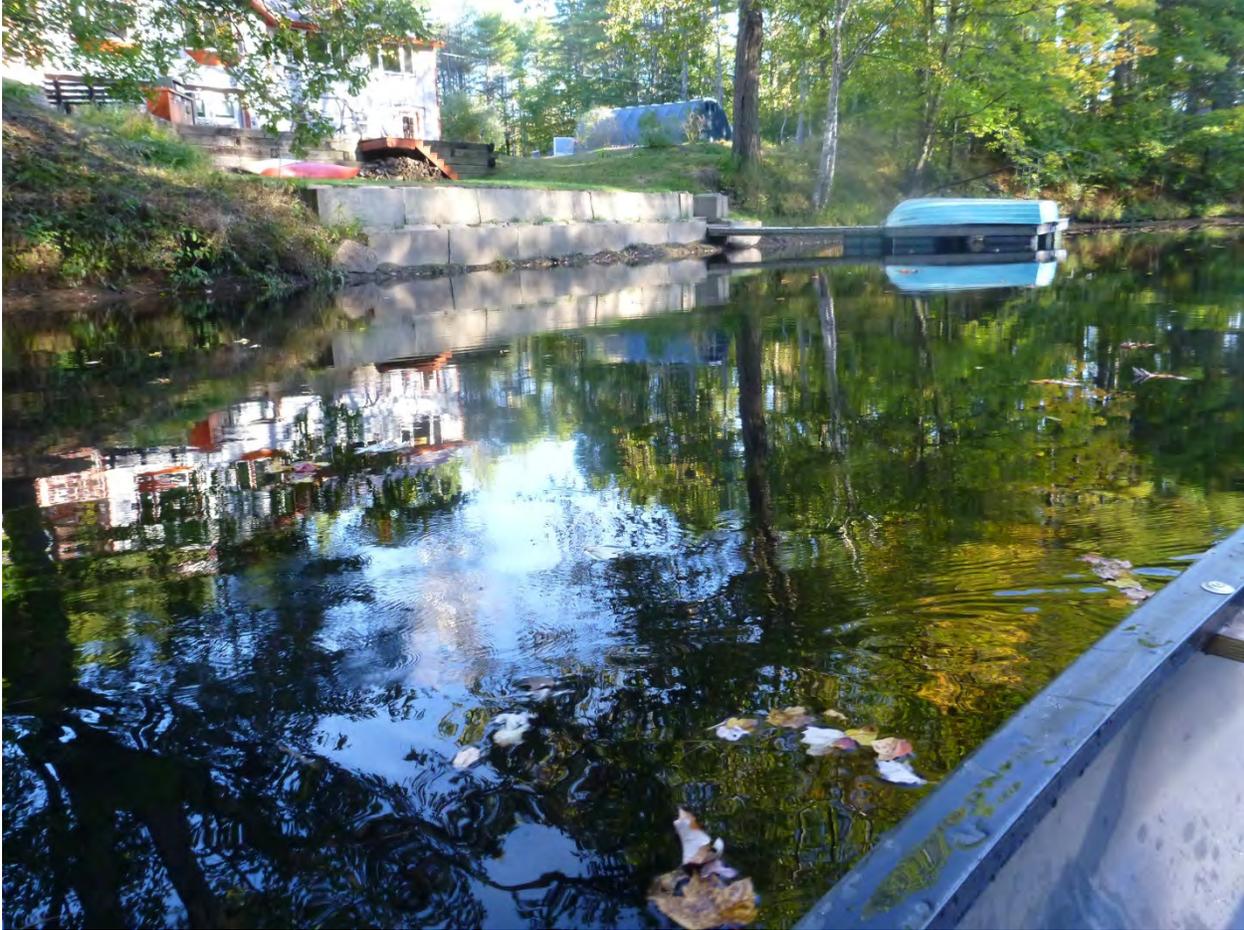
Figure 6. Example typical view of Reach 5A.

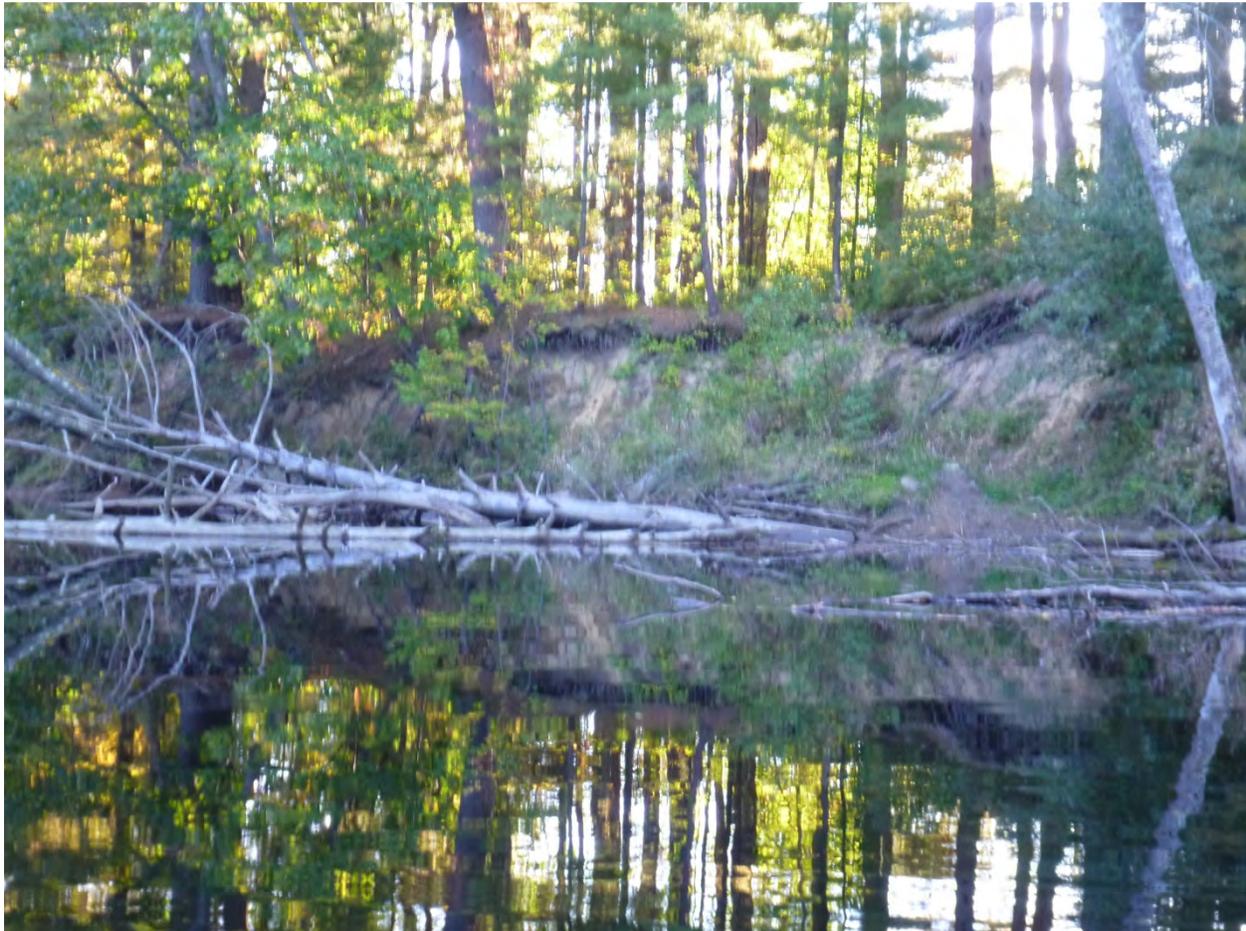
Slopes of the streambanks are typically steep throughout the reach, and are comprised of non-cohesive sand. Bank erosion occurs throughout the reach, with a total length of 7410 feet on the west bank and 7668 feet on the east bank, with average heights of erosion averaging 8 feet on the west bank and 7.1 feet on the east (Figure 7). Bank revetment has been installed on both banks, with a total length of 1851 and 1284 feet on the west and east banks. The channel canopy is open. Directly to the west of the river, the land consists of residences, while the land to the east is comprised of farm fields, with some residences.

Figure 7. Example of high bank scour/erosion present in Reach 5A.

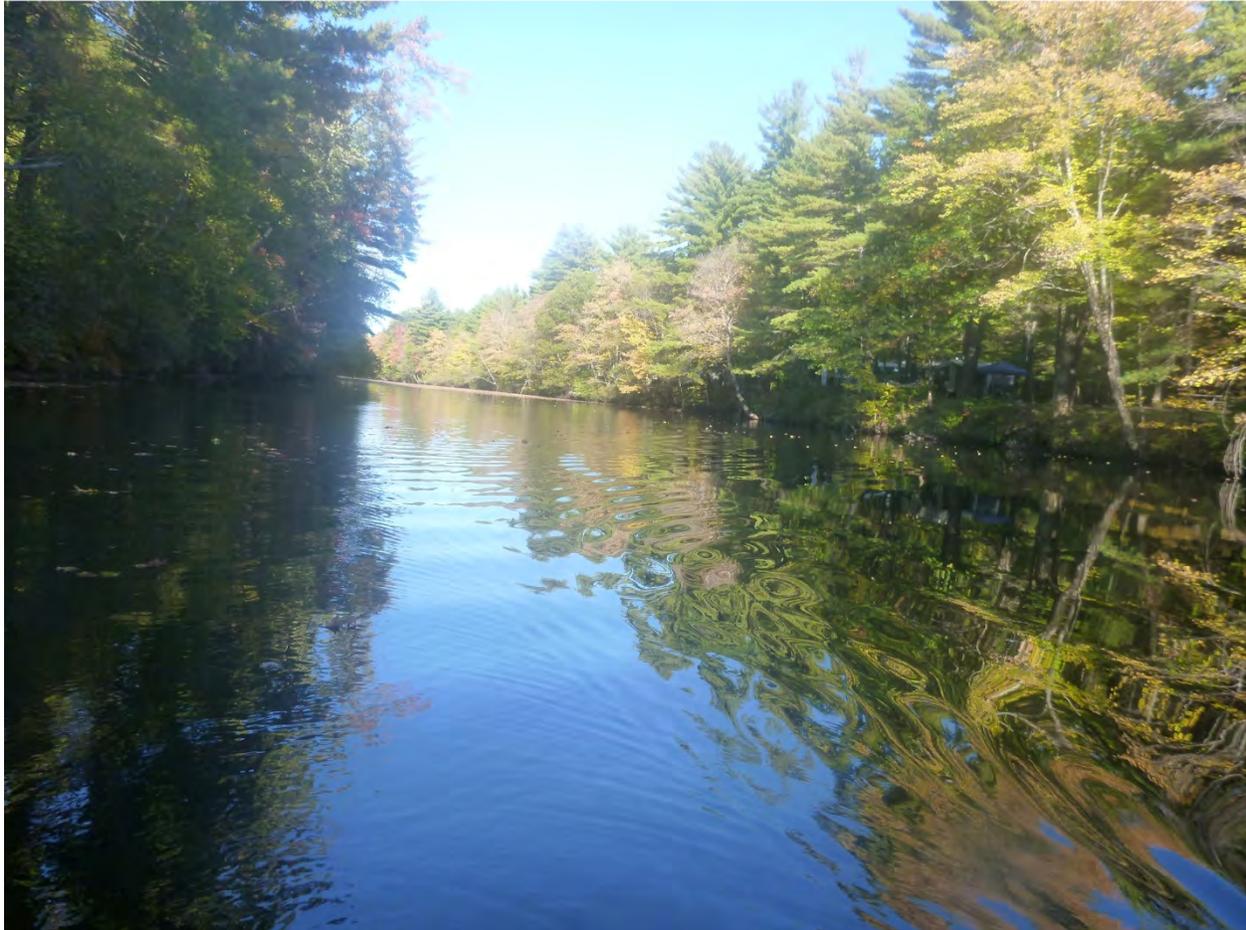
One flood chute is present in the reach, with 1.96 miles of the reach length (74%) identified as having been straightened (Figure 8).

Figure 8. Typical view of a straightened section of the Suncook River in Reach 5A (view upstream).

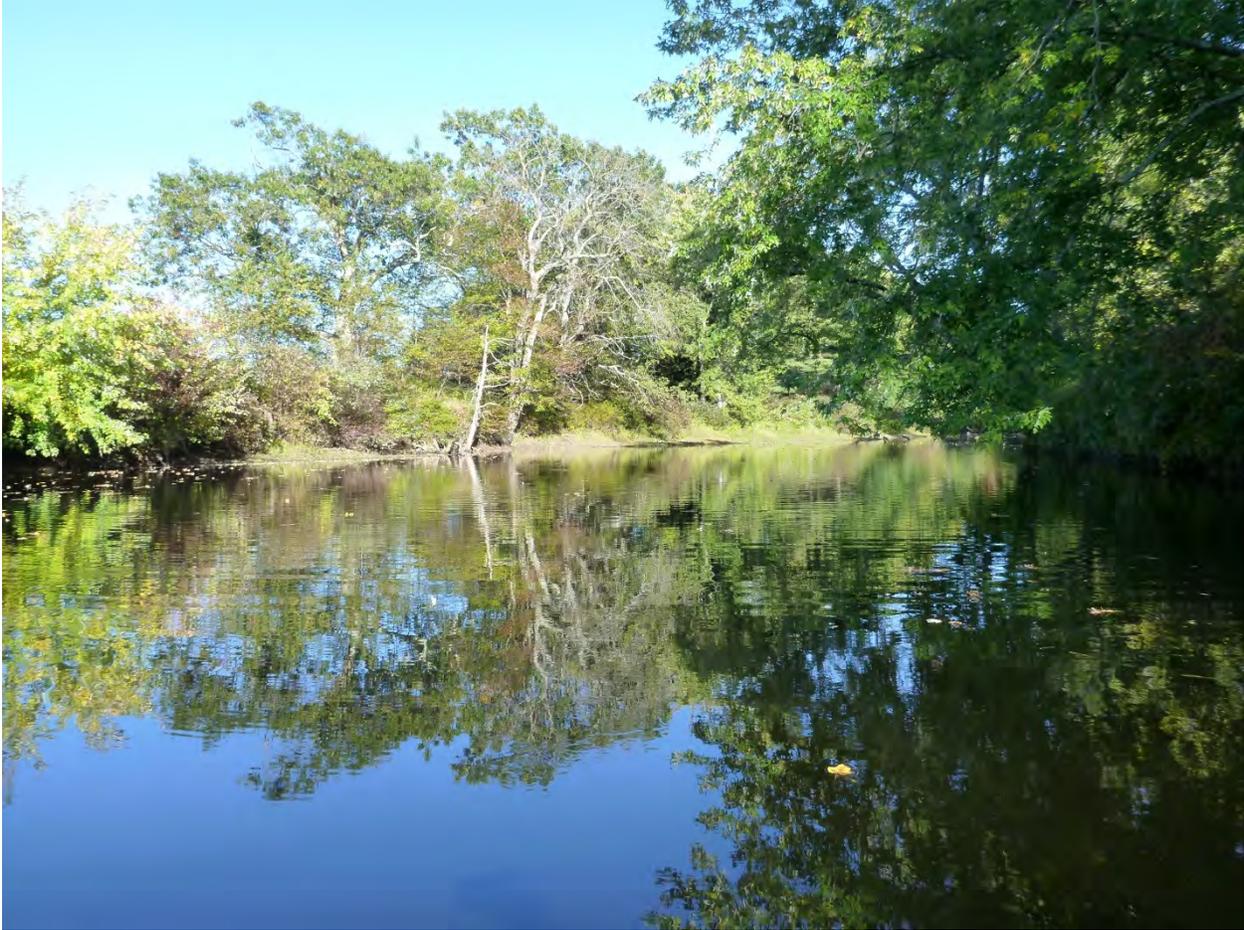
Figure 9. Typical view of Reach 5B. Note the backwater pool condition. (Upstream view.)

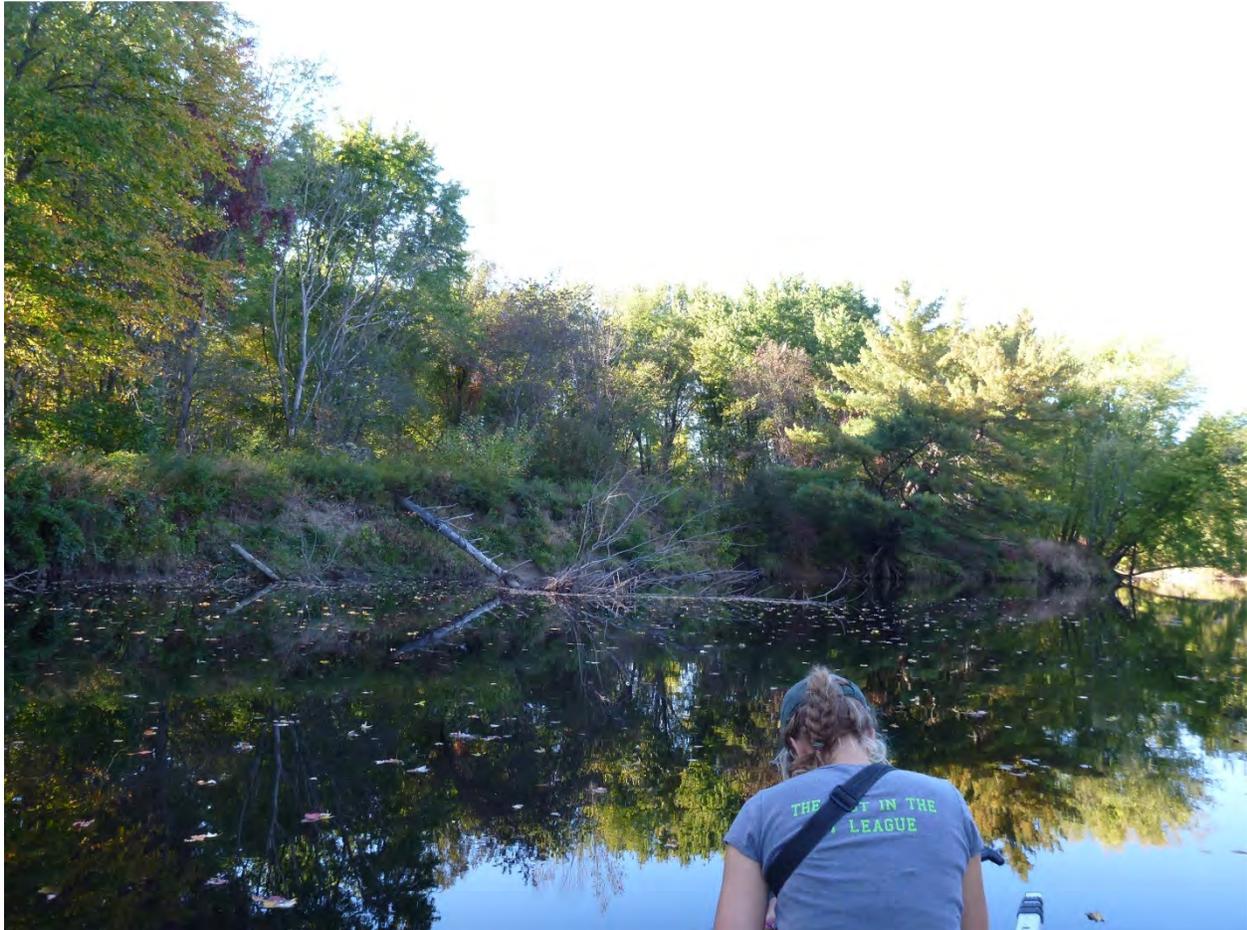
Figure 10. Example view of the banks (east bank in photo) in Reach 5B. Note the sandy, unconsolidated and erosive nature of the banks.

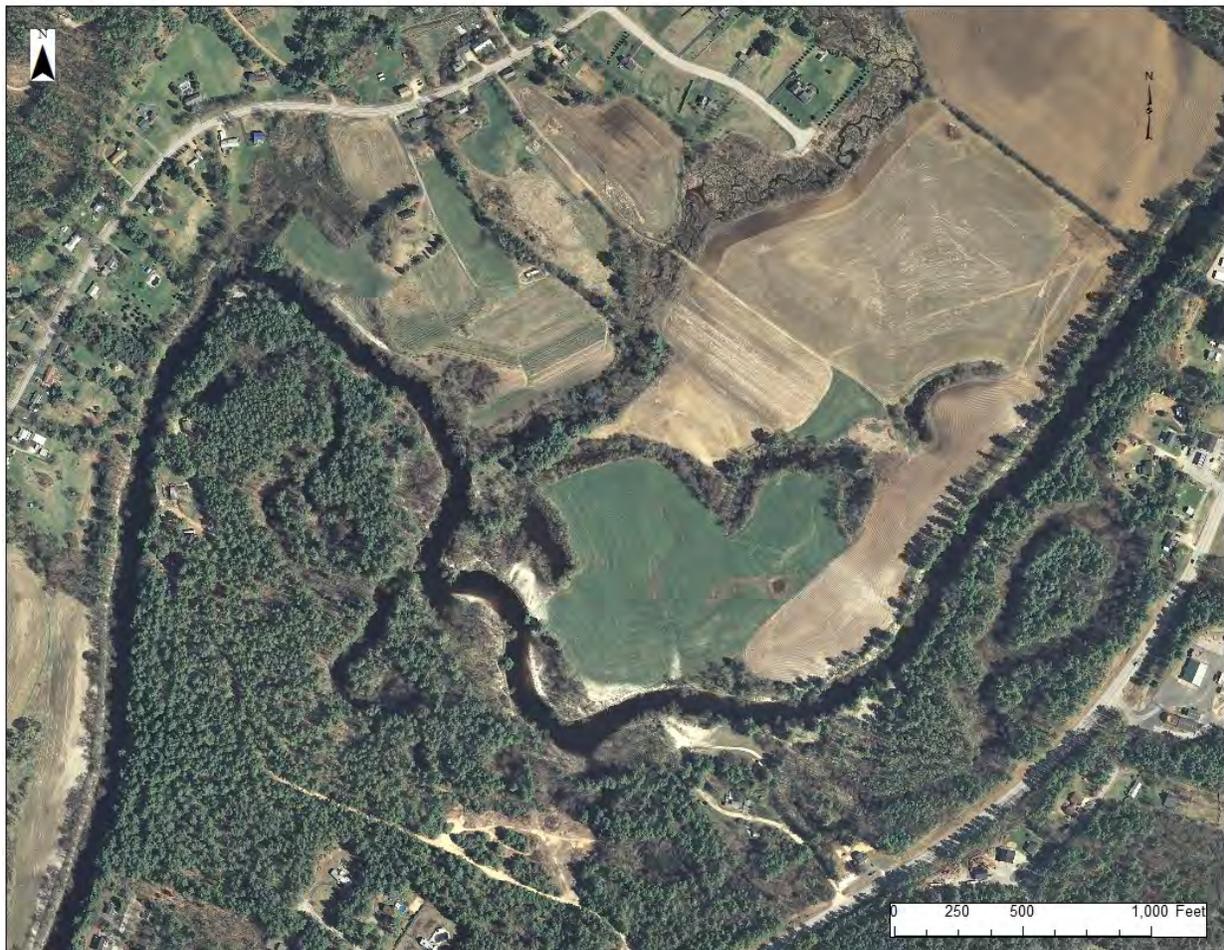
Figure 11. Aerial view of the Suncook River segment classified as Reach 5B. Note the increased incidence of meanders present in the reach, and the presence of oxbows (old river paths) adjacent to it in the floodplain. Note the greater amount of meandering (sinuosity) as compared to the straighter sections of river both directly upstream and downstream.

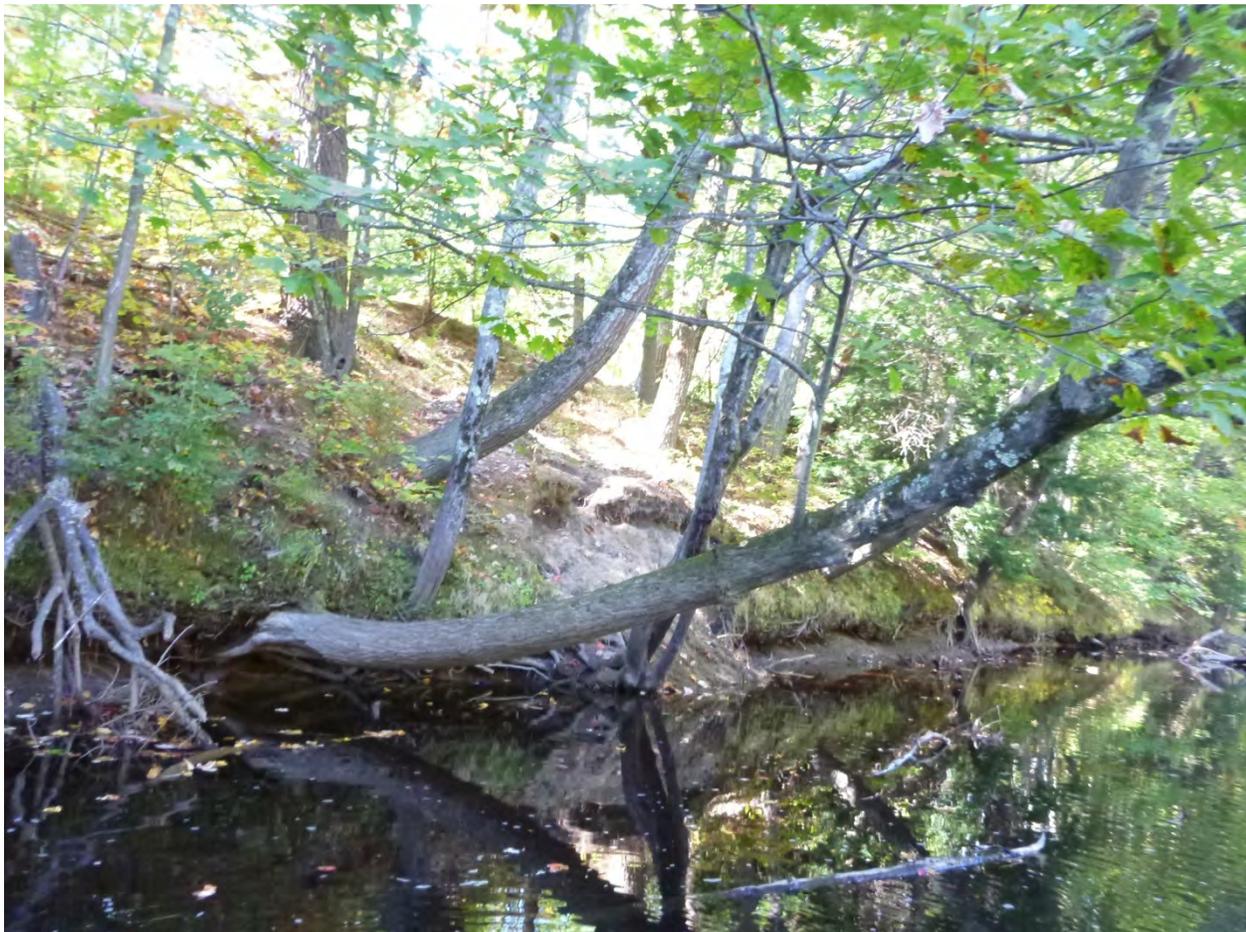
Slopes of the streambanks are typically steep, and are comprised of sand. Bank erosion is present on both banks, with a total of 1079 feet on the east bank (average 3 feet height) and 2480 feet on the west bank (average 5.5 feet height), which is producing overall channel widening (Figure 12). Bank revetment was mapped (length = 281 feet on east bank and 216 feet on west bank), which includes a wood armor bulkhead on the east bank. Adjacent land to the east of the channel is residential, while farm fields dominate to the west. Trees are also present adjacent to the channel on both sides, mainly near the banks, which are mostly deciduous, with a smaller quantity of coniferous. The channel canopy is open.

Figure 12. View of bank erosion and slumping in Reach 5C.

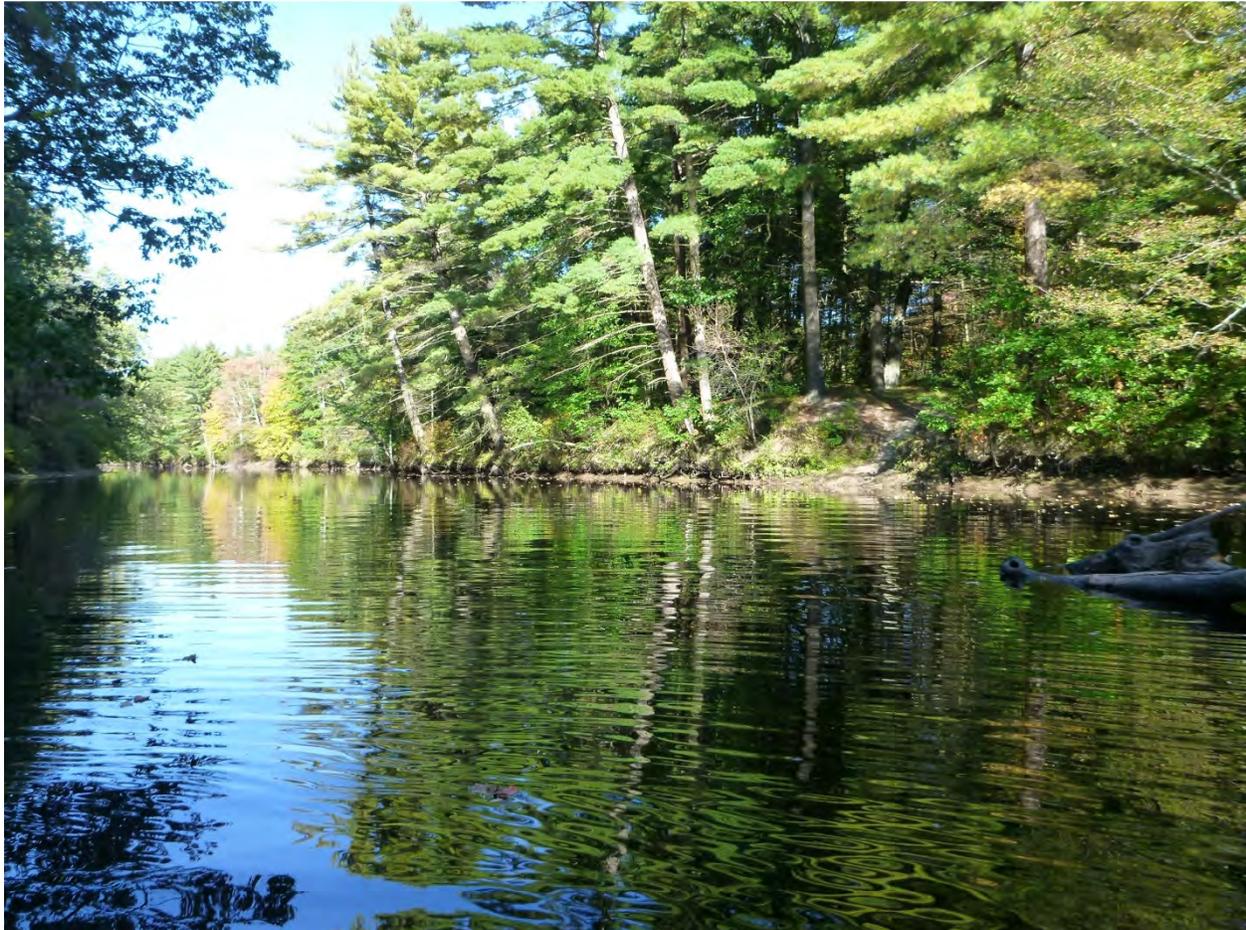
A total of 2 side bars, in addition to 1 island, are present within the reach. The entire length of river has been straightened (Figure 13).

Figure 13. Typical view of Reach 5C, looking upstream. Note the straightened nature of the reach.

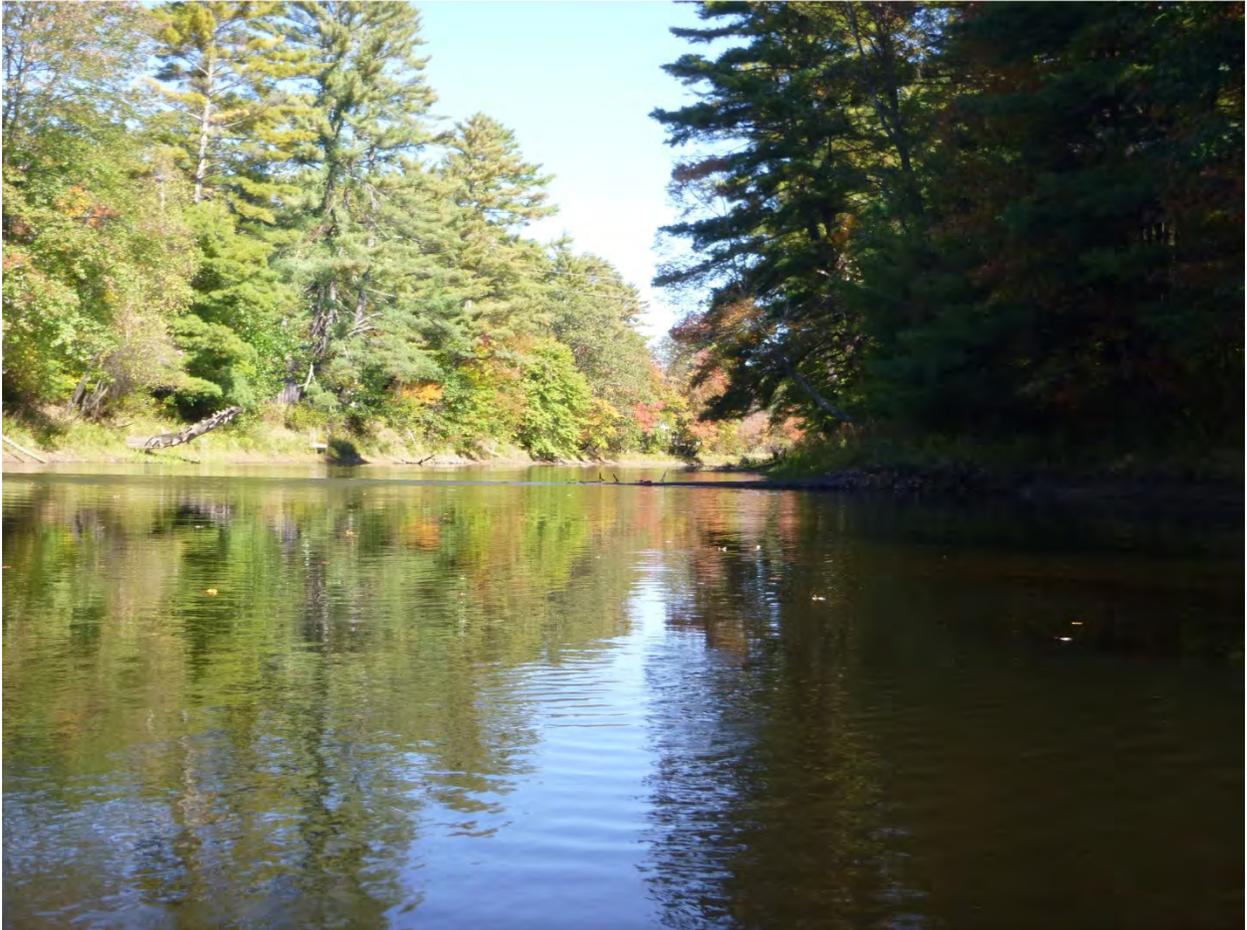
feet. The bed material is sand, with a fairly uniform ripple-dune bedform and no riffle-pool features present in the reach (Figures 14 and 15).

Figure 14. View that is typical of most of Reach 6A.

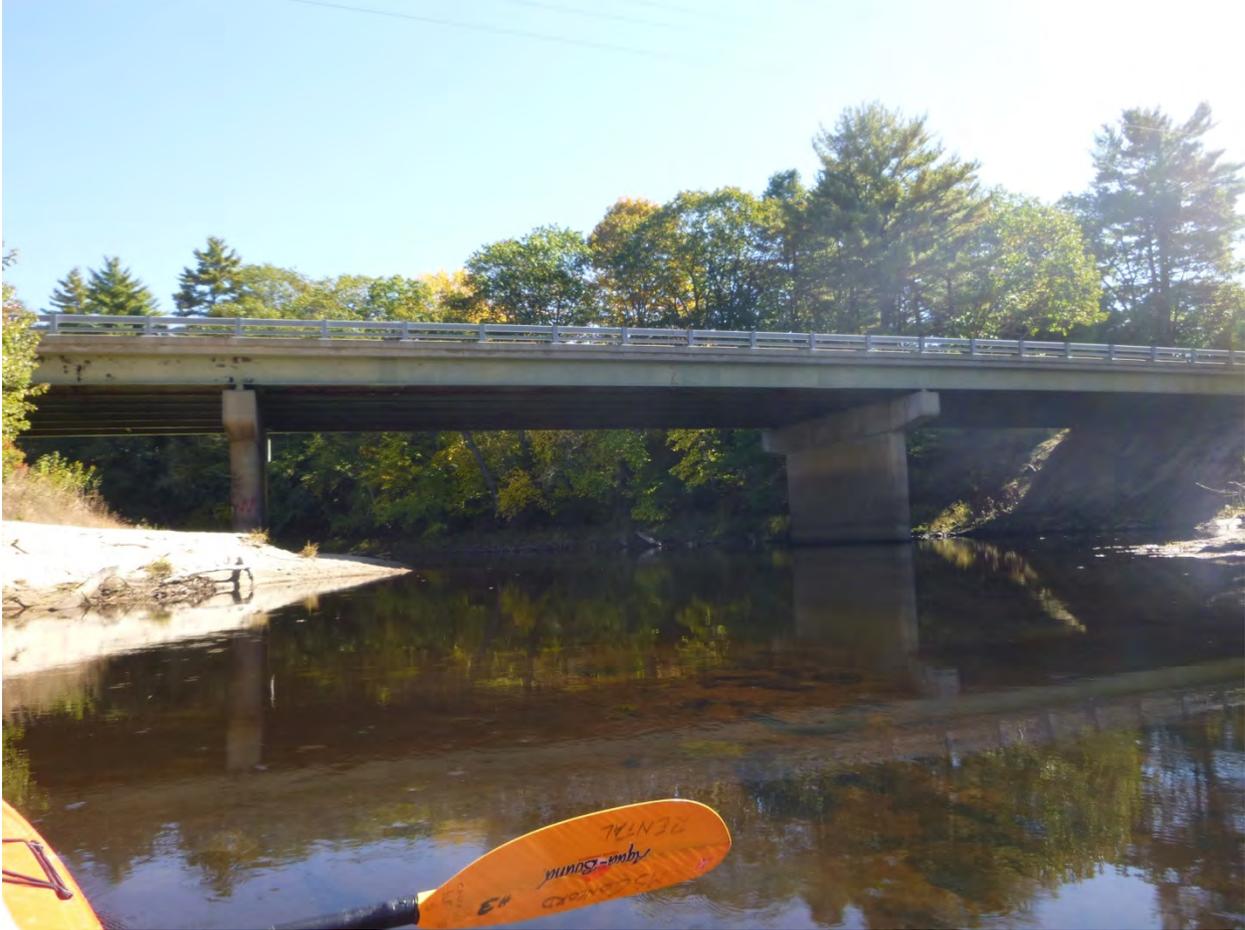
Figure 15. Another typical view of Reach 6A, upstream of the former Buck Street Dam site.

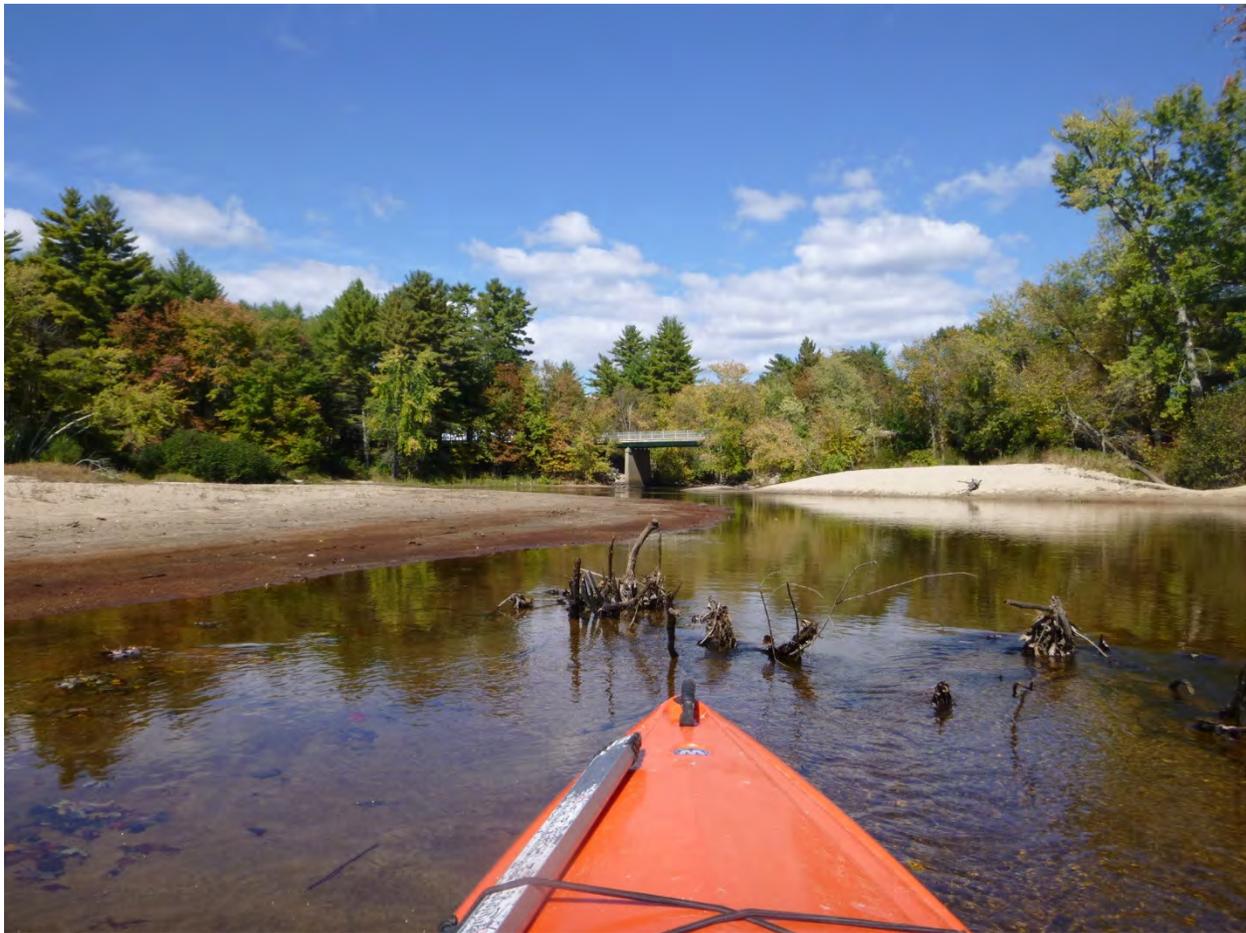
Based on a representative cross-section, the channel width is 126 feet, with a maximum depth of 3.8 feet. Width of the floodprone area is 132 feet. Riffles and pools were not present on the bed in the reach, which is governed instead by a sandy, ripple-dune form (Figures 16 and 17). Sand accretion on the bed in this reach is extensive, and results from the avulsion upstream that occurred in 2006 (Figures 16 through 18).

Figure 16. View in Reach 6B, looking upstream at the Short Falls Road bridge. Note the extensive sand accumulations on the bed and the large sand bars.

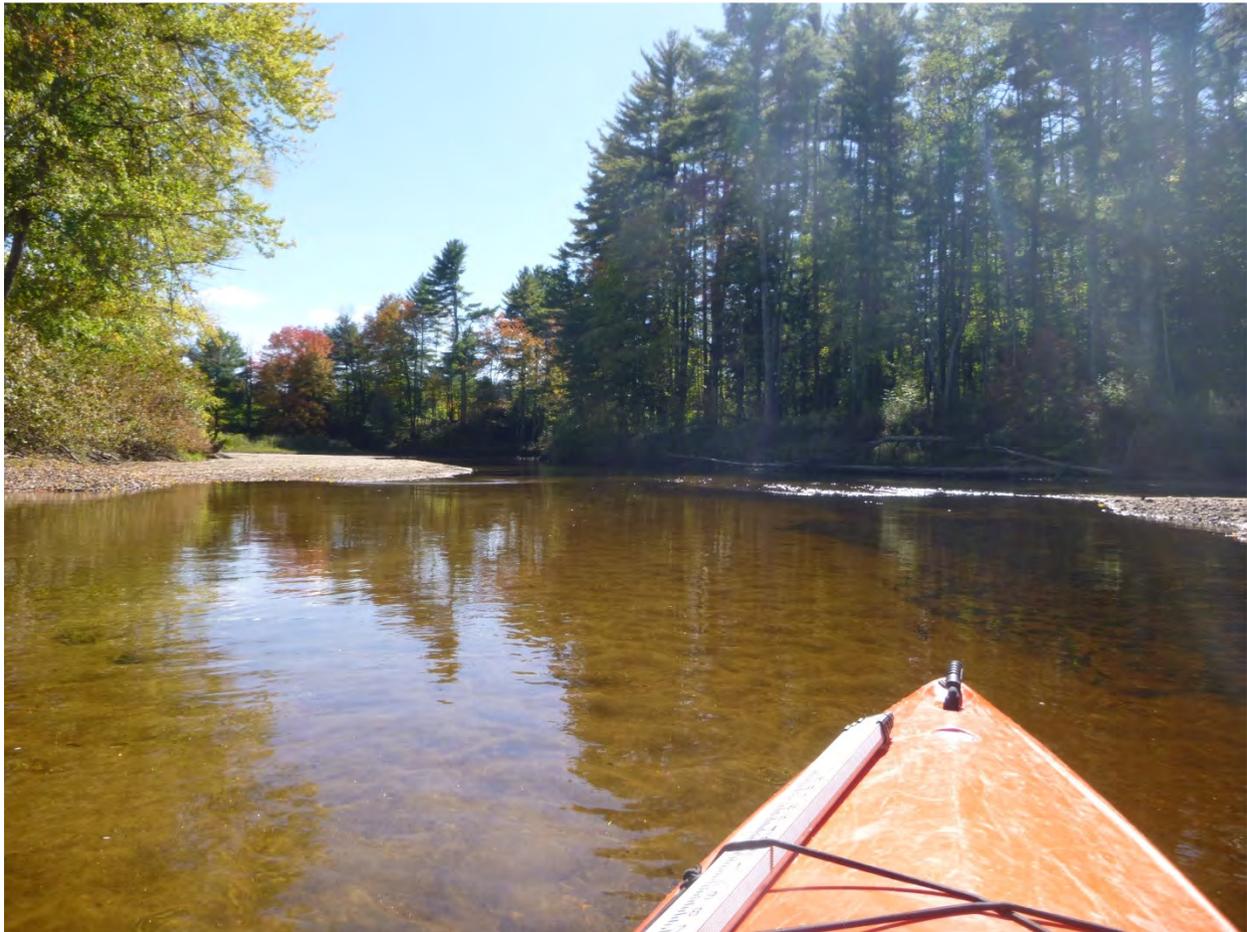
Figure 17. Downstream view from the vantage point in Figure 16. Note the extensively sandy, uniform bed, and side bar deposits in the distance.

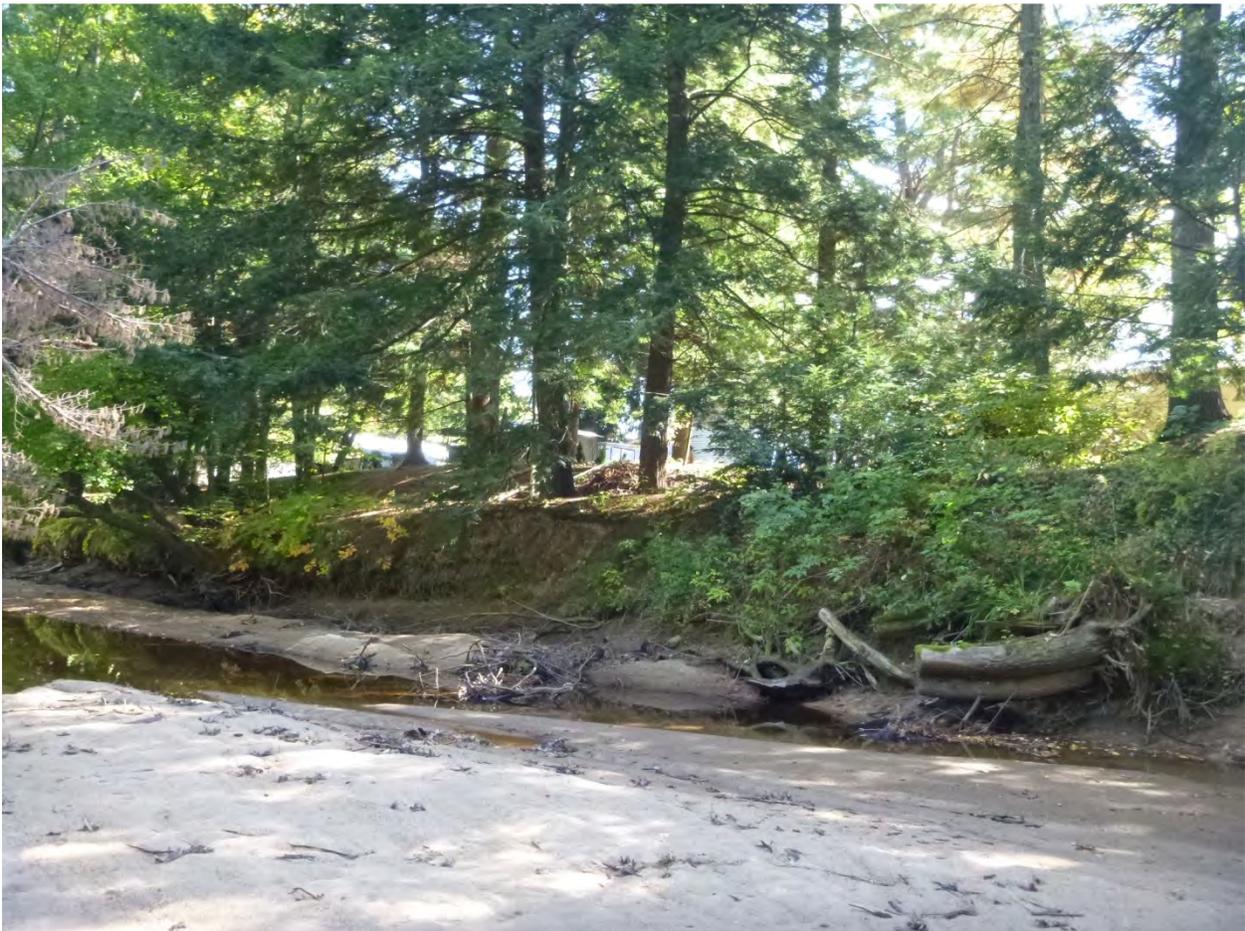
In this reach, 11 side bars, and 7 each of mid-channel and point bars (comprised of sand), a consequence of the 2006 avulsion upstream are present (Figure 18). One flood chute, and one instance of channel migration were also noted. A total of 18% of the reach length (1164 feet) is identified as having been straightened in the past, and this was found to have occurred with windrowing, meaning that evidence of material dredged from the river in the past being deposited adjacent to the river was found.

Figure 18. A view of the west bank in the vicinity of the trailer park downstream of Short Falls Road. Note the depositions of sand, both in the form of a bar (foreground) and adjacent to the base of the banks.
