Suncook River
Fluvial Geomorphology Assessment
Explanation Guide
Allenstown, Pembroke, and Epsom, NH

New Hampshire Geological Survey
New Hampshire Department of Environmental Services
Spring 2015

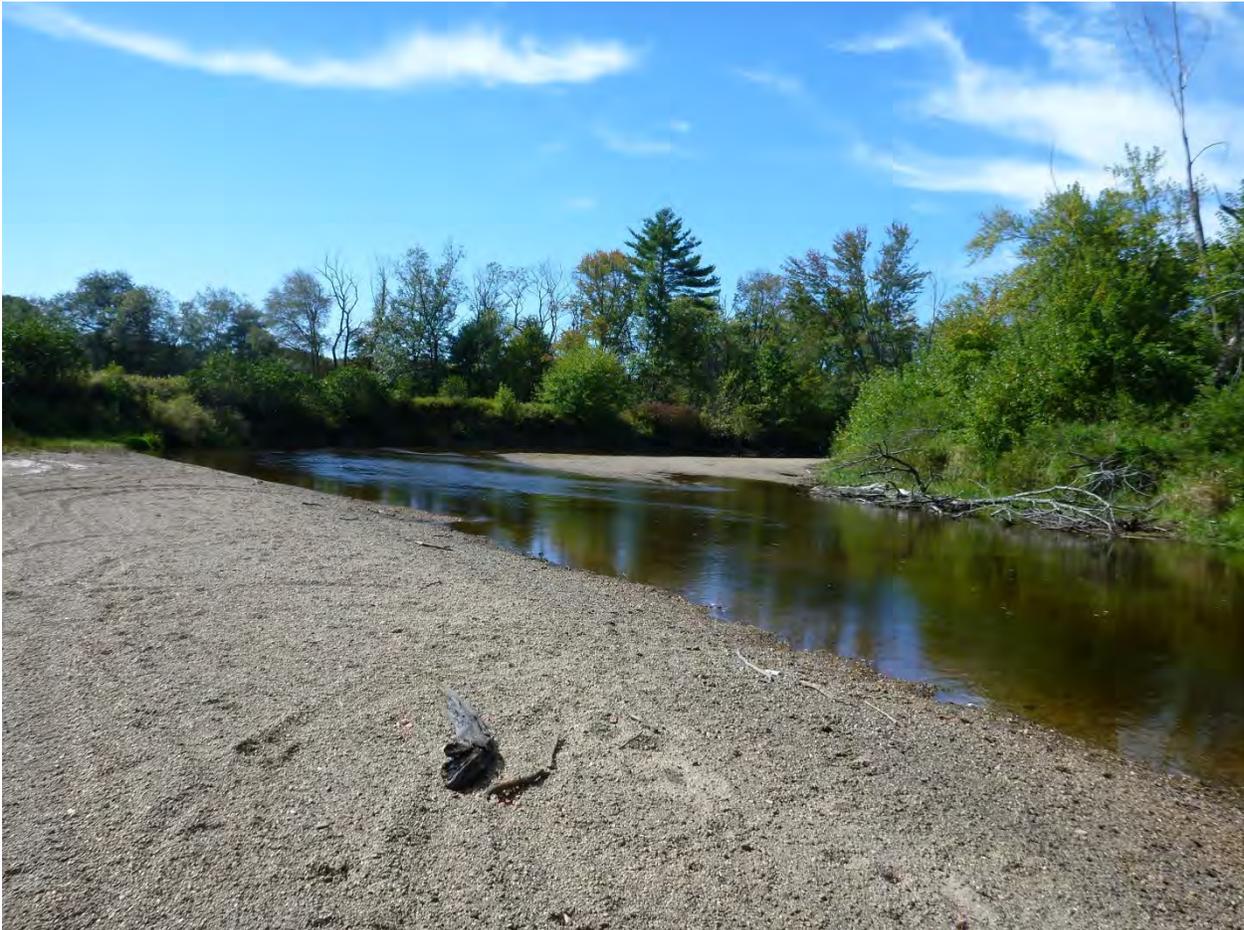
Figure 19. View looking downstream into the first meander bend from the upstream end of the reach.

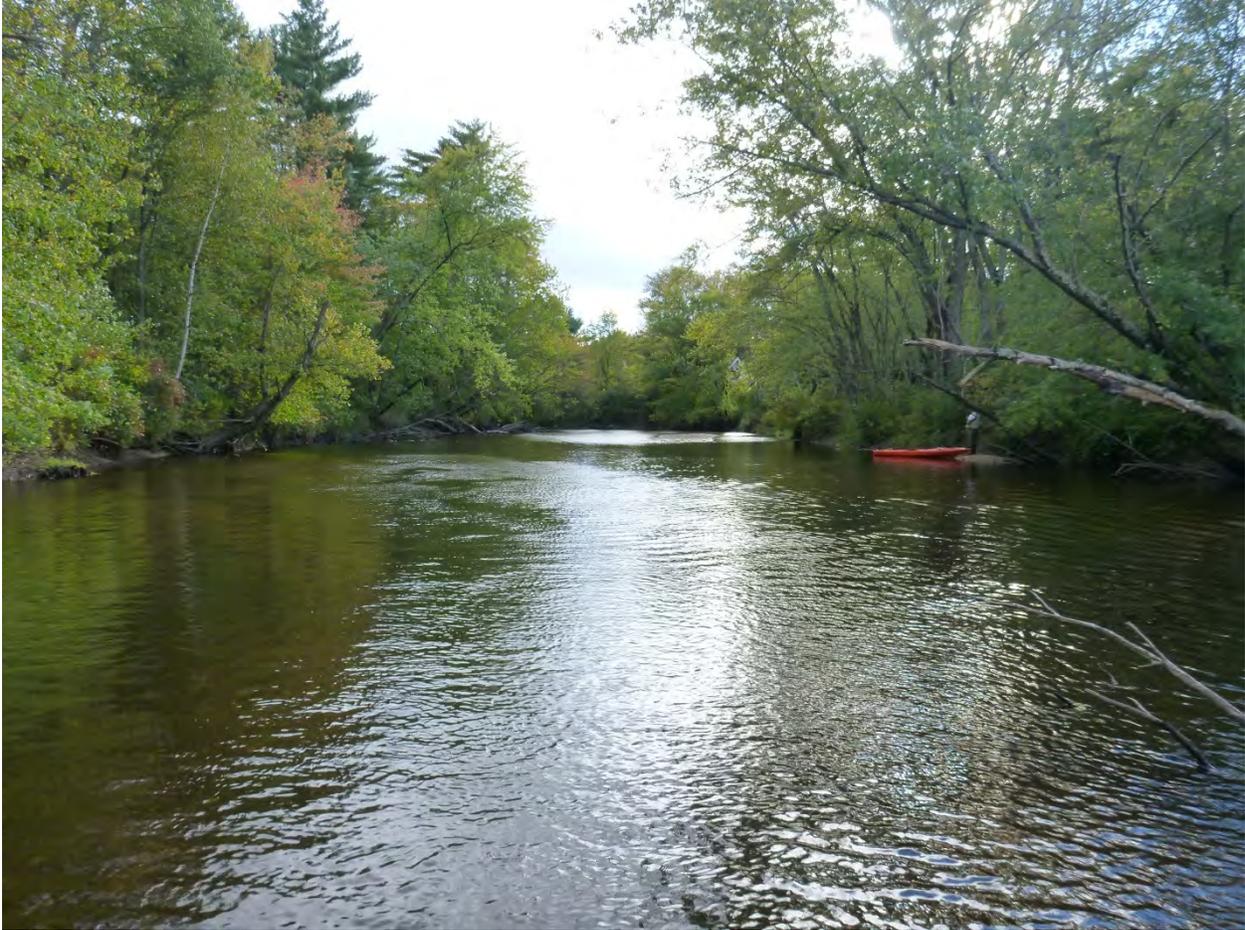
Figure 20. View (looking downstream) toward the lower end of Reach 7A.

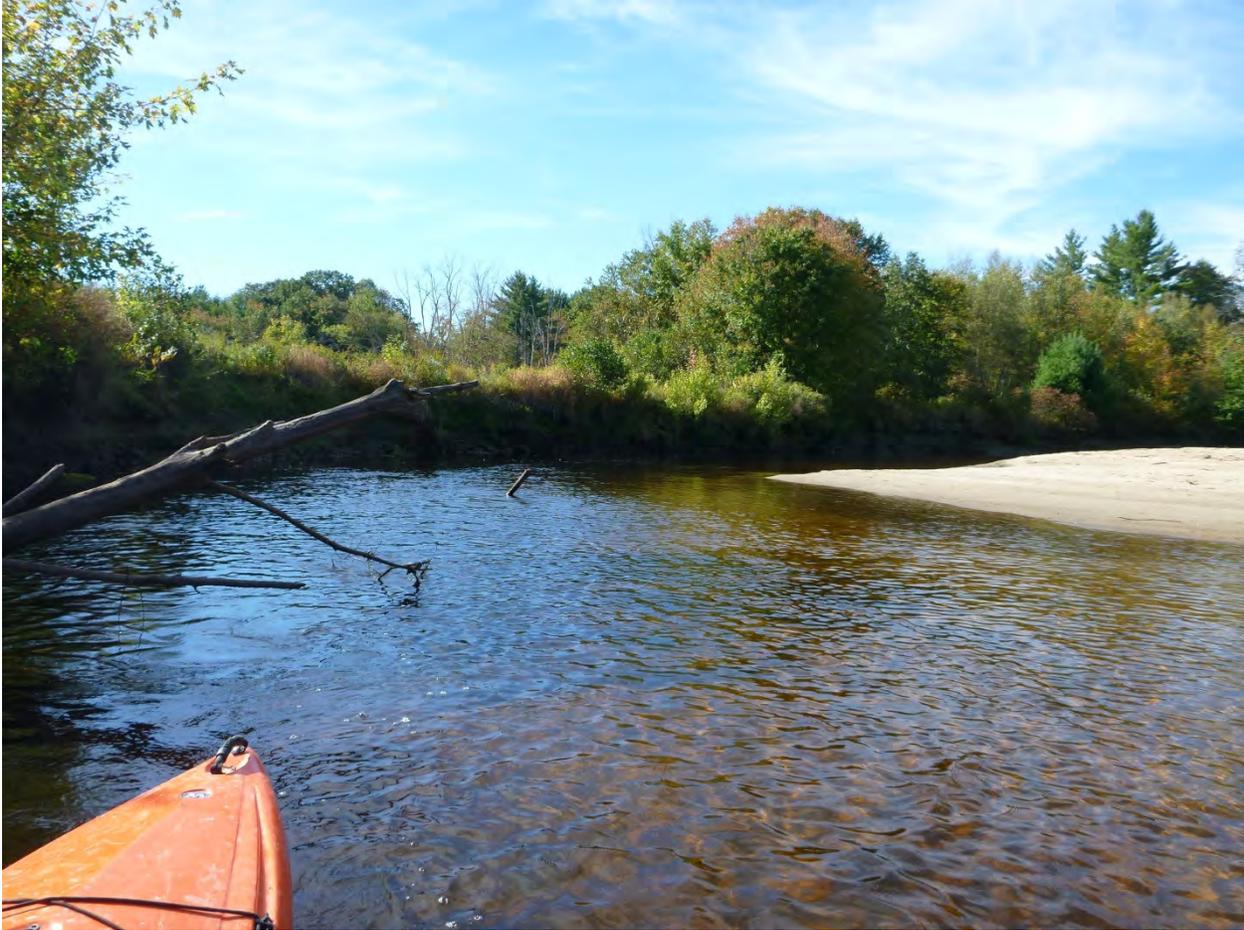
Streambank slopes are typically steep, with the bank bases composed of cohesive silt/clay, which is overlain by non-cohesive sand. In terms of bank erosion, 1130 feet of erosion (with an average height of 4.2 feet) is present on the east bank, with 700 feet (average height of 3.4 feet) on the west bank. Presence of erosion is marked on the outsides of meander bends, and the potential exists for some channel migrations or cut-offs of the existing meanders. Bank revetment in the form of rip-rap for the reach totals 451 feet to the east, and 647 feet to the west. There is a 1-25% bank tree canopy on both sides of the channel. The adjacent floodplain consists mostly of fields, with shrubs and saplings also present. The river itself has an open channel canopy.

Figure 21. Closer view of the bank erosion on the outside of a meander bend in Reach 7A.

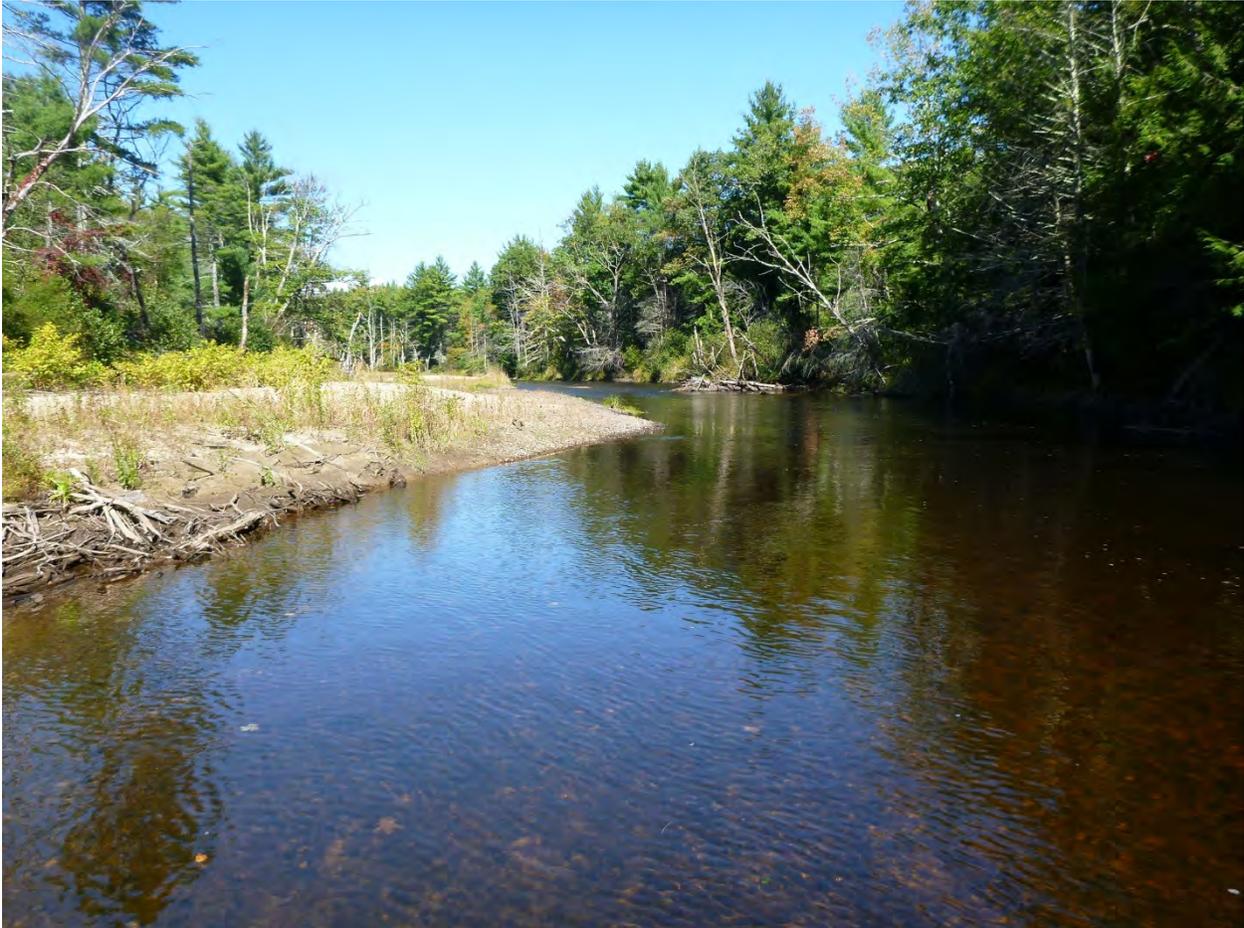
Figure 22. Typical view of the Suncook River in Reach 7B, looking upstream. Note the uniform gravel nature of the bed.

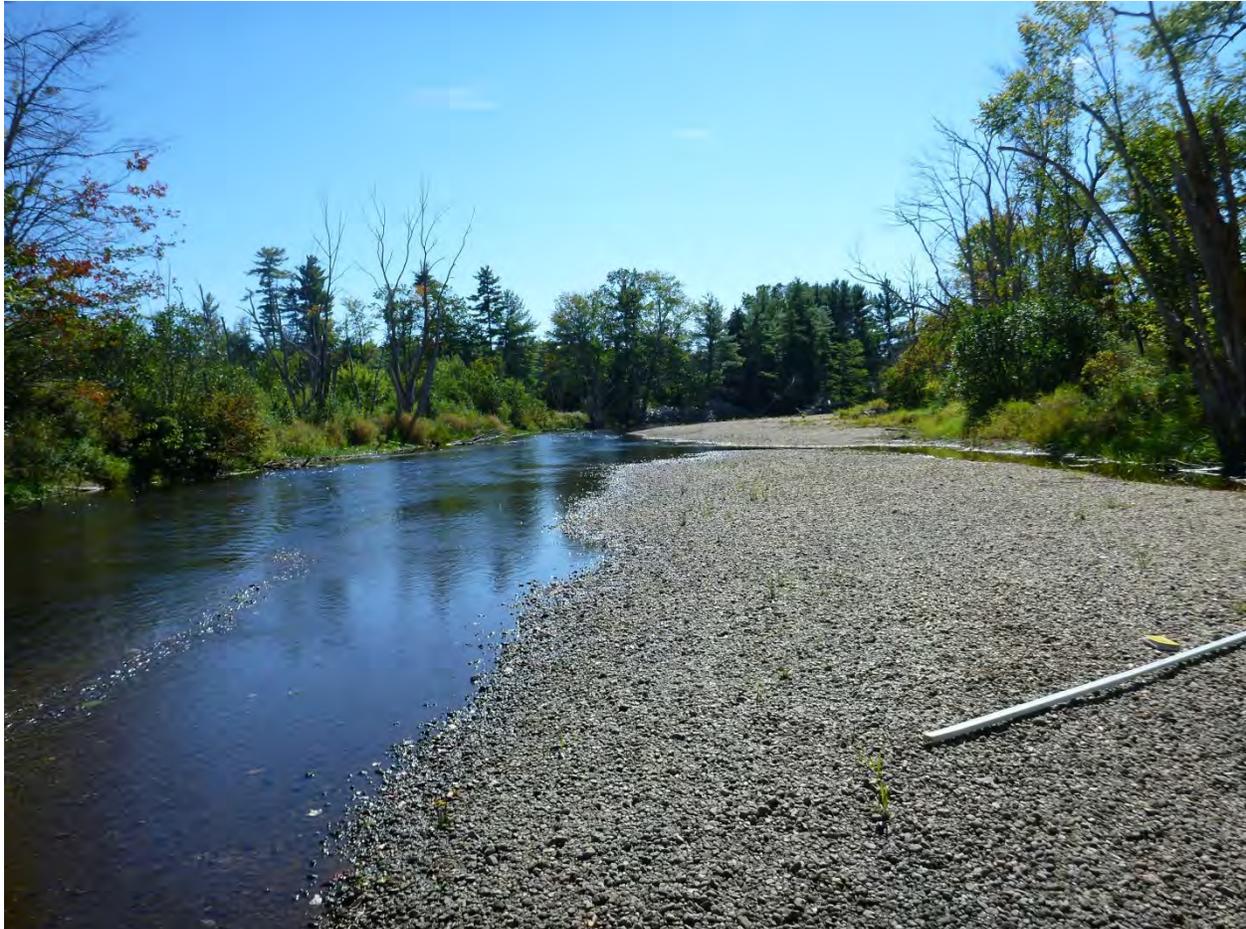
Figure 23. Downstream view in Reach 7B, with east bank at left. Note how the river flow is connected with the adjacent wetland here.

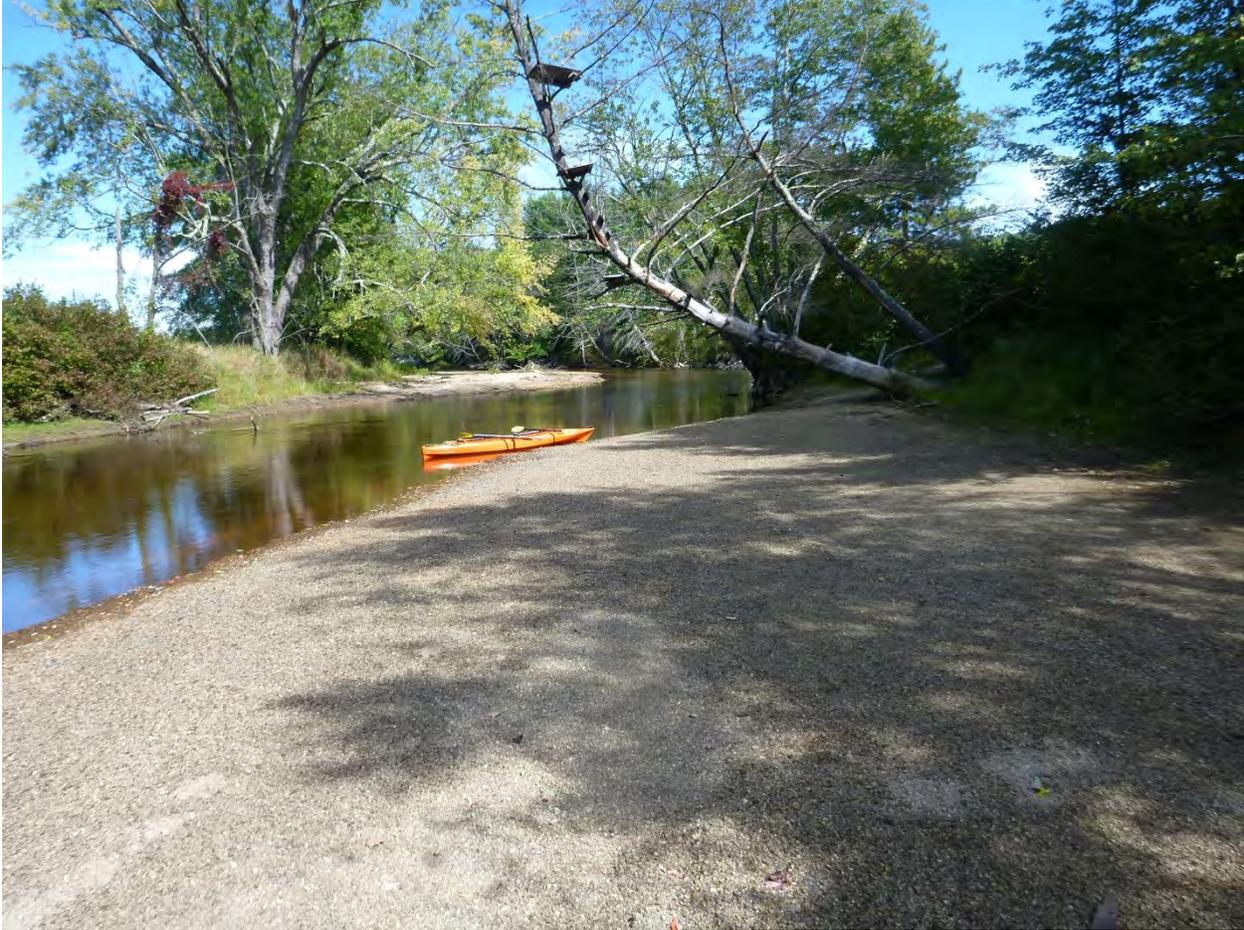
A total of 12 bars were mapped in the reach, including 2 mid-channel bars, 6 alternating point bars, and 4 side bars (Figure 24). A total of 3227 feet, or 99% of the reach length, has been straightened. The only area that is not mapped as straightened is directly at the downstream end of the reach, where the river enters the tight meander loops that constitute the majority of Reach 7A. As noted above, 34% of the east bank has erosion, and it is in these locations where the river is attempting to meander, a process typical of straightened river reaches.

Figure 24. Typical view of Reach 7B, looking upstream in this photo. Note the presence of the gravel bars, and the leaning trees, indicative of bank erosion.

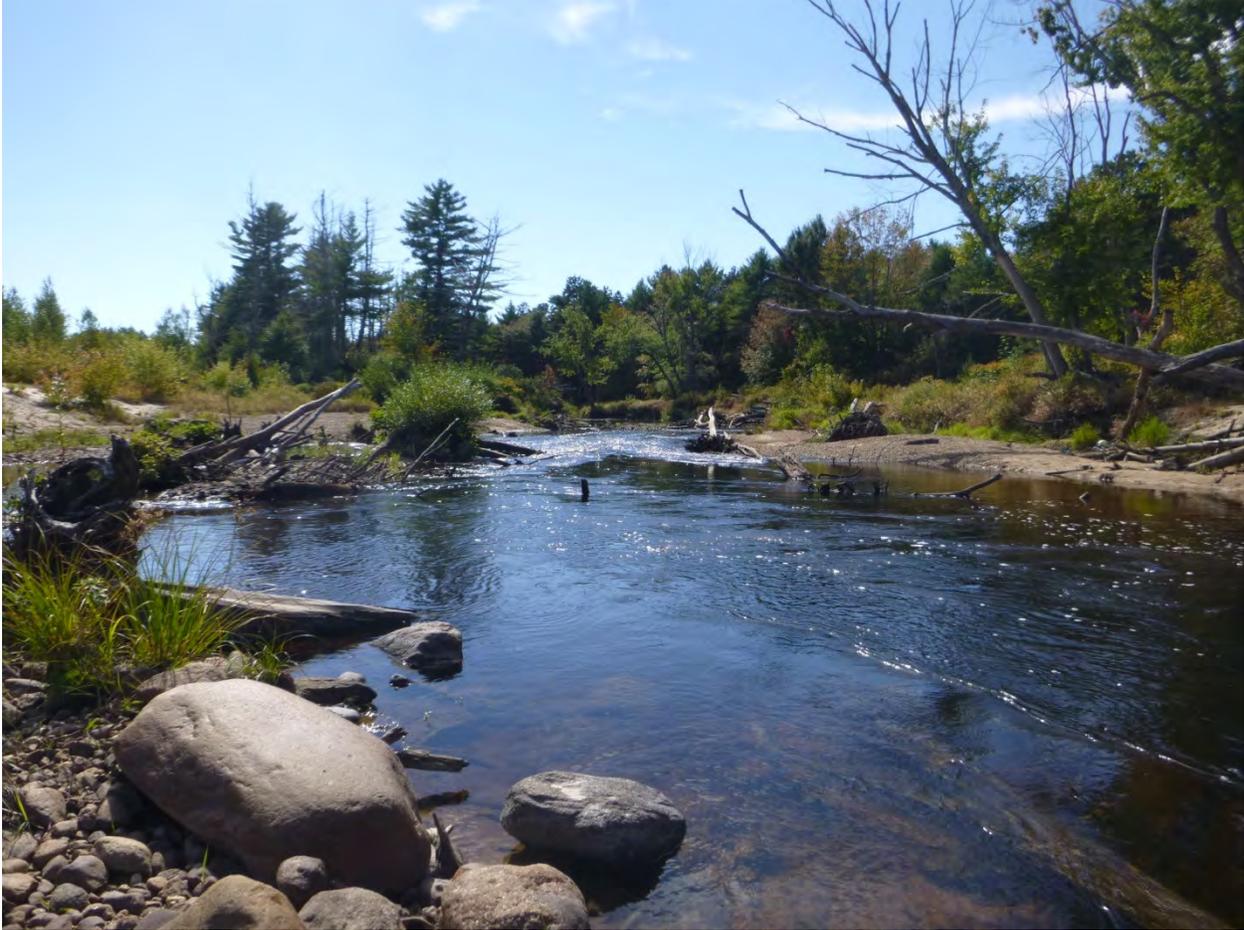
Figure 25. Example view of Suncook River, Reach 8. In this view, you are looking downstream at the upstream extent of the reach (just downstream of the avulsion).

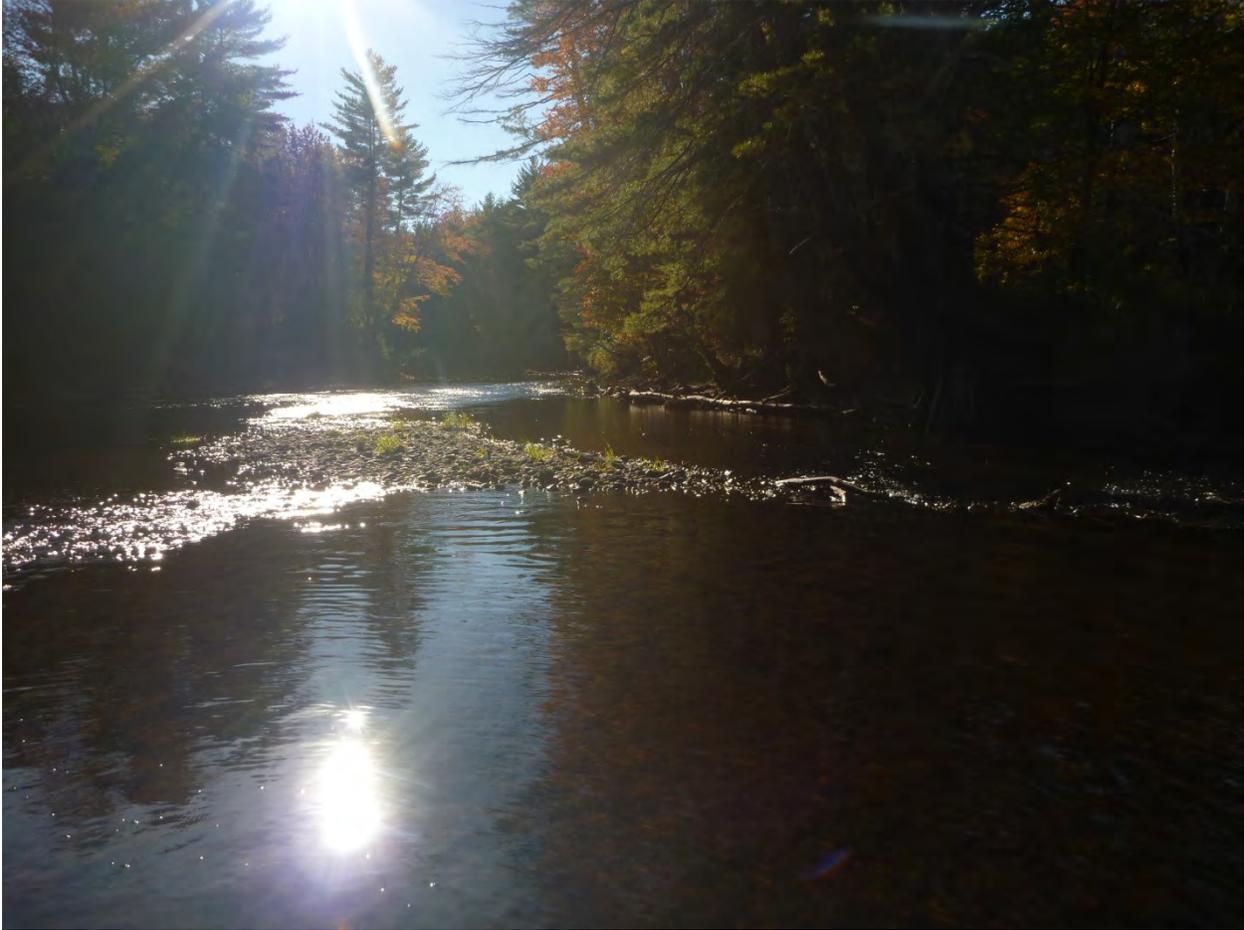
Figure 26. Typical view of Reach 8, looking downstream. While there is sun glare in this photo, note the relatively level topography of the streambed, the predominantly gravel composition, and the very shallow conditions. The mid-channel bar (the area raised and not covered by water) in the photo appears to be comprised of cobbles.

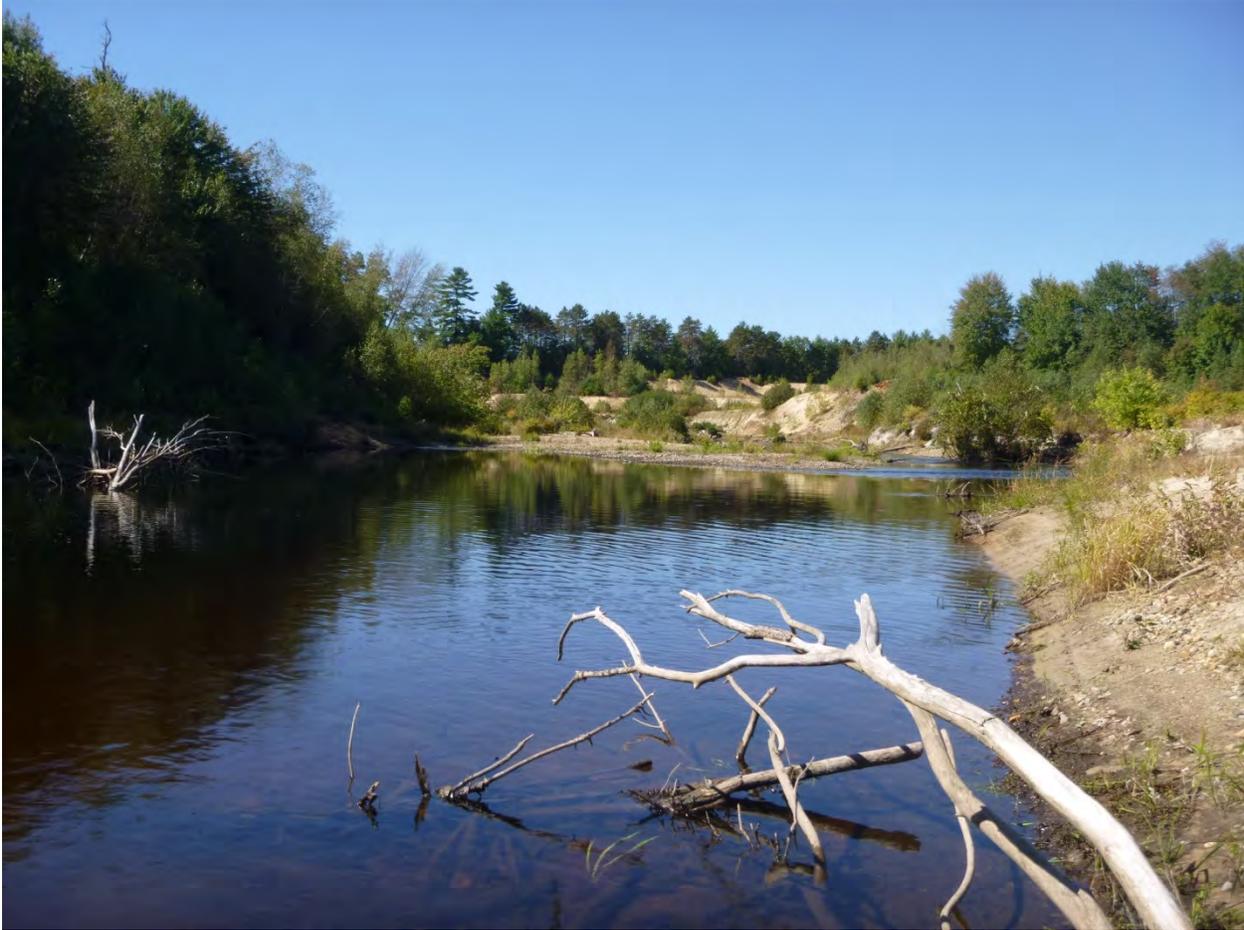
Figure 29. View of Suncook River looking downstream along the new channel resulting from the 2006 avulsion. The section of the channel in the foreground was a wetland area prior to the avulsion. A former sand and gravel operation can be seen in the distance to the right (or west) of the river in the distance.

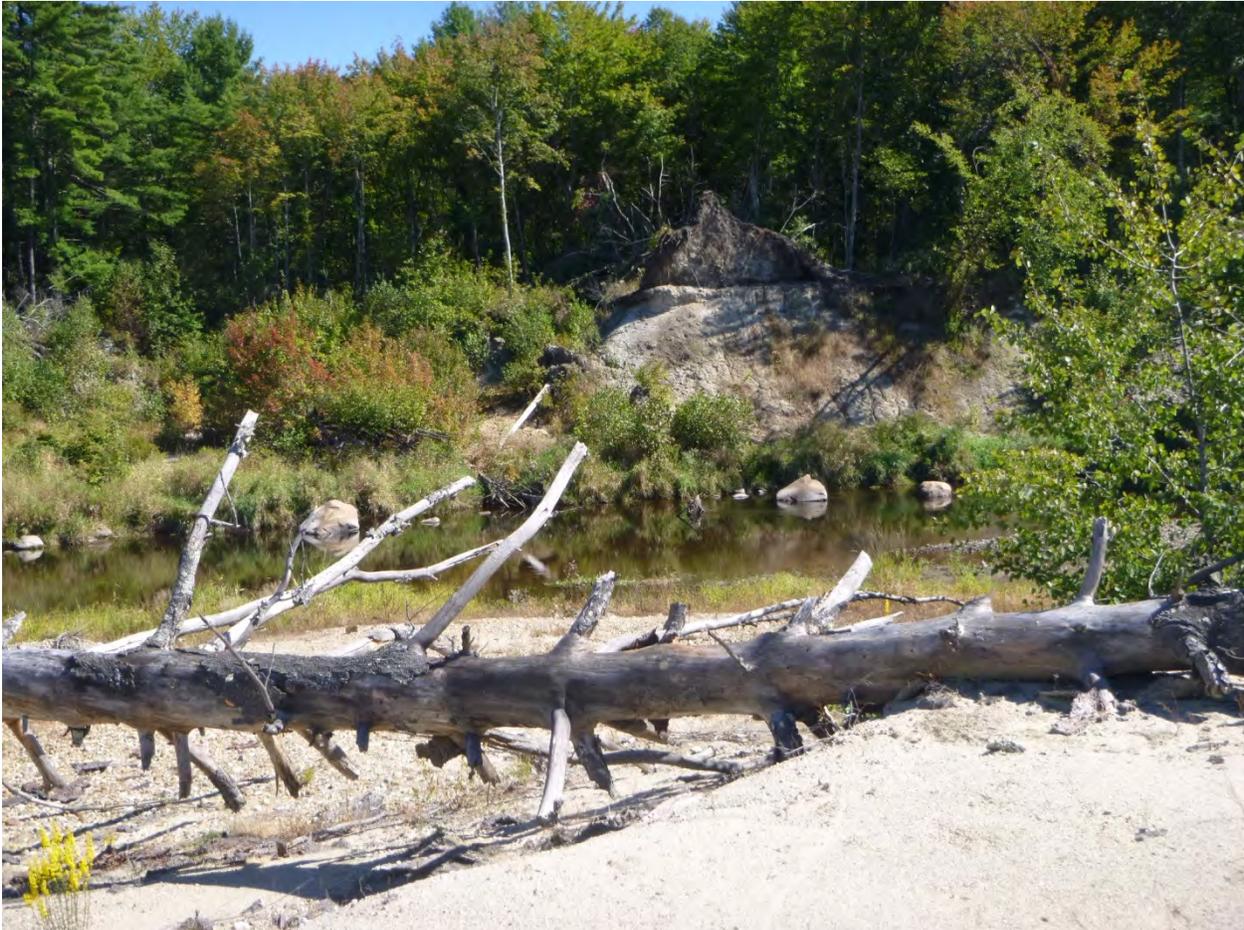
Streambank slopes are typically steep, and are comprised of sand throughout. Mass failures and bank erosion are present along the east bank downstream of the Leighton Brook tributary confluence to the end of the reach. Length of the mass failure that begins at Leighton Brook extends for 720 feet downstream along the outside of the meander bend, with bank erosion continuing for another 765 feet downstream (average height of 15.5 feet) (Figure 30). Along the west bank, a total of 994 feet of erosion is measured, with an average height of 12 feet. The river continues to erode downward into the landscape and into the banks, and thus, widening continues. No bank revetment is present in the reach.

Figure 30. Looking east toward the outside of the meander bend on the Suncook River near the Leighton Brook tributary input. The mass failure on this bend can be clearly seen.

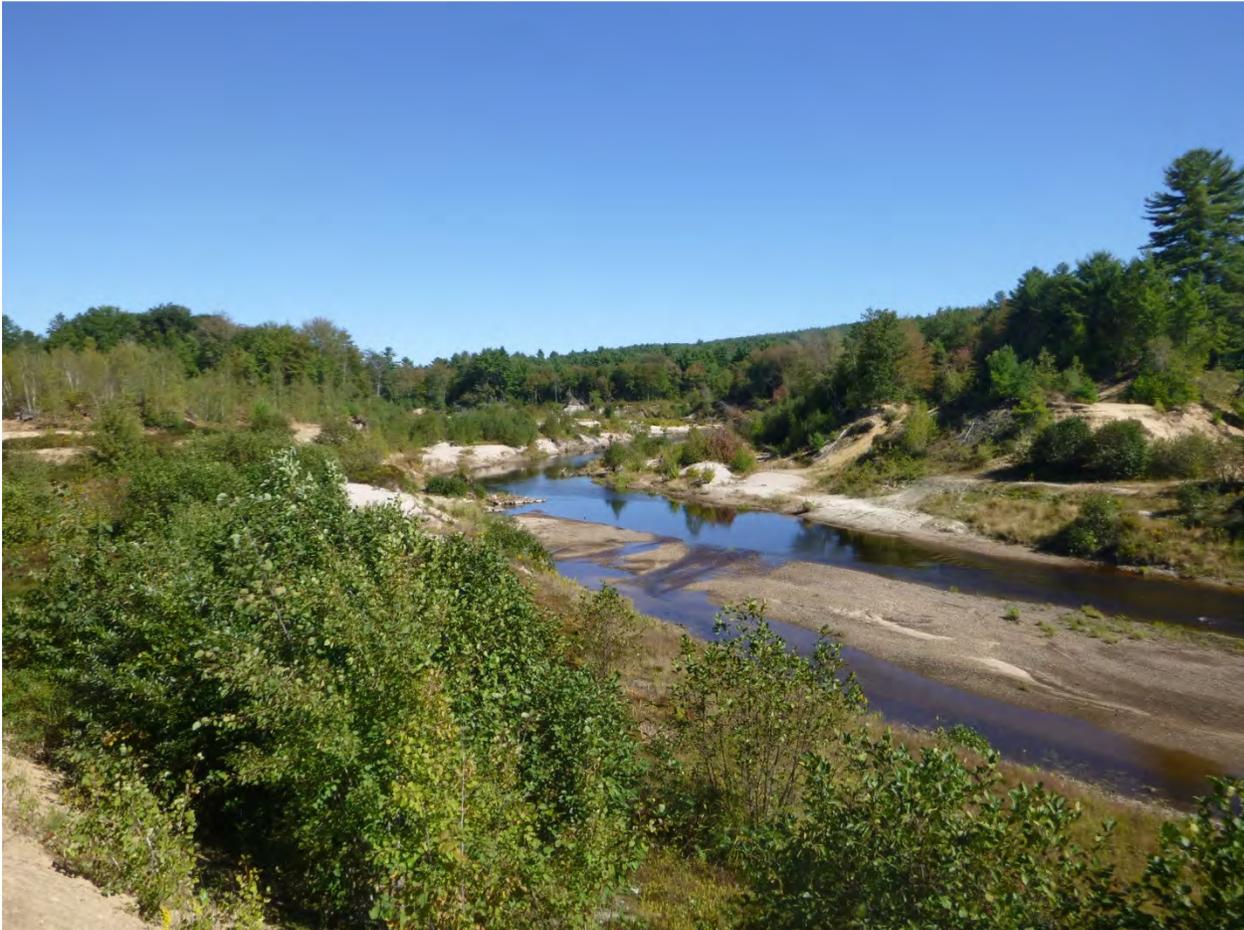
Figure 31. Upstream view through much of Reach 9. The area in view upstream of this location is a former wetland. Note the accumulation of gravel and sand in the stream channel, which constitutes the steep riffle noted above.

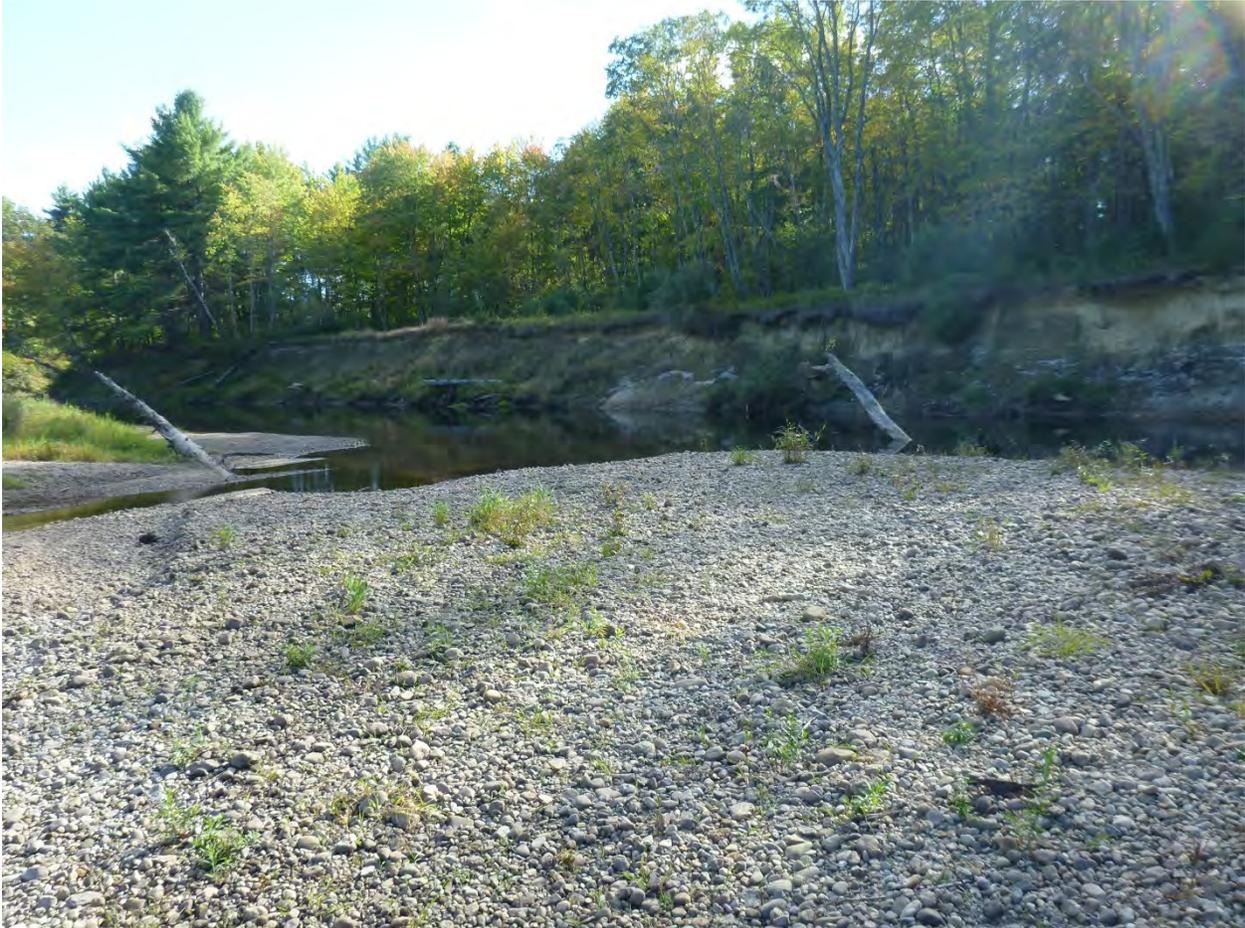
Figure 32. Looking at the west bank of the Suncook River from a depositional bar. Note the erosion on the bank, and the distance between the water surface and the top of the bank, which is the elevation of adjacent floodplain.

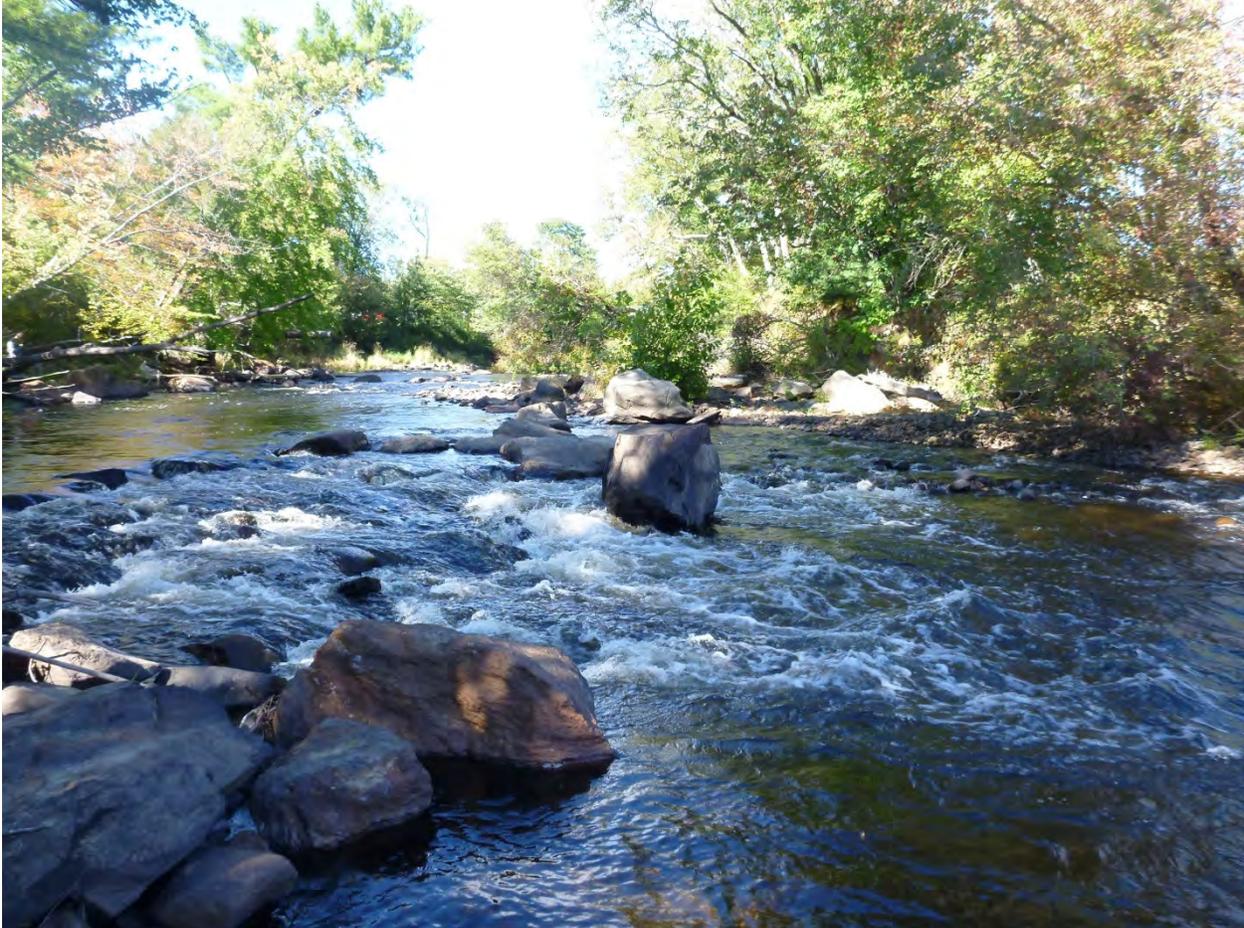
Figure? 33. View upstream. Route 4 bridge is in the distance beyond the green sapling in the channel, which appears to have recently fallen into the channel. The feature to the left of the photo is one of the head cuts that are present in this reach.

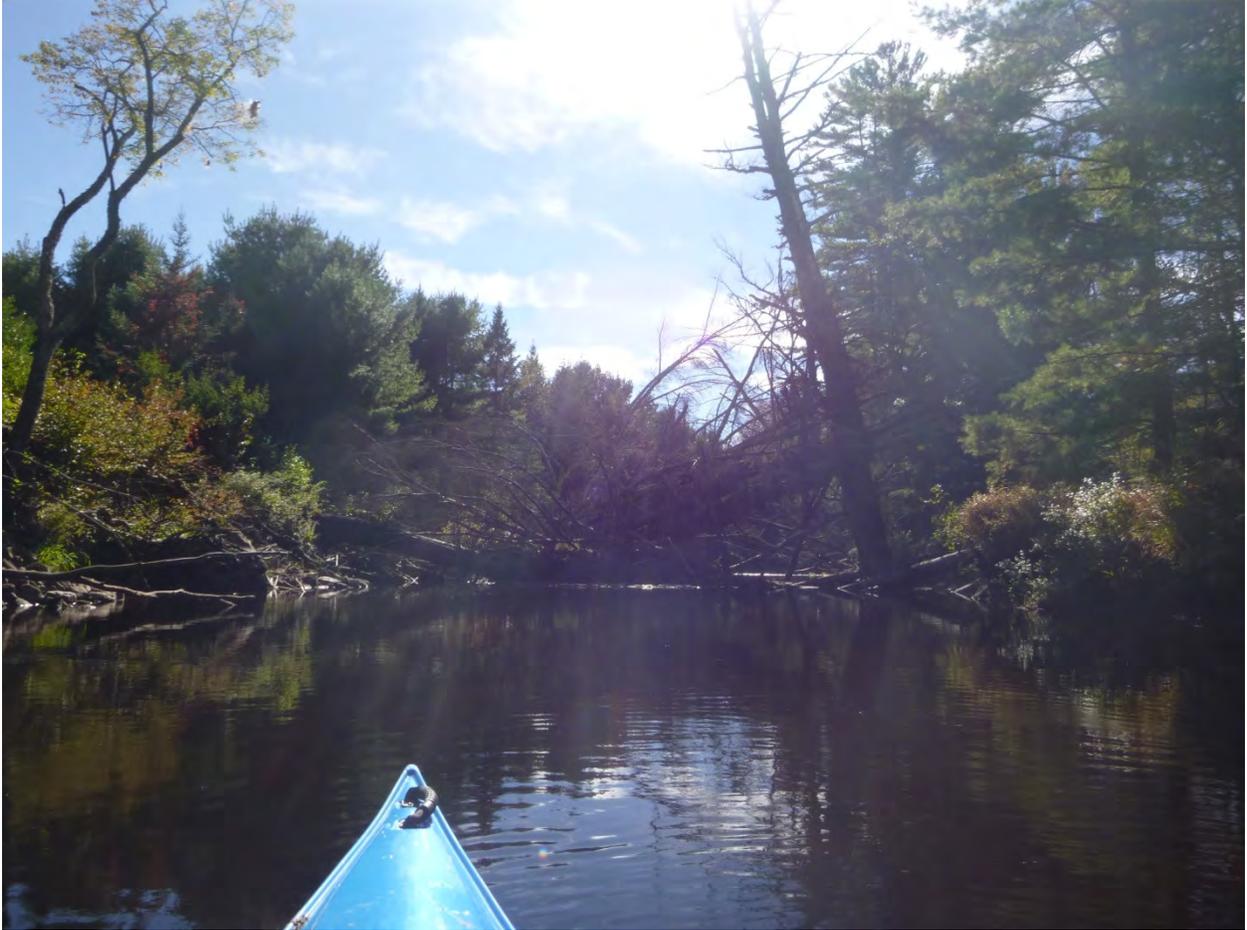
Figure B-1. View looking downstream at the very large log jam in the Suncook River between the former gravel operation and Round Pond. (Photo 1 of 3 from highest density segment.)

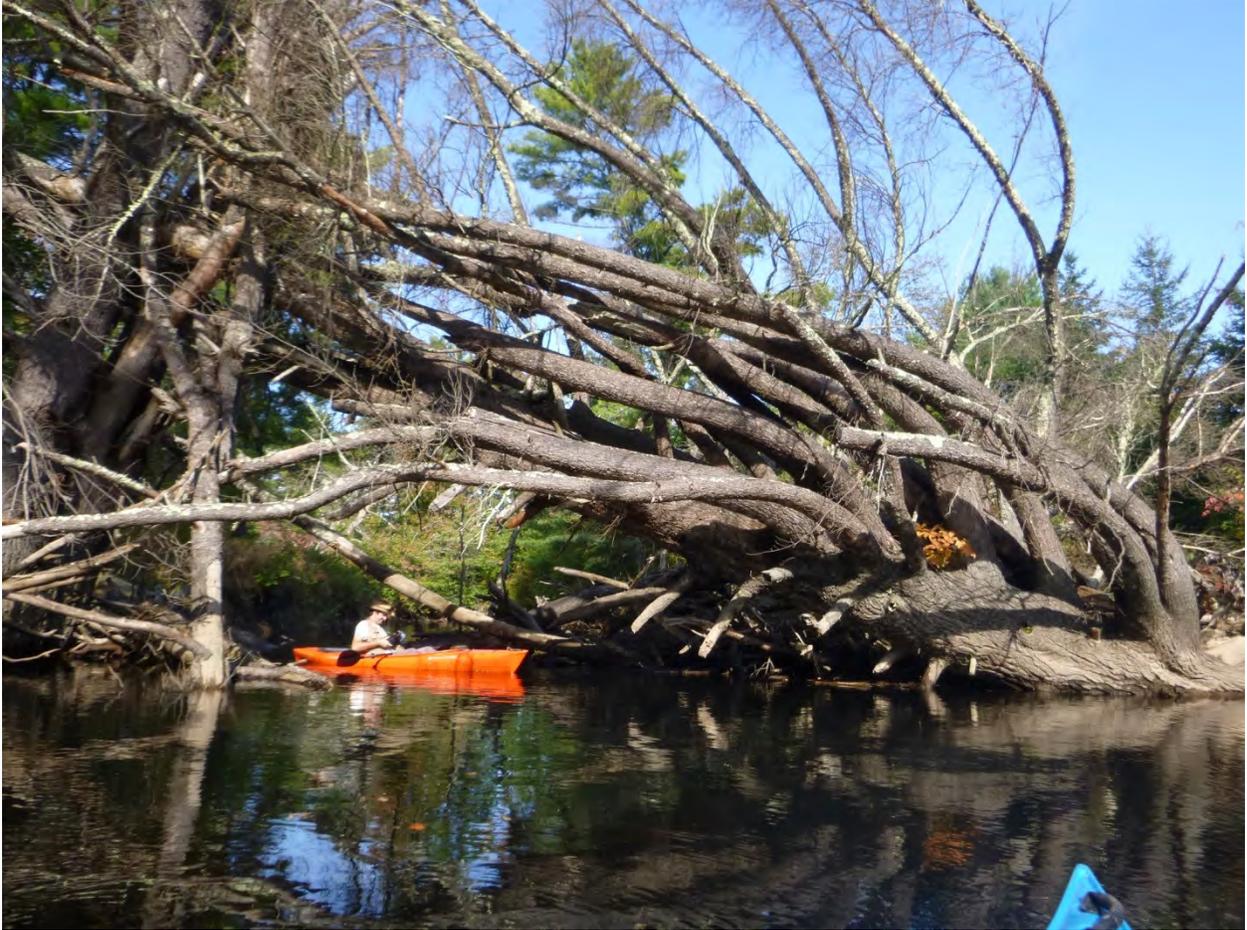
Figure B-2. View looking upstream at the very large log jam on the Suncook River. (Photo 2 of 3 from highest density segment.)

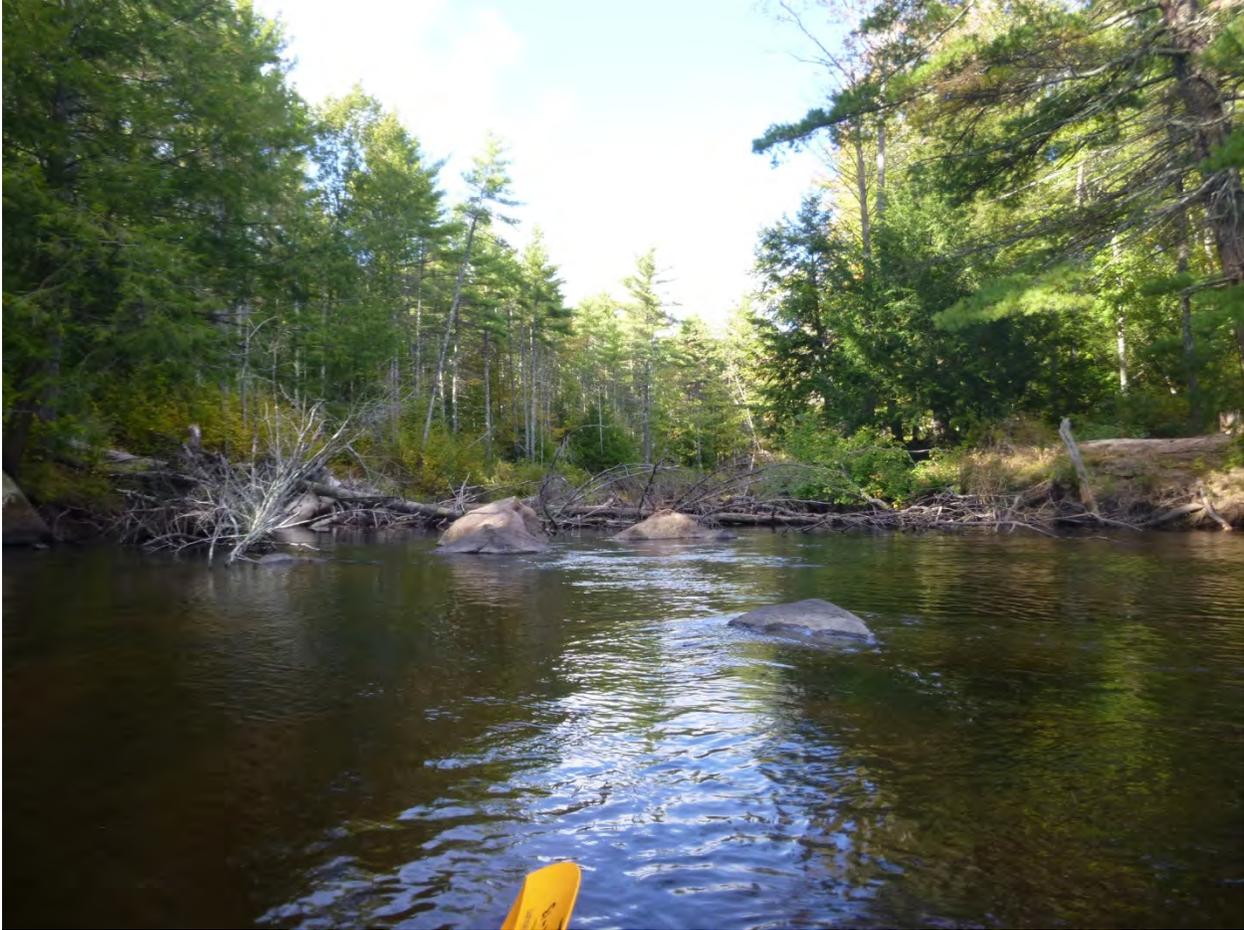
Figure B-3. Upstream view of log jam, located in the Suncook River directly upstream of Round Pond. (Photo 3 of 3 from highest density segment.)

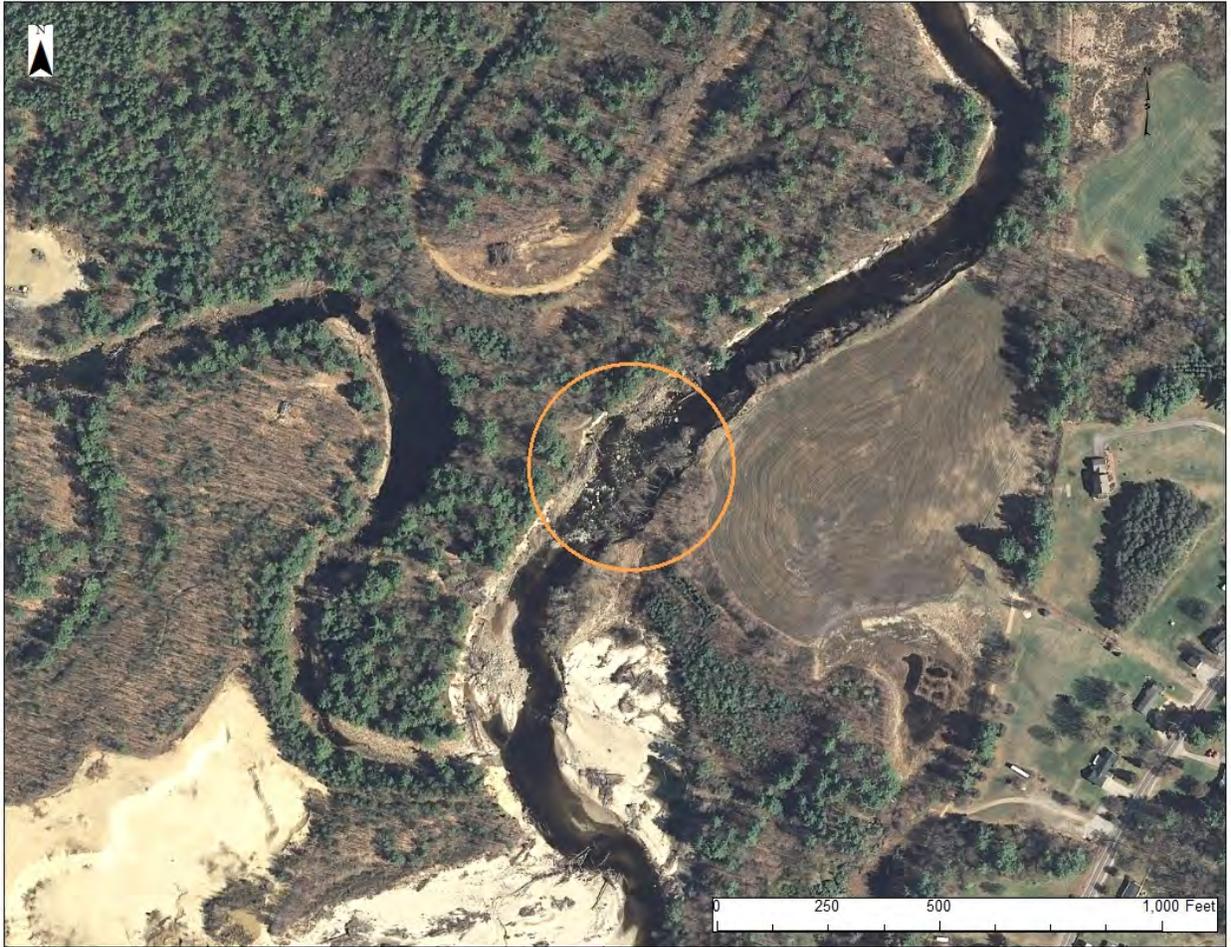
Figure B-4. View of the area upstream of the avulsion with the second highest densities and highest individual piece count in the Suncook River assessment, shown within the tan circle on map.

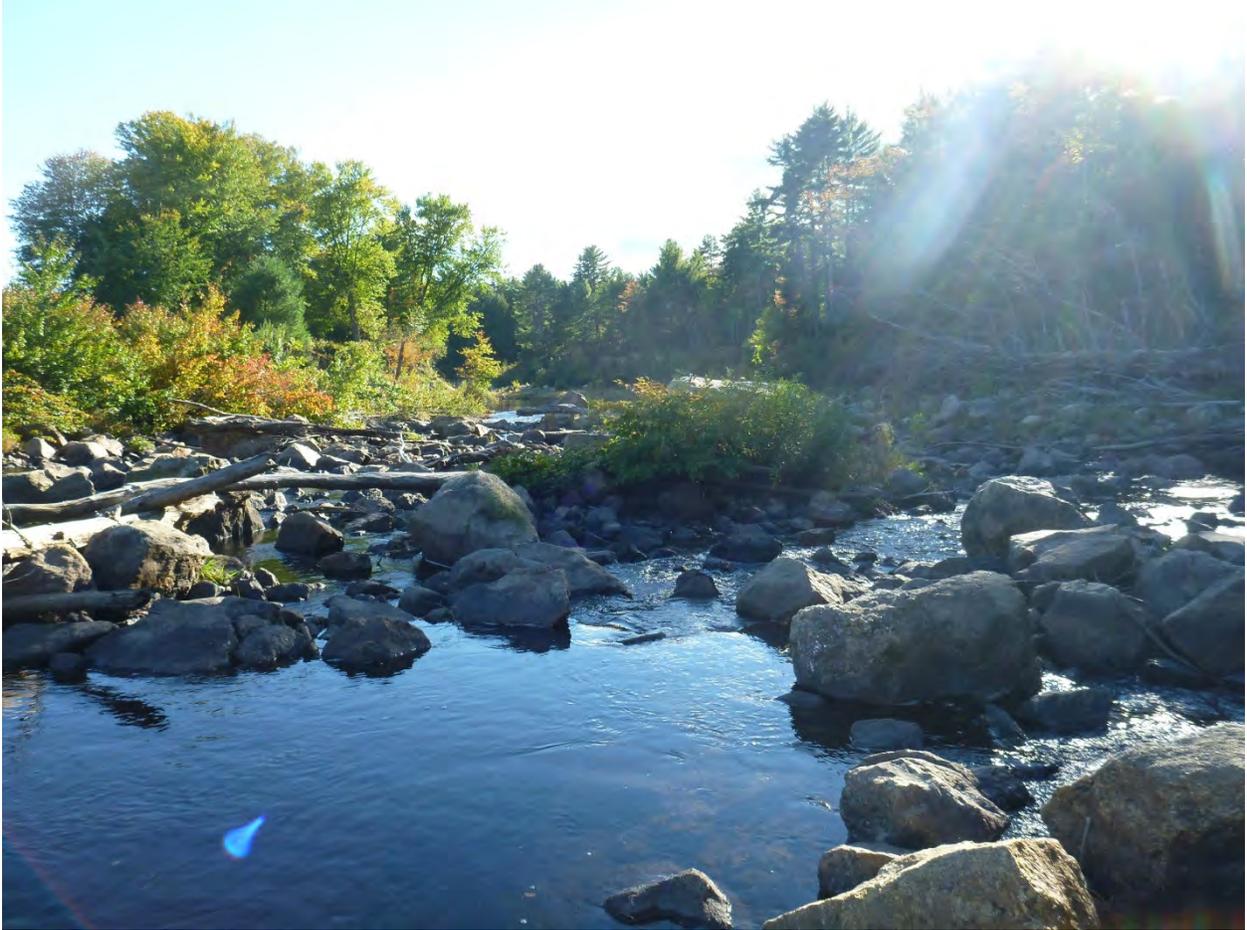
Figure B-5. View looking downstream through the area of exposed boulders. Note the many pieces of wood in the photo.
