Suncook River
Fluvial Geomorphology Assessment
Explanation Guide
Allenstown, Pembroke, and Epsom, NH

New Hampshire Geological Survey
New Hampshire Department of Environmental Services
Spring 2015

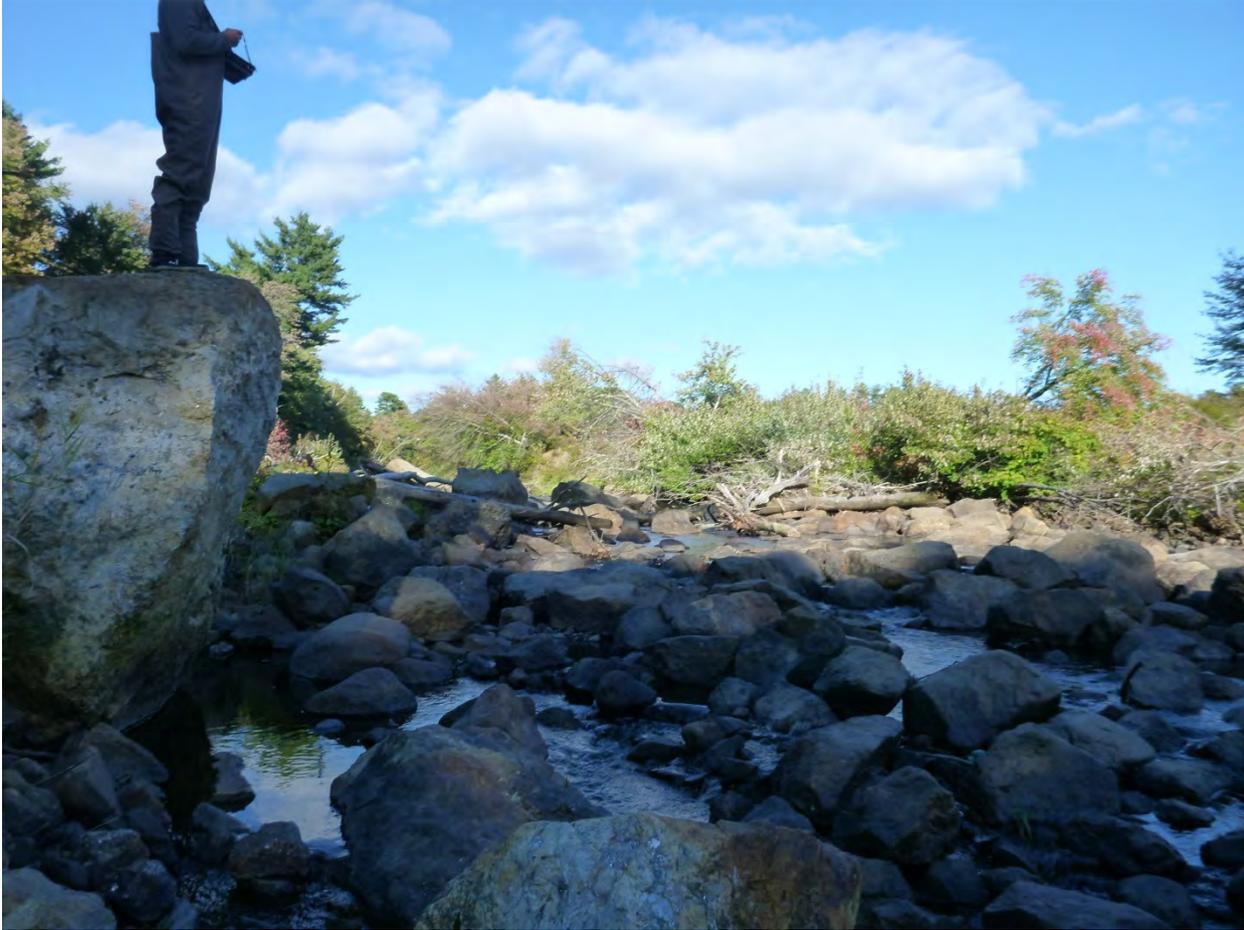
Figure B-6. View looking upstream in the area with the large boulders. Note the pieces of wood across the bed.

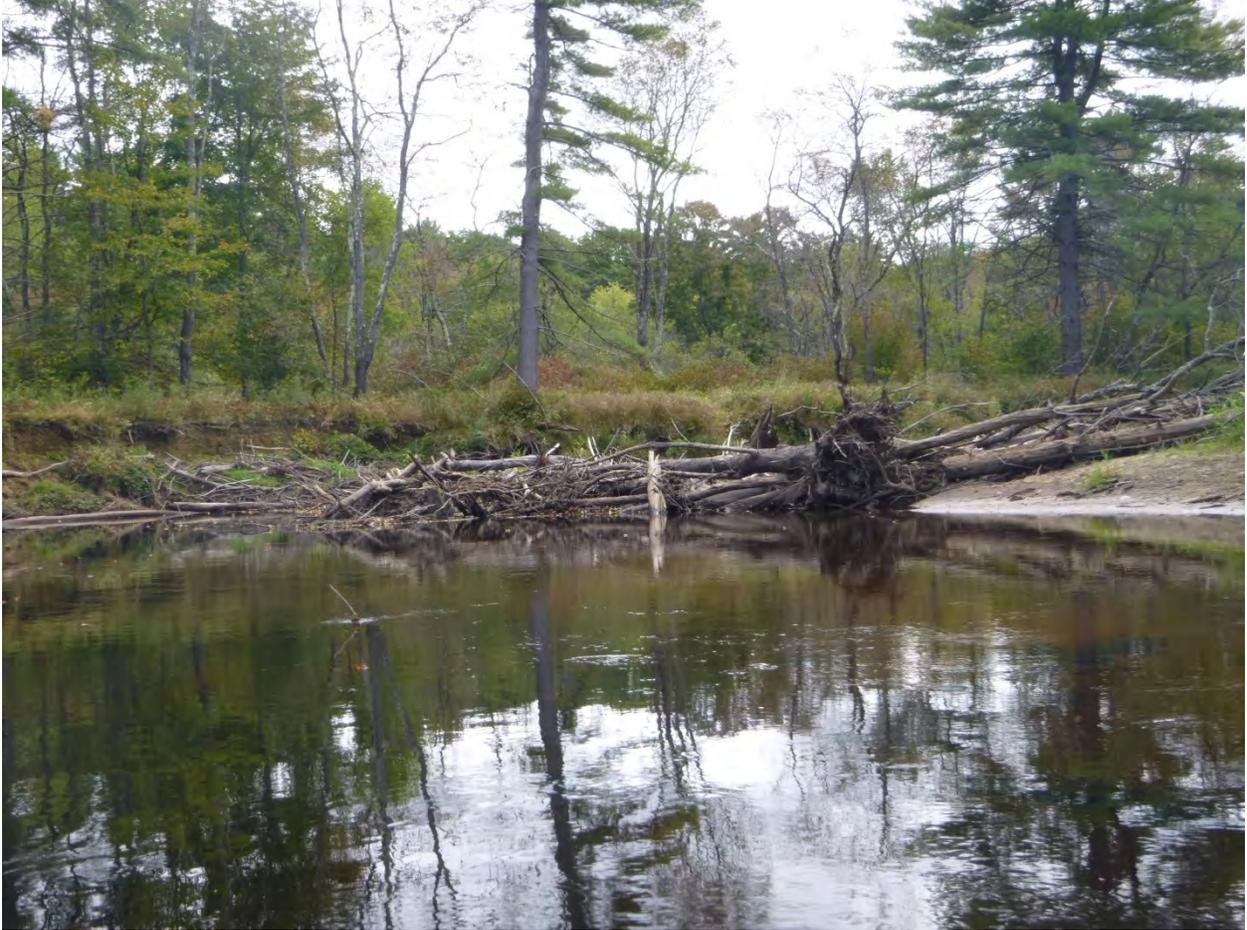
Figure B-7. Debris jam in Suncook River within Reach 11 in Epsom. View looking downstream.
