PORTSMOUTH

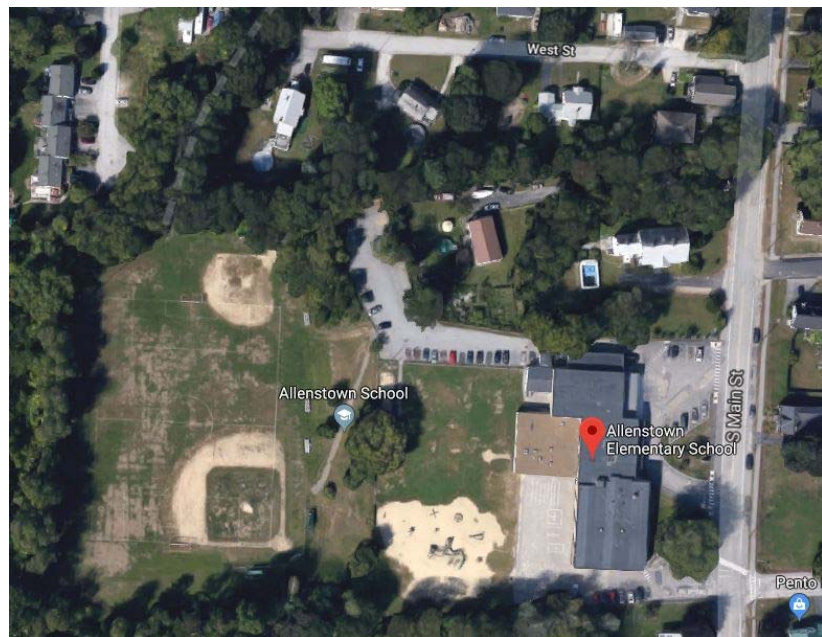
The narrative that follows is based on observations made during site visits in August of 2018 by Harriman's architects, civil, mechanical, electrical, and structural engineers. No destructive investigation was conducted during the site visits other than the removal of ceiling tiles and access panels from mechanical spaces.

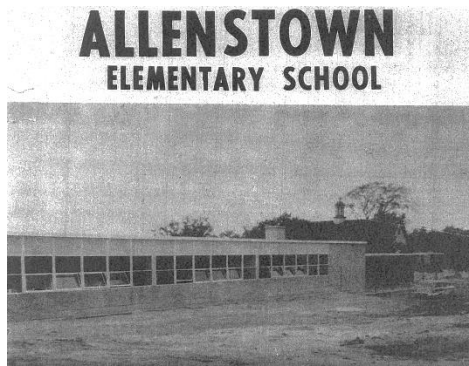
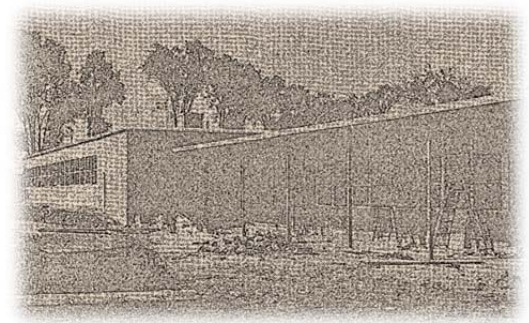
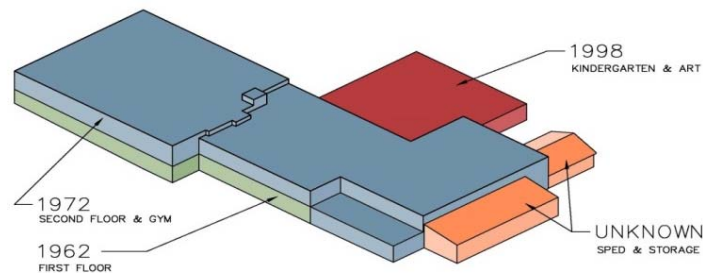
Note: Building codes are typically updated every three years with a new edition. The State of New Hampshire is presently enforcing the 2009 IBC codes. The NH Building Code Review Board is now reviewing the 2015 IBC codes, which are most likely to be adopted by the state within a next year. Over time, we have seen newer editions increase design loads. Please note that the applicable code takes effect at the time of obtaining a building permit. By waiting, codes will eventually change and may require additional upgrades to the structure and building systems.

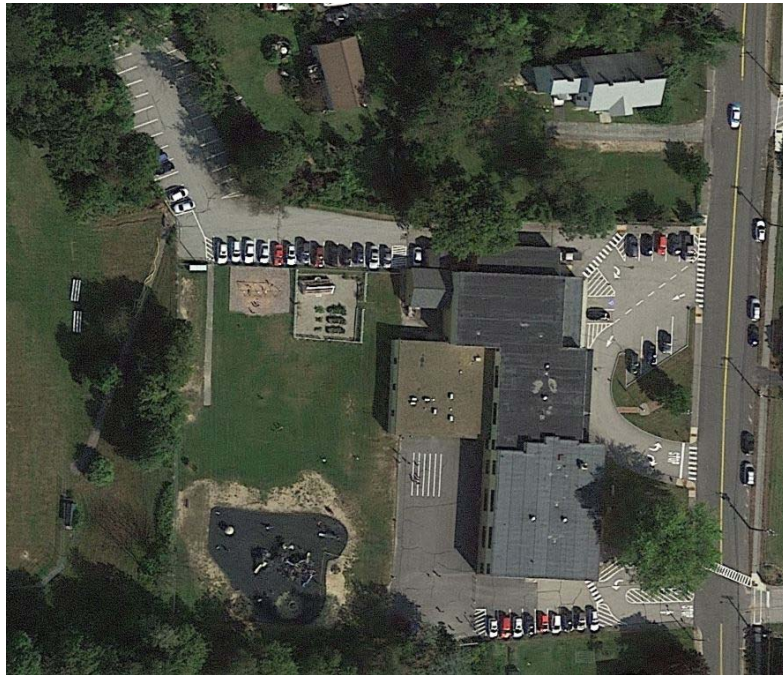
Google Earth Image: Dated September 11, 2017

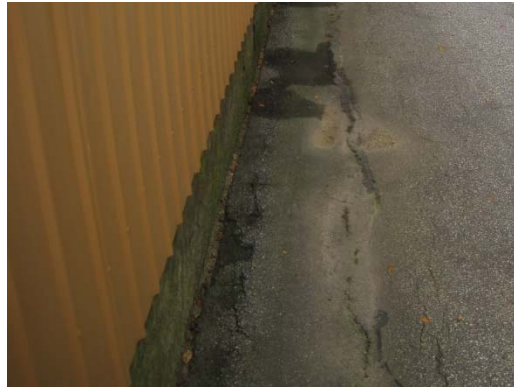
Cracking and differential settlement at north building edge

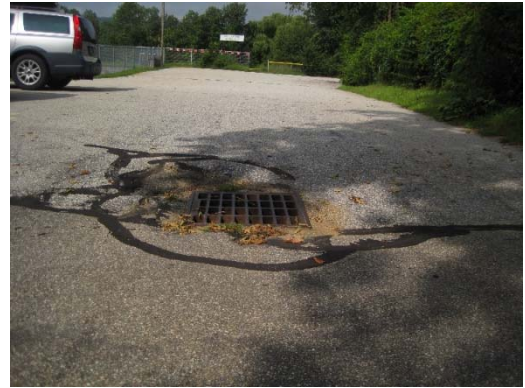
Settlement/sediments surrounding existing catch basin

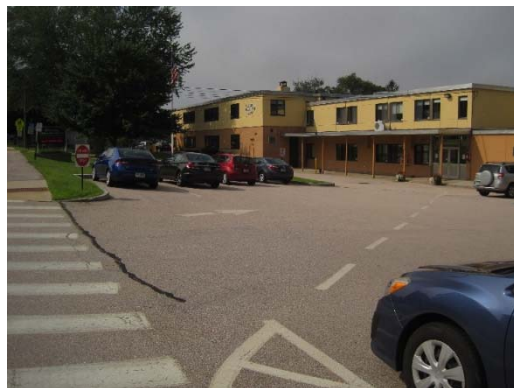
Bus loop paint and pavement in great condition

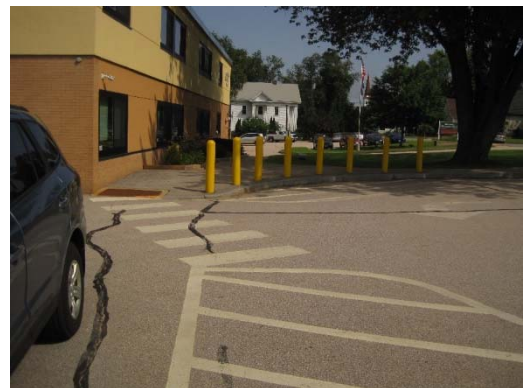
Parent drop-off paint and bollards in great condition

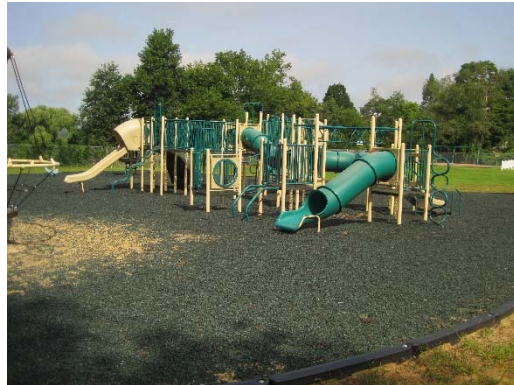
Existing playground area

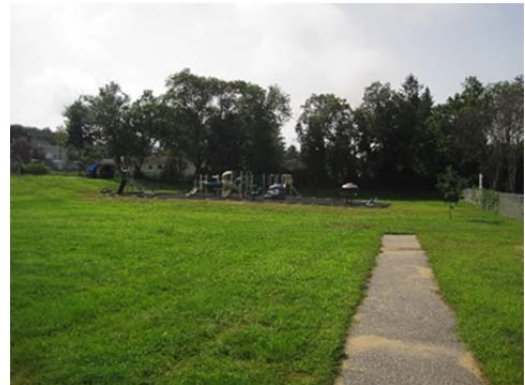
Existing vegetative area at playground area

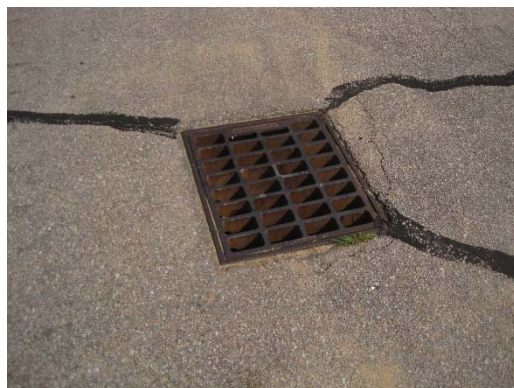
Existing catch basin outside of main entrance

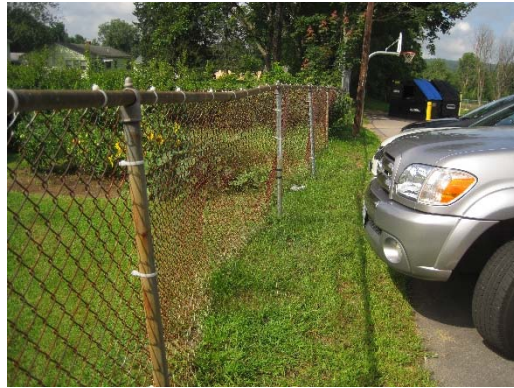
Damaged/rusted fence at southern perimeter

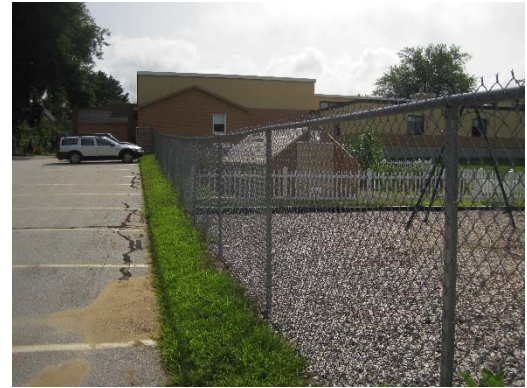
Northern perimeter fence in great condition

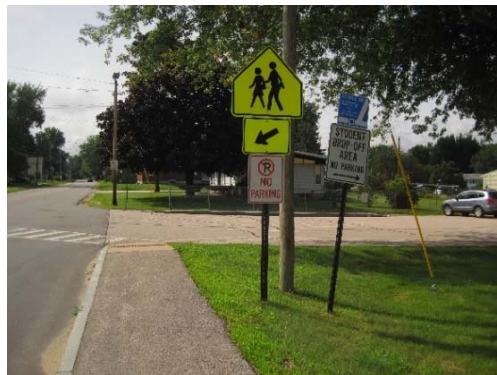
Existing signage along S Main Street

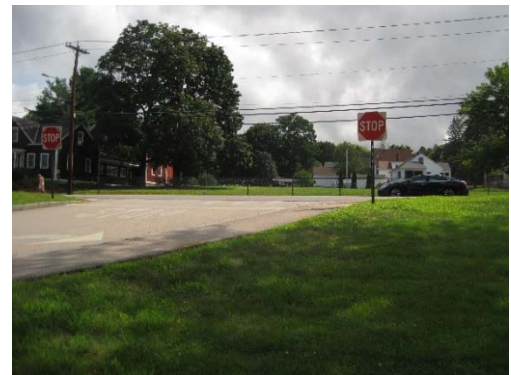
Existing stop signs at bus loop exit

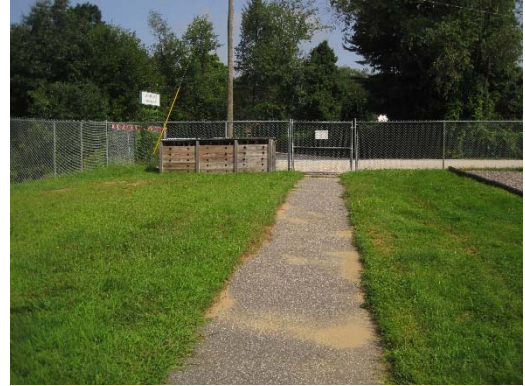
Accessible walkway into the playfield area

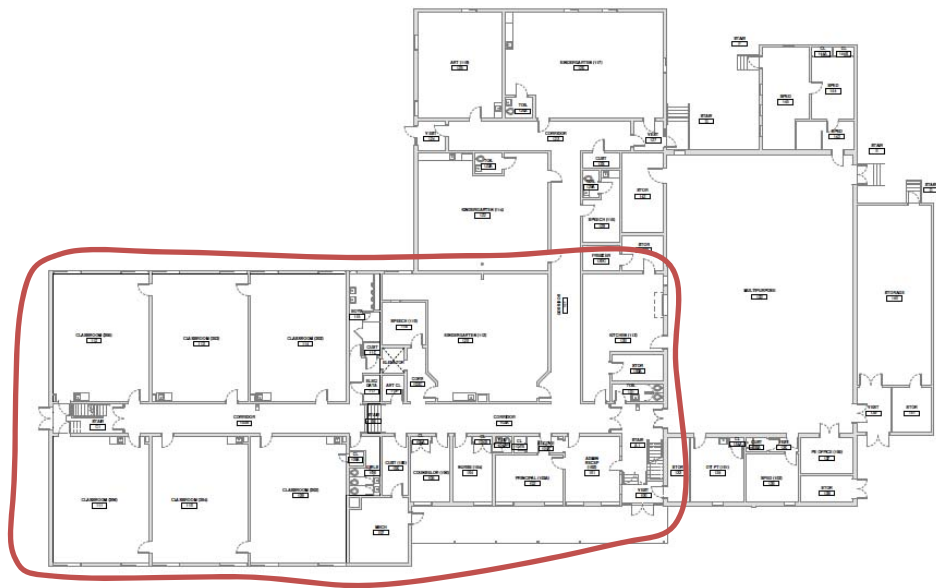
ALLENTOWN ELEMENTARY SCHOOL

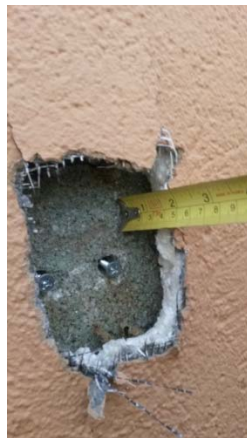
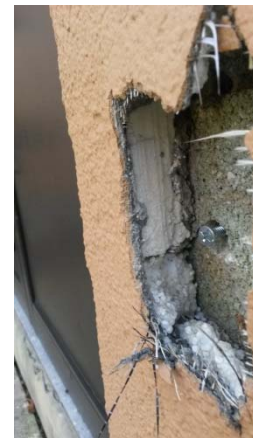
Stucco finish with exposed 1-1/2 inch Styrofoam insulation

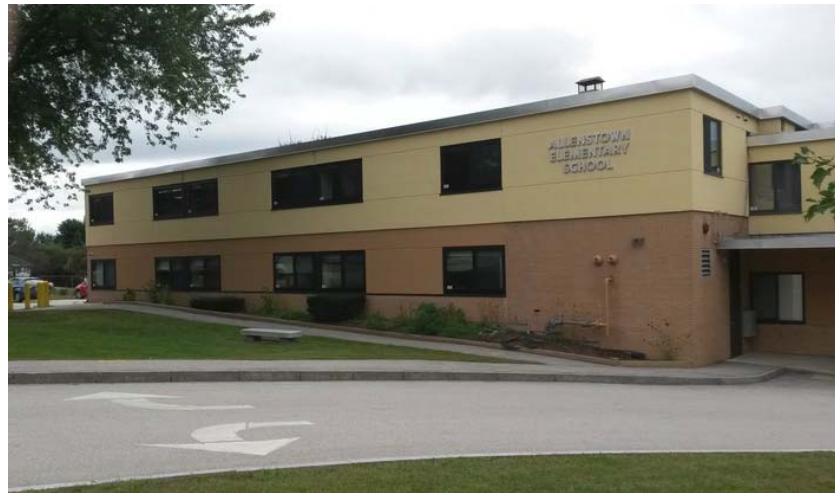
Front elevation – first story 1962 and second floor 1972 addition

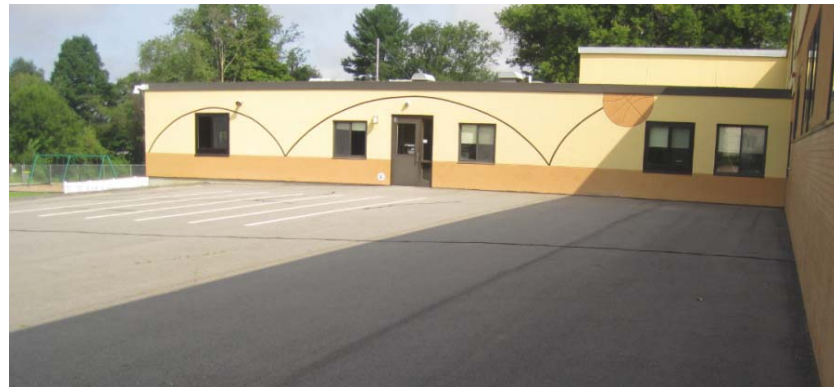
Rear elevation - single story Kindergarten and Art 1998 addition

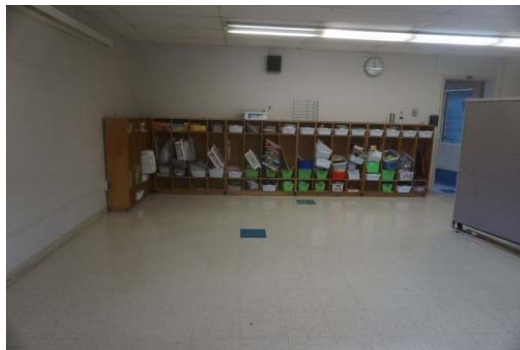
The predominant floor finish is vinyl tile. It is throughout the classrooms, SPED areas, Multipurpose, Offices, teacher's area, corridors and storage rooms. Classrooms in the 1998 addition are about one-third vinyl tile at cubbies, with the remaining area being carpet. Carpet was a miss-lot color run and needs to be replaced. Carpet is also installed at the Library and the SPED area by Multipurpose. The Boys and Girls toilet rooms are ceramic tile. There is quarry tile in the Kitchen.

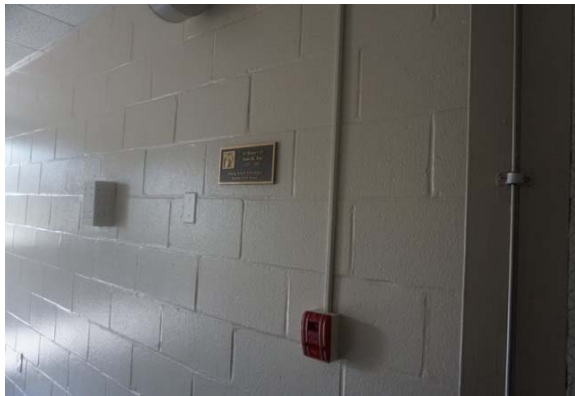
CMU wall - running bond coursing

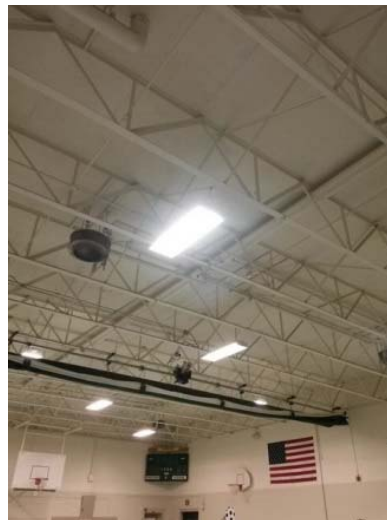
Exposed structure and deck

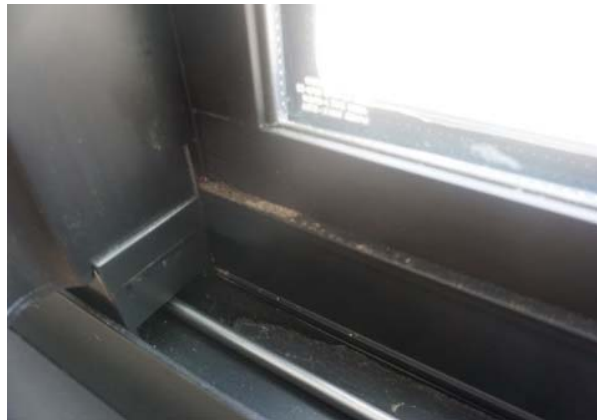
Typical sliding window

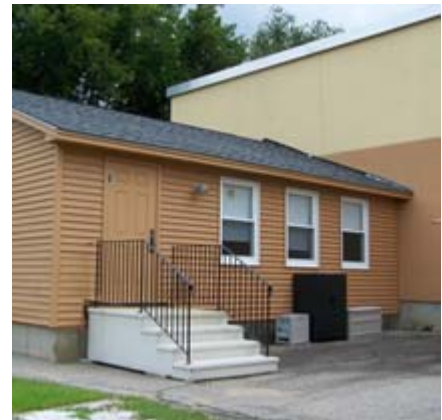
SPED addition - residential windows

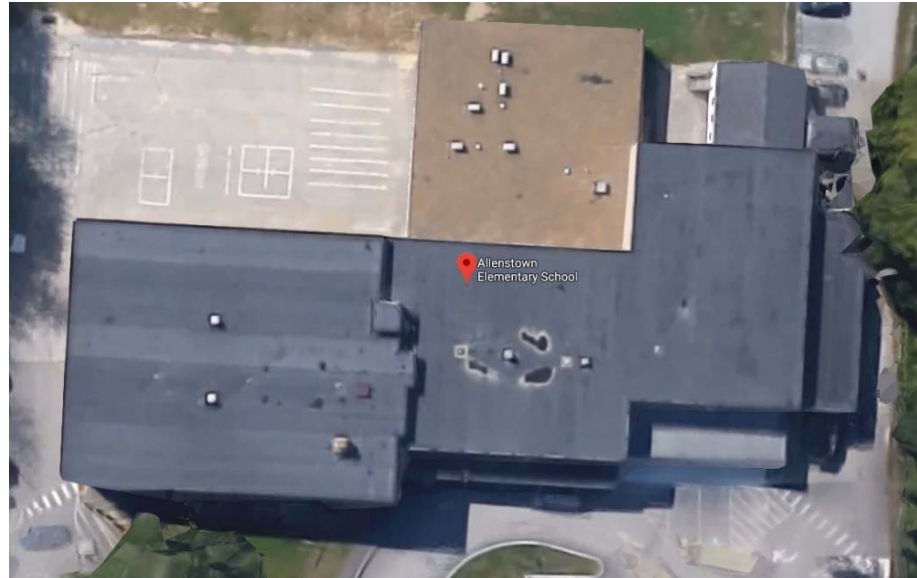
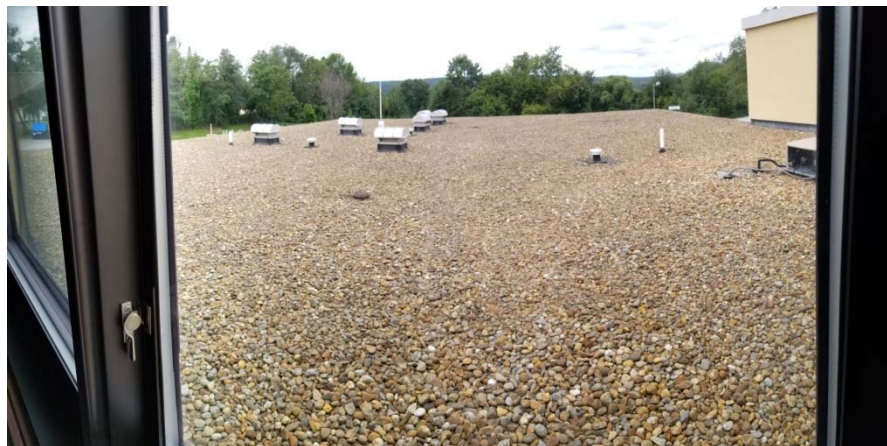
ALLENSTOWN ELEMENTARY SCHOOL – FACILITY ANALYSIS

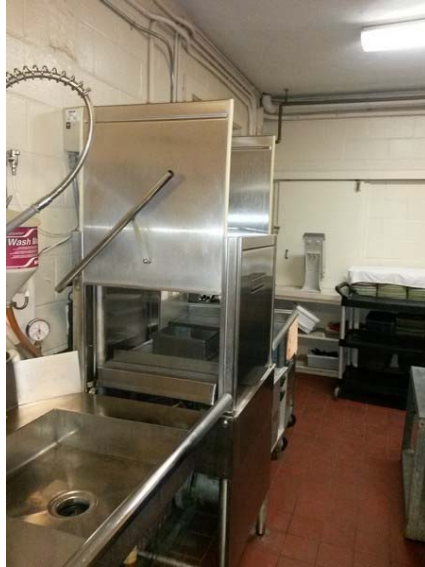
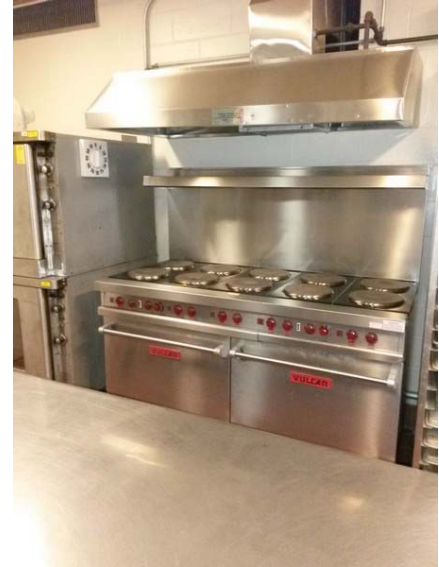
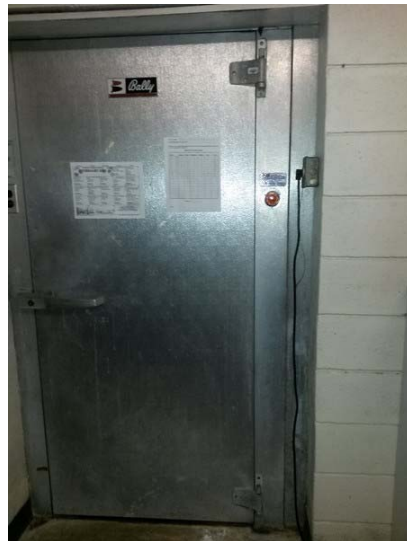
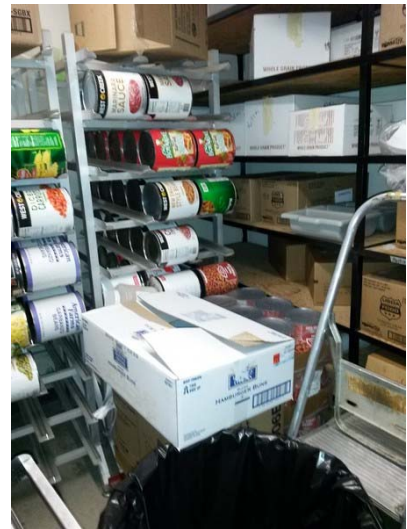
ALLENSTOWN ELEMENTARY SCHOOL – FACILITY ANALYSIS

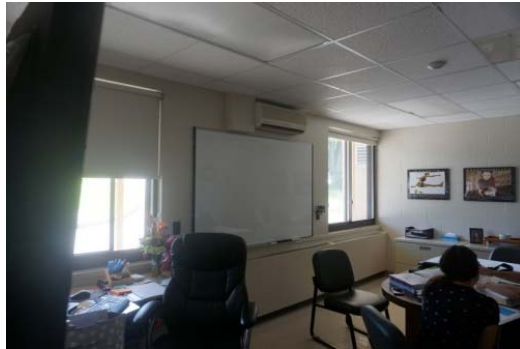
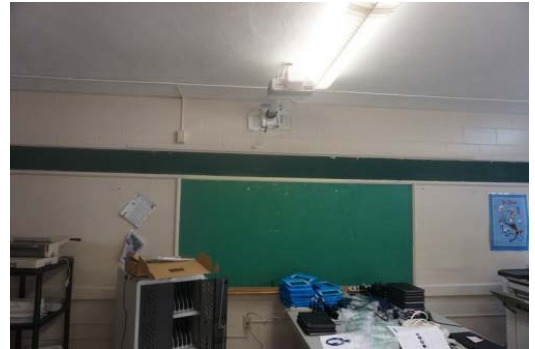
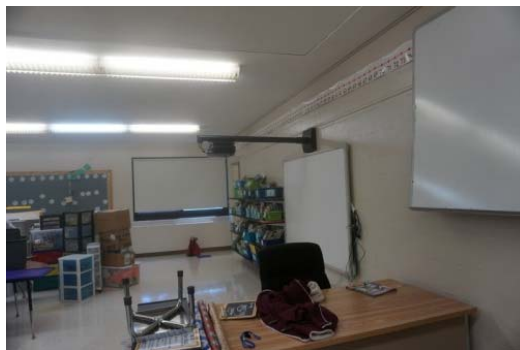
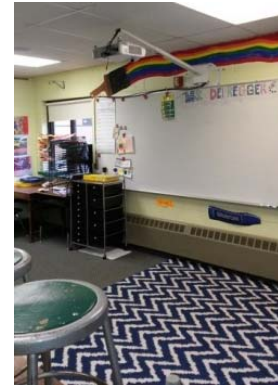
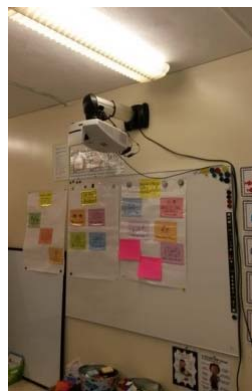
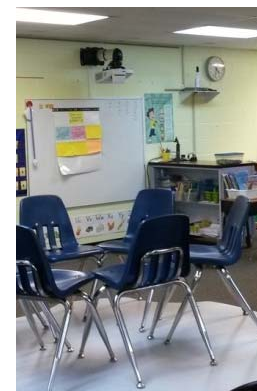
Typical marker boards, tack boards and Interactive marker boards /projectors

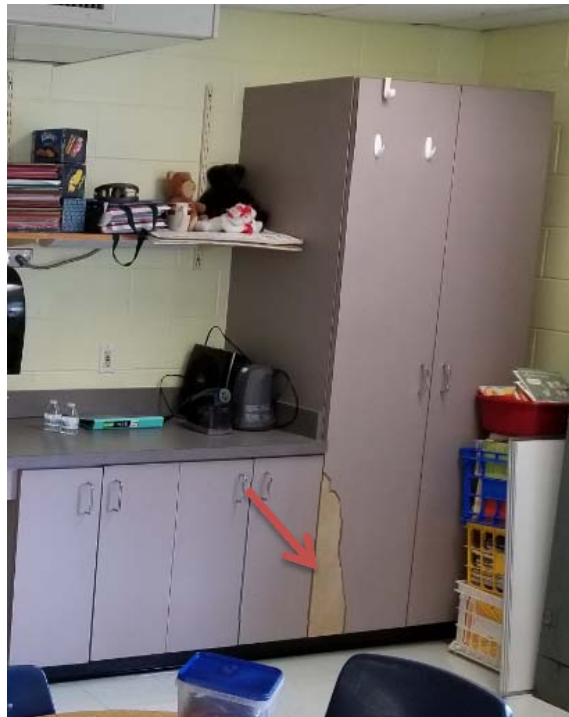
Plastic laminate delamination

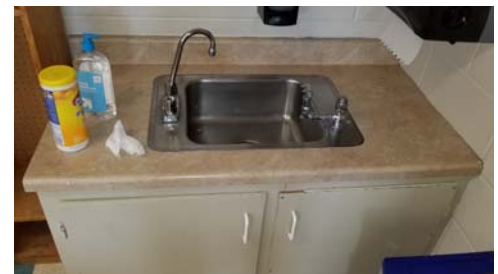
Door replaced with plywood

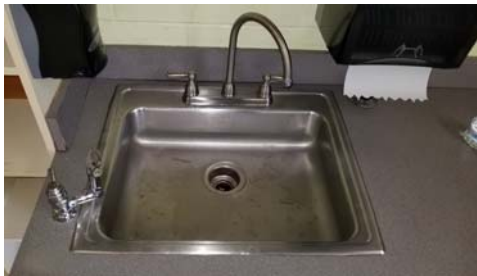
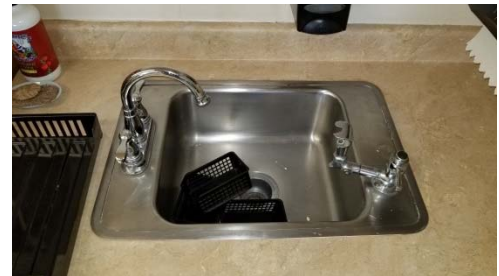
Most classroom sinks have bubbler and per code they must have a separate sink to meet hygiene standards

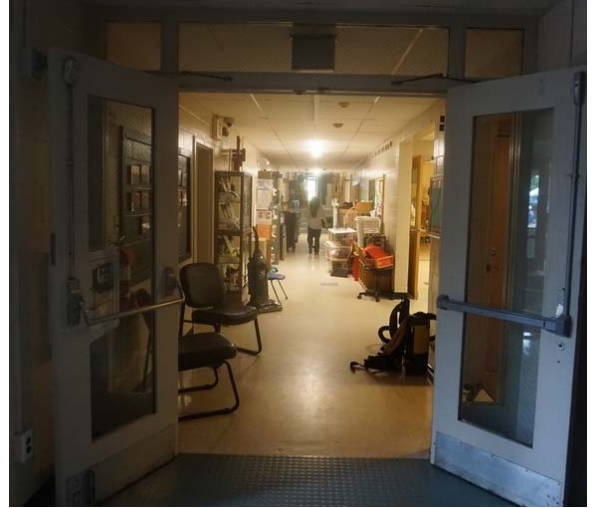
Doors vary from stained wood to painted hollow metal

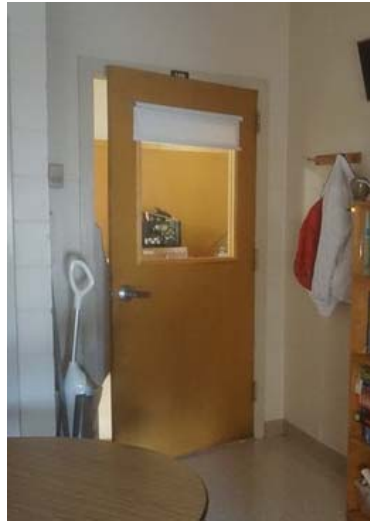
Typical wood door with half glass with knob

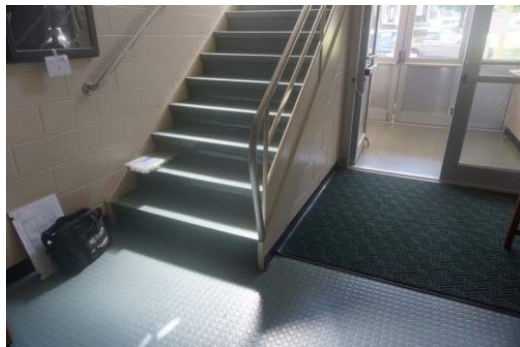
Stair A – handrail termination and guardrail/handrail along open stair does not meet code.

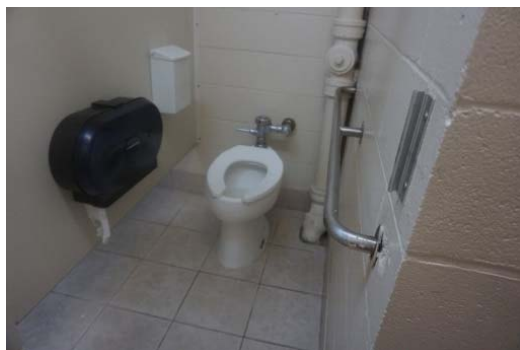
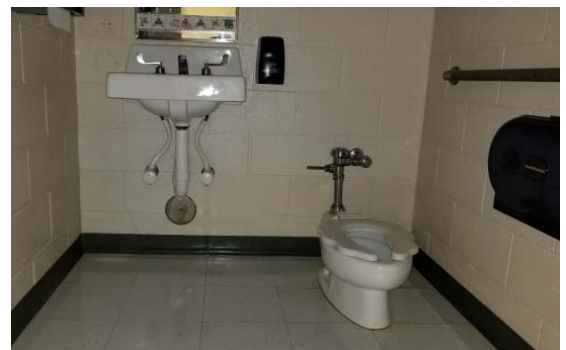
Examples of ADA toilet compartments that have no rear or vertical grab bars

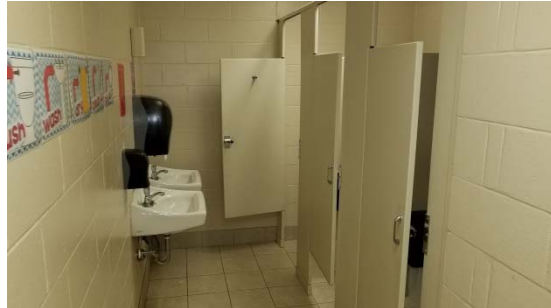
Girls 205 – width from toilet stalls to lavatory wall non-compliant. Similar condition in Girls 108 and Boys 115 and 213.

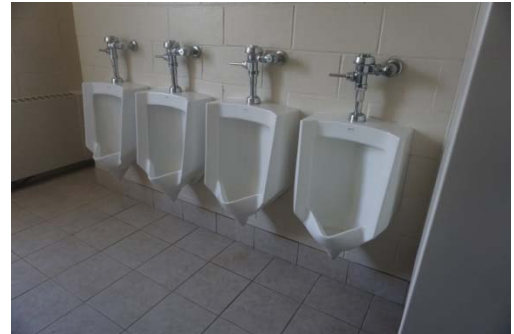
Typical Boys urinals – no ADA code compliant urinals. Require 1 ADA compliant per toilet room in Boys 115 & 213.

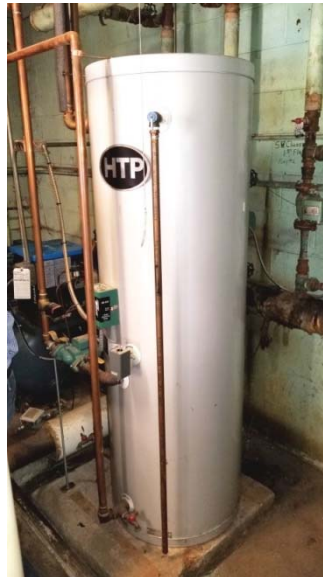
Existing Indirect Fired Water Storage Tank

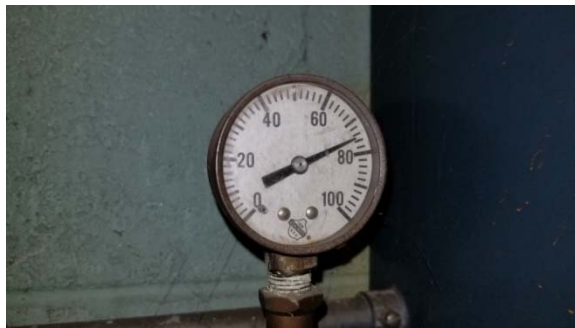
Building Water Pressure Gauge

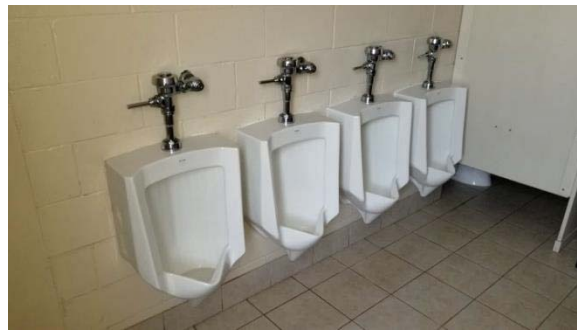
Typical Lavatories with Metering Faucets

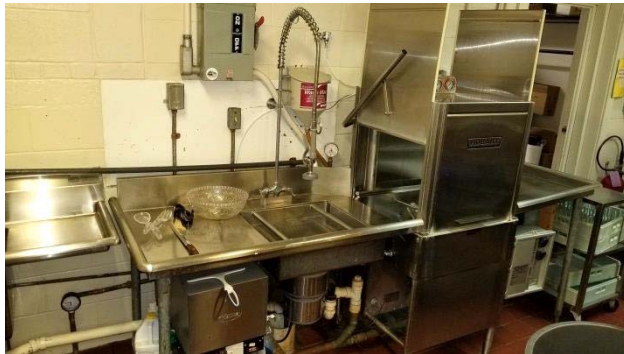
Pot Wash and Dishwasher

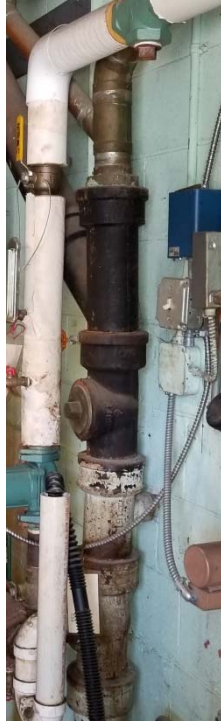
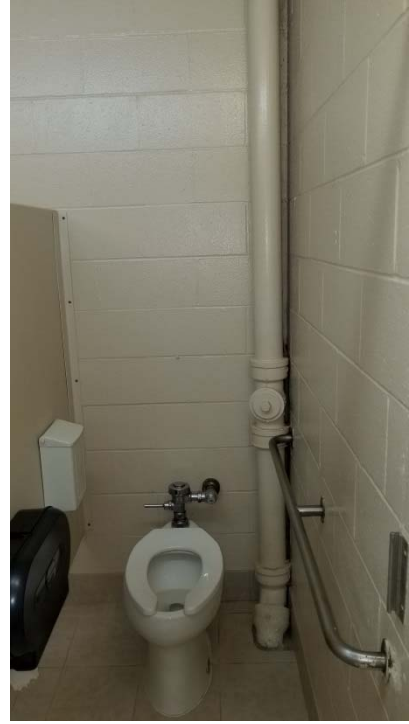
Examples of Cast Iron Piping

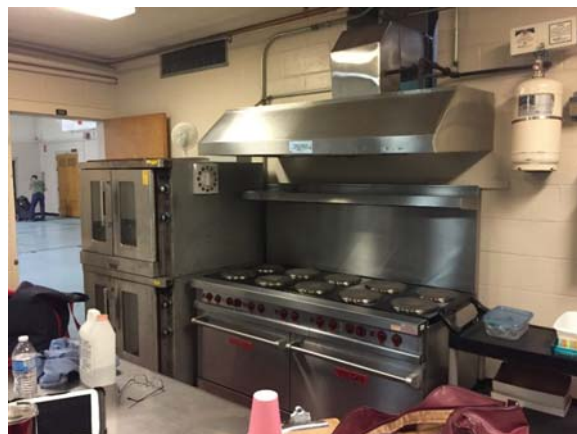
Kitchen Cooking Equipment

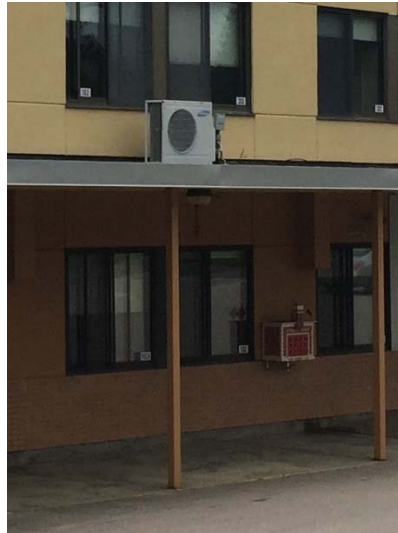
The only rooms that are air conditioned are the reception area and principal's office. Cooling is achieved with a ductless split system consisting of wall mounted evaporators in each room and a single condensing unit located on the roof overhang outside.

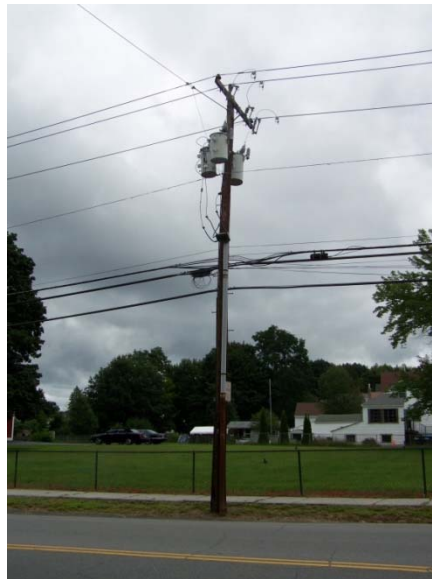
pole mounted transformers serving building

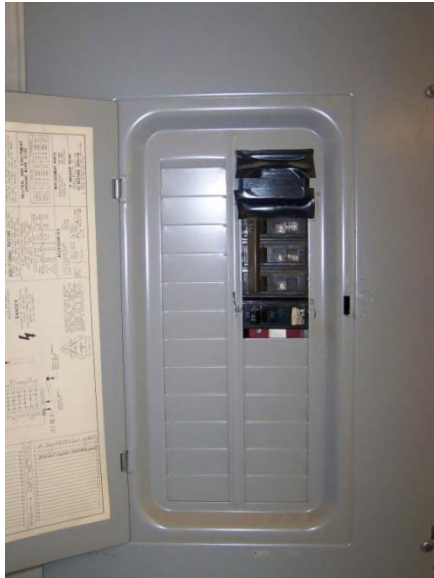
kitchen panelboard, newer panelboard, space remaining for additional circuit breakers, improper filler pieces, exposed parts and appears that a circuit breaker that is not intended for this panelboard installed

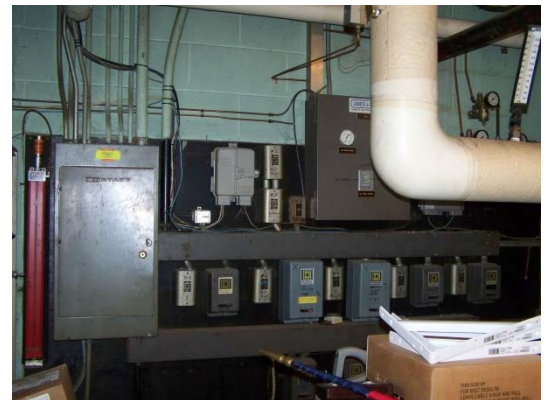
boiler room panelboard with storage impeding access

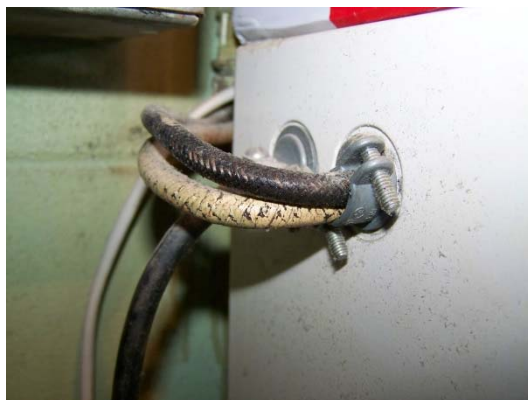
cloth insulated wiring

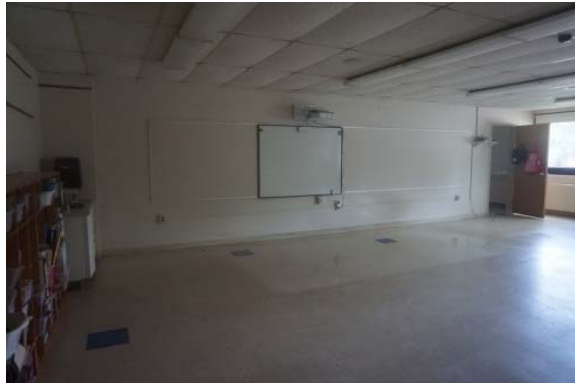
surface mounted raceway in typical classroom

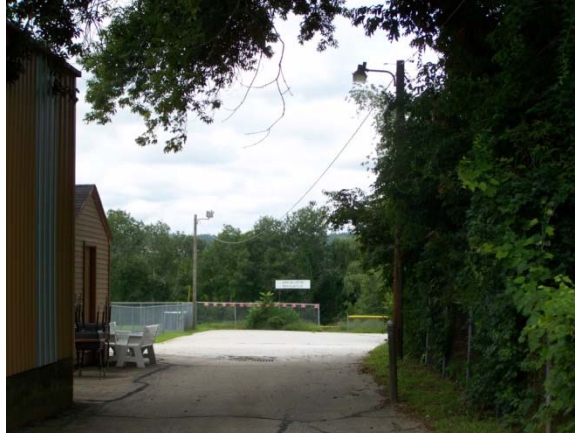
pole mounted flood lighting, utility company leased lights to ball fields, right side of building

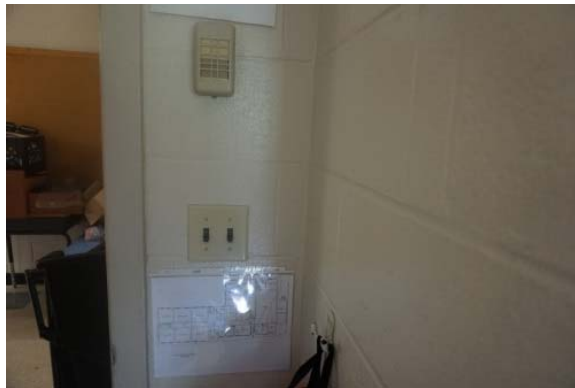
typical classroom switch arrangement

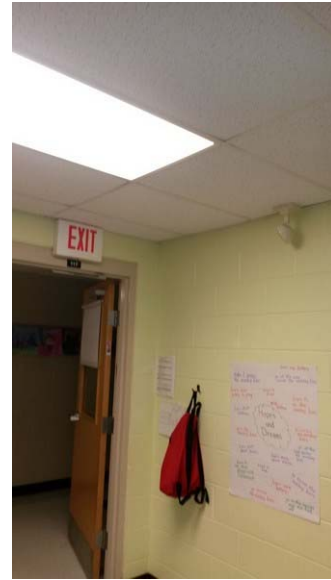
typical exit sign in kindergarten wing

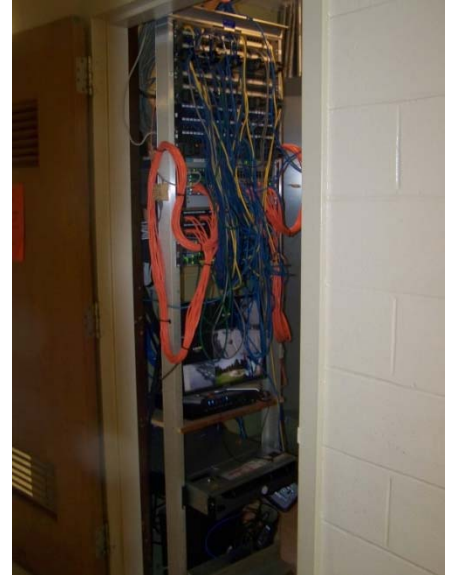
communications rack in main electrical room, inadequate working clearances

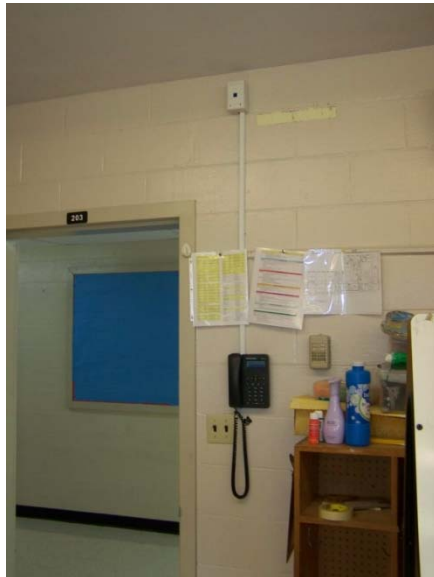
typical classroom, phone at door

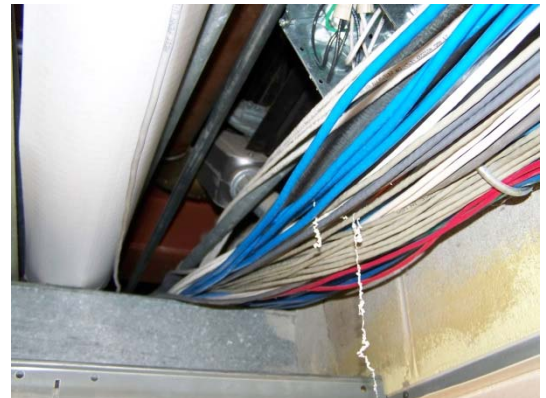
cables above first floor corridor ceiling

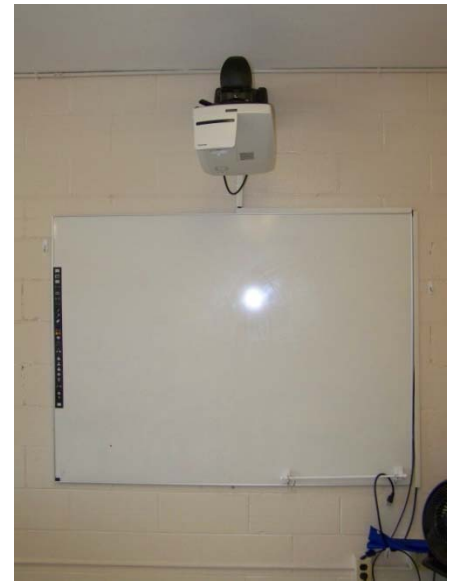
classroom interactive projector/board

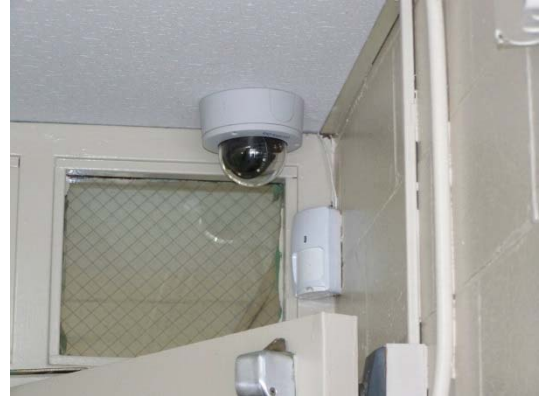
typical interior camera

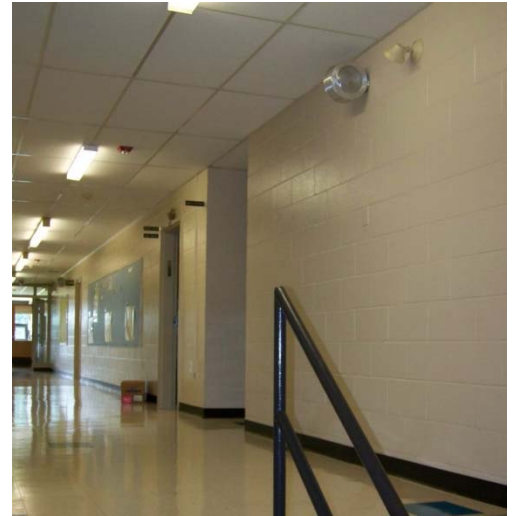
typical wall mounted speaker, used in some corridors
