ALLENSTOWN MEETING HOUSE HISTORIC STRUCTURE REPORT

JAMES L. GARVIN

MAY 3, 2004

REVISED JUNE 21, 2007, JULY 10, 2010

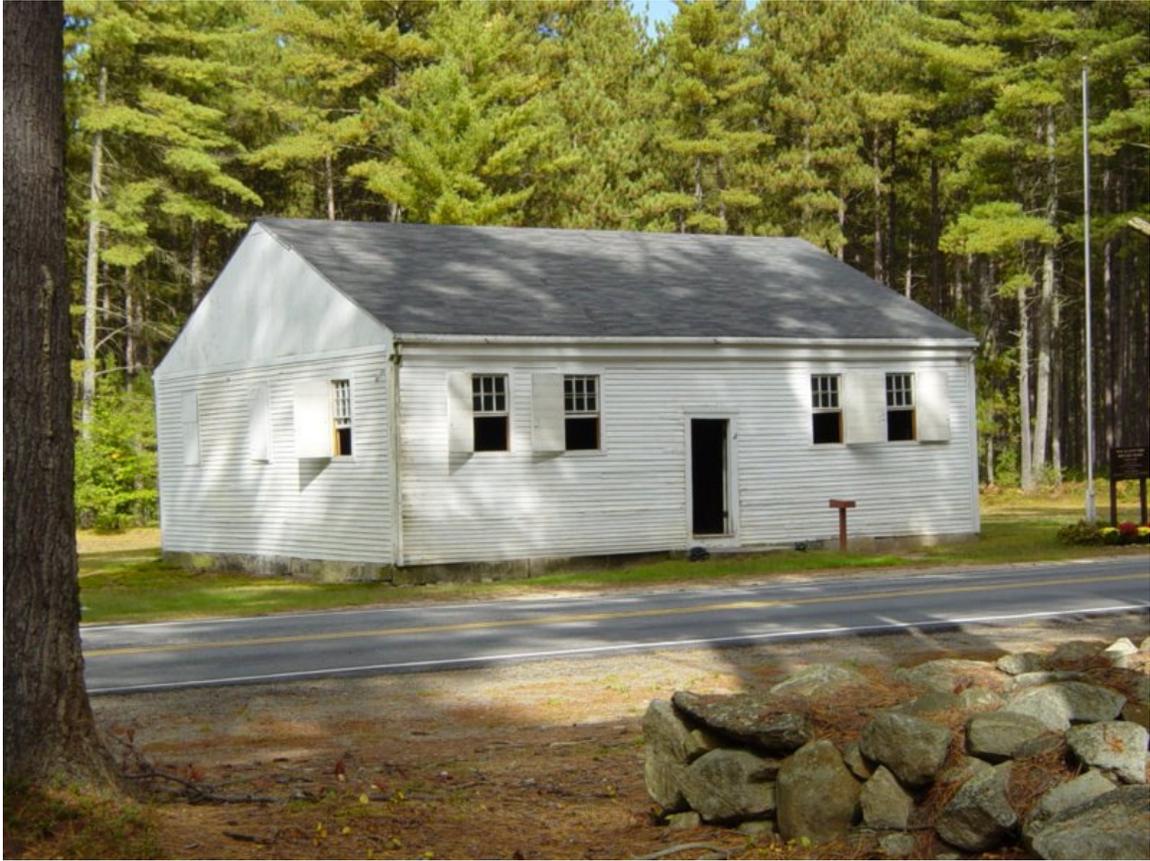
ALLENSTOWN MEETING HOUSE
100 Deerfield Road
Allenstown, New Hampshire
Prior to replacement of roof in 2006 and re-clapboarding in 2010

These trusses had an insufficient span to throw roof water well away from the building's walls, and water penetrated the laminations of the front and rear wall plates, causing the plates to begin to deteriorate. This roof of poorly-designed trusses was replaced by the current roof of prefabricated trusses, covered by pine sheathing boards, during the fall of 2006.

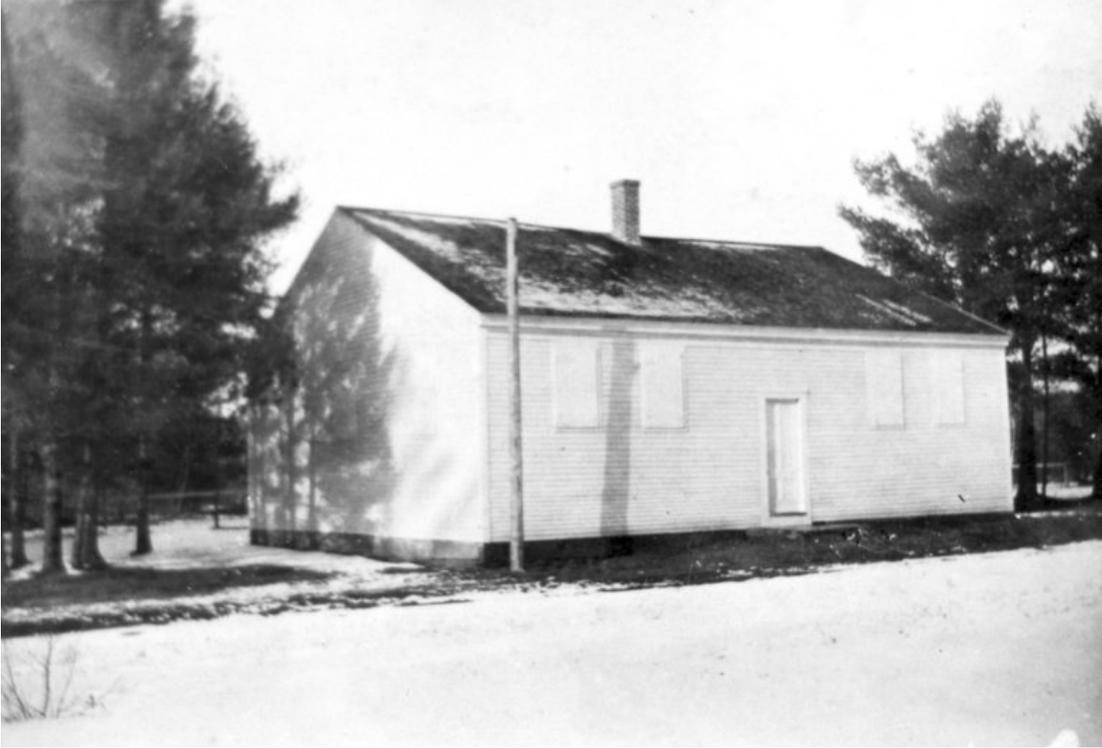
ALLENSTOWN MEETING HOUSE
As it appeared after restoration in 1909
by Buntin Chapter, Daughters of the American Revolution

Under regent Sarah E. W. Cochran, Buntin Chapter undertook restoration of the building. The structure was rededicated on August 22, 1909. Photographs of the period show that the DAR renewed the exterior of the structure. On the inside, some machine-planed casings on the wall posts and machine-planed boards in parts of the desk or pulpit suggest that the DAR replaced missing elements or repaired deteriorated woodwork. In general, however, the interior of the building had probably survived without much change since the building was first opened. At the completion of the restoration in 1909, a bronze tablet was donated by J. A. Lang and affixed to the front of the building; it is now inside.

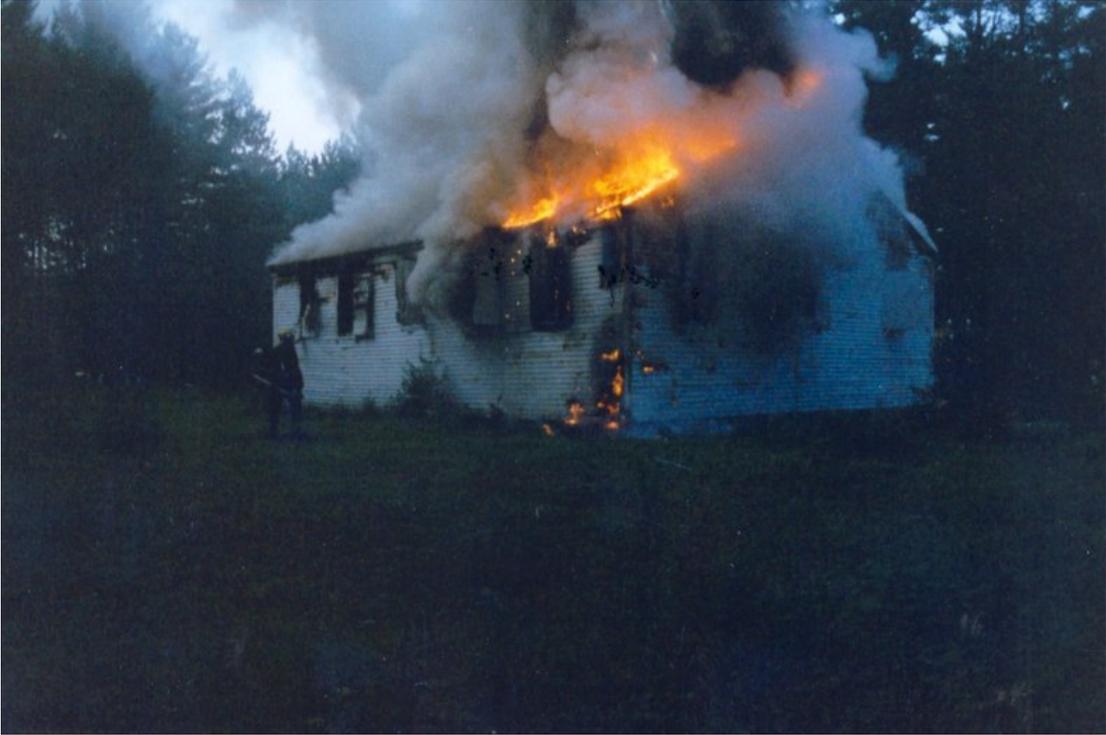
ALLENSTOWN MEETING HOUSE
Rear wall during the fire of July 15, 1985

1985 An arsonist attempted to burn the building on July 15, 1985. The fire destroyed the roof and damaged the northwest rear corner of the structure.

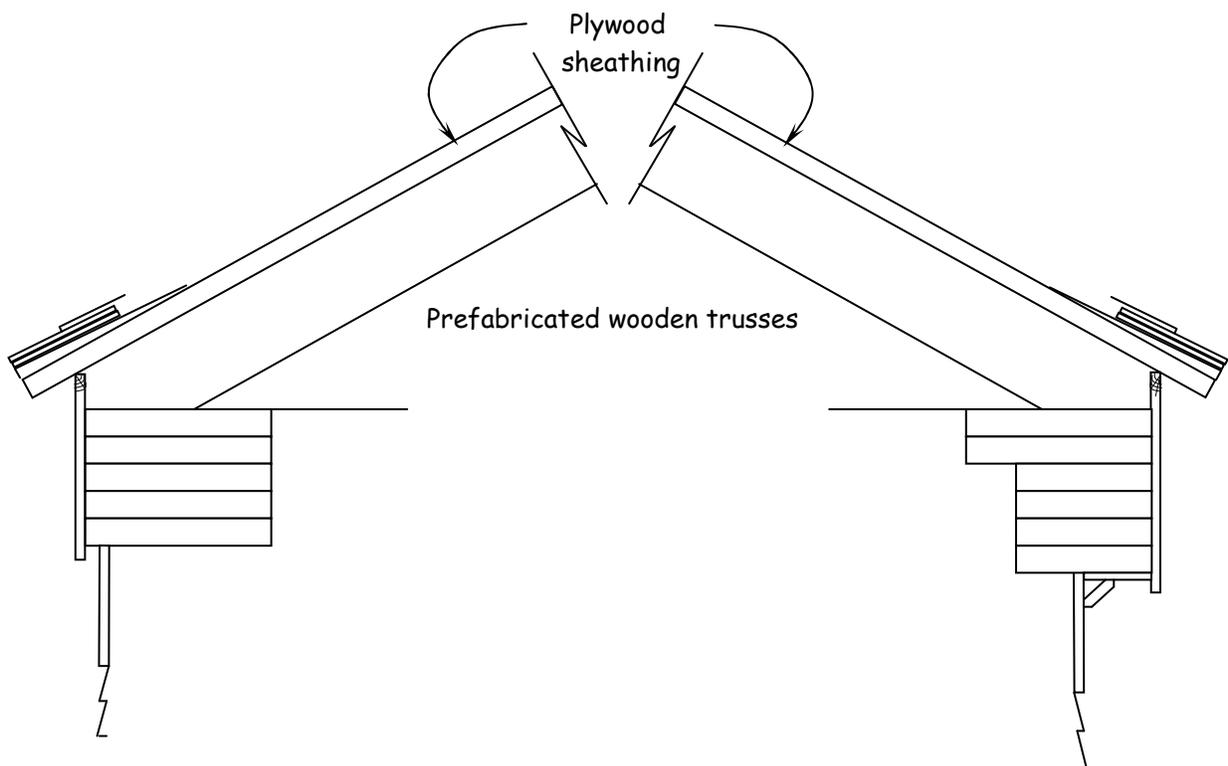
Buntin Chapter took immediate steps to brace the walls of the structure and to provide a temporary roof over the building. The first such roof collapsed under the weight of winter snow, and a second was constructed by Roland A. Martel of Allenstown. Later, a roof of prefabricated trusses, covered by plywood sheets, was installed atop new wall plates that were fabricated from laminated two-inch planks, as shown below:

1985 Buntin Chapter, D. A. R., erected a temporary roof over the body of the building. This roof collapsed during the winter of 1985-6 and was replaced by a roof of prefabricated wooden trusses, placed on wall plates made from laminated two-inch planks, stacked horizontally.

2006 The Old Allenstown Meeting House Task Force had the roof trusses of 1986 replaced with new prefabricated trusses with deeper overhangs. The laminated front and rear wall plates of 1986 were replaced with plates of solid timber.

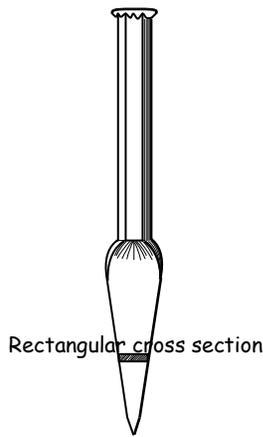
Prior to about 1830, the procedure for splitting granite entailed the cutting of a line of shallow slots in the face of the stone, using a tool called a cape chisel, struck with a heavy hammer. Small, flat steel wedges were placed between shims of sheet iron and driven into these slots, splitting the stone. The new splitting method of circa 1830 used a “plug drill,” which had a V-shaped point and was rotated slightly between each blow of the hammer, creating a round hole two or three inches deep.

Cape chisel for flat slot

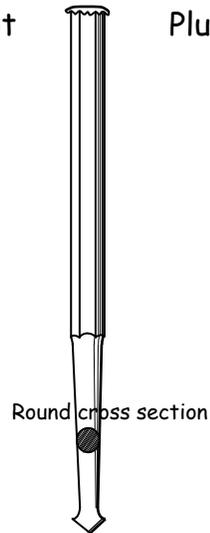
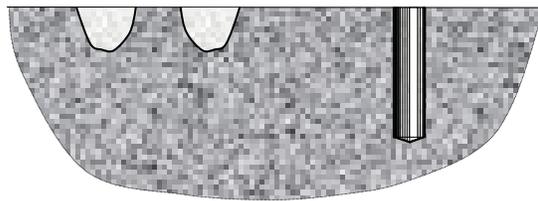
Plug drill for cylindrical hole

Plug and feathers

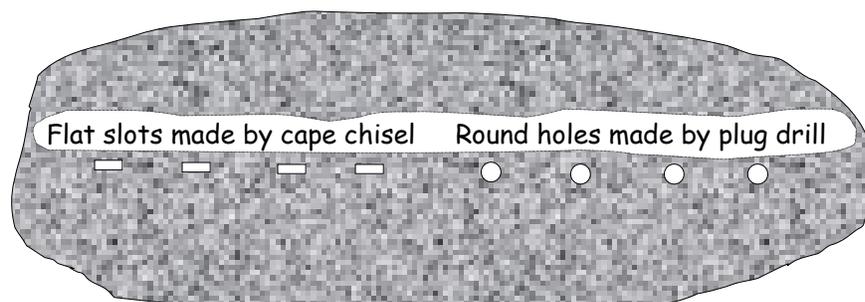
The new splitting technology seems to have spread rather rapidly through the granite quarrying centers of New England, although one is likely to find evidence of both old and new methods being used concurrently in stonework of the 1830s, especially in rural areas. The technique employed on a given stone can usually be seen on the split face, and provides some aid in dating granite masonry. The old, flat-wedge method is marked by a series of slot-like depressions which extend inward an inch or so from the edges of the split stone. The plug-and-feathers method leaves a row of rounded holes, two or three inches deep and usually about six inches apart.

When seen on the surface of a stone that was prepared for splitting but never split, these slots or holes appear as shown below:

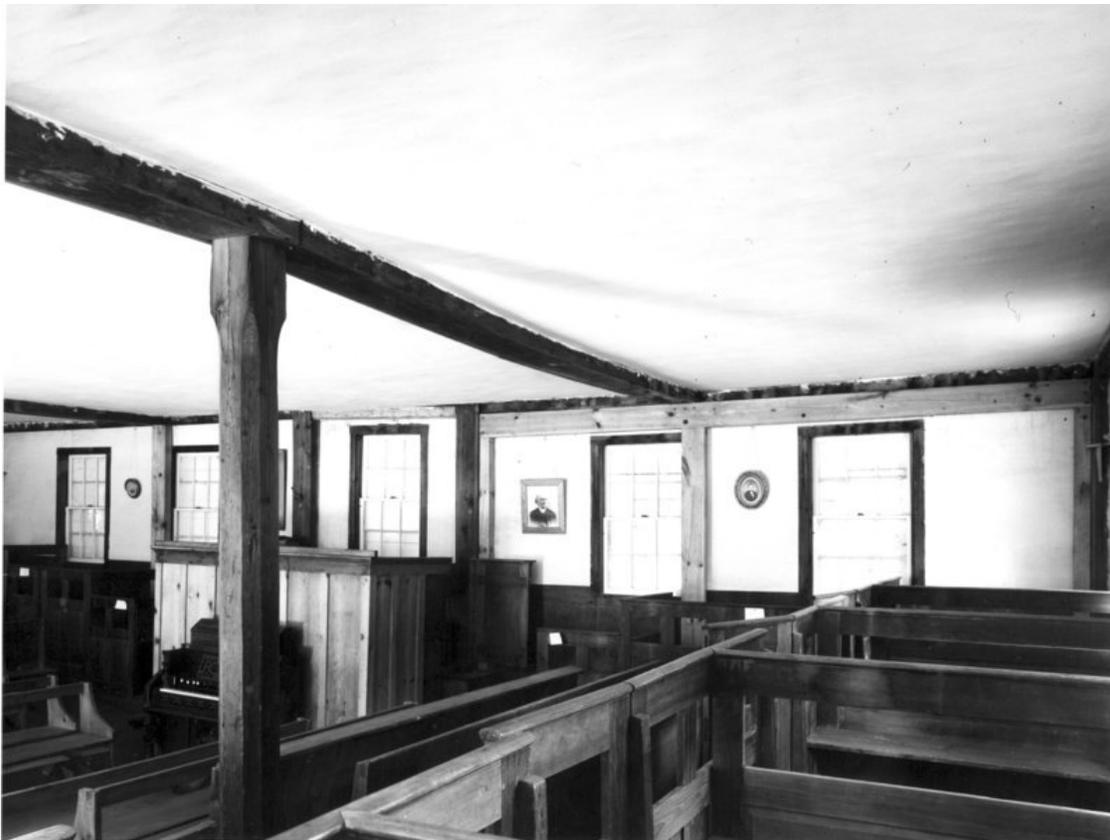
Workshop participant Edward Levin created a digital model of the roof. He then imposed the snow loading to be expected in Allenstown, together with the weight of the original plastered ceiling that had trapped the heat of the fire within the attic and thereby saved the old building from complete destruction. When these loads were applied, the animated computer model deflected precisely as pre-fire photographs showed that the original roof and ceiling had sagged over time.

ALLENSTOWN MEETING HOUSE
As it appeared before the fire of July 15, 1985
showing the deflection of the truss tie beam from roof loading
and weight of the plaster ceiling

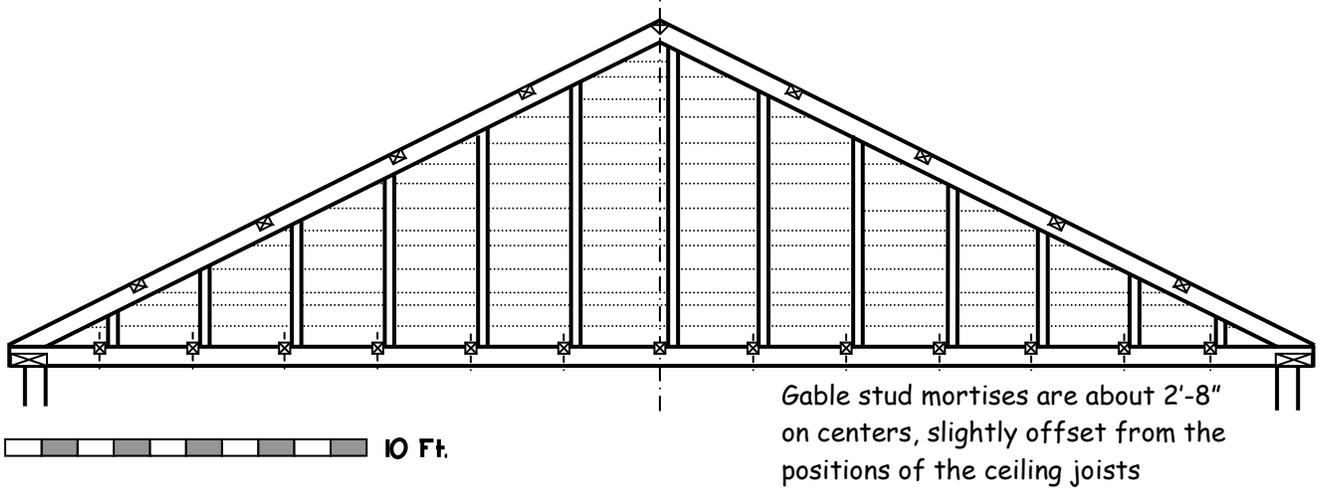
The three methods of framing the original roof of the building, as theorized following the workshop, are shown below. These diagrams detail the support of the gable ends of the building, the method of support above the two octagonal wooden columns that are shown on the floor framing plan, and the method of support above the broad expanse of ceiling in the center of the structure.

Interior elevation of gable ends

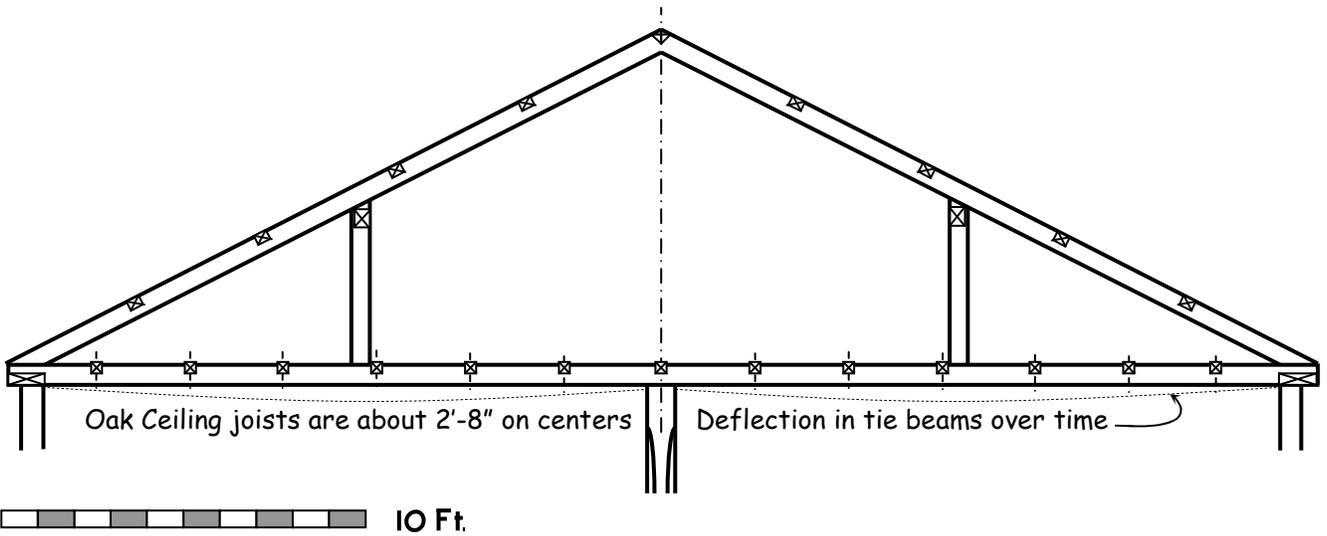
Section through roof frame above each of two wooden columns

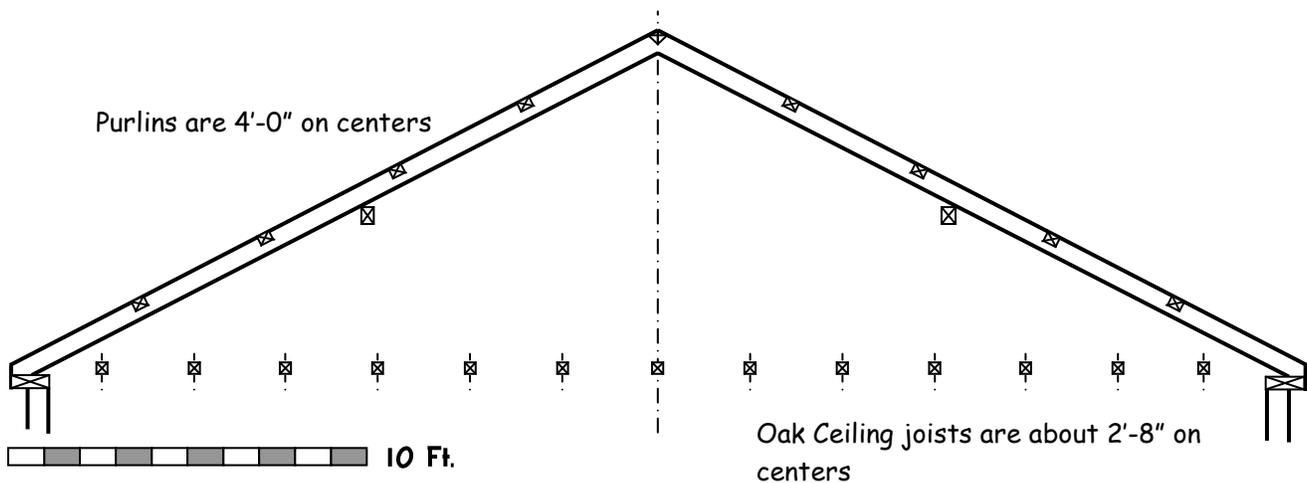
Section through roof frame
at each of two center rafter couples

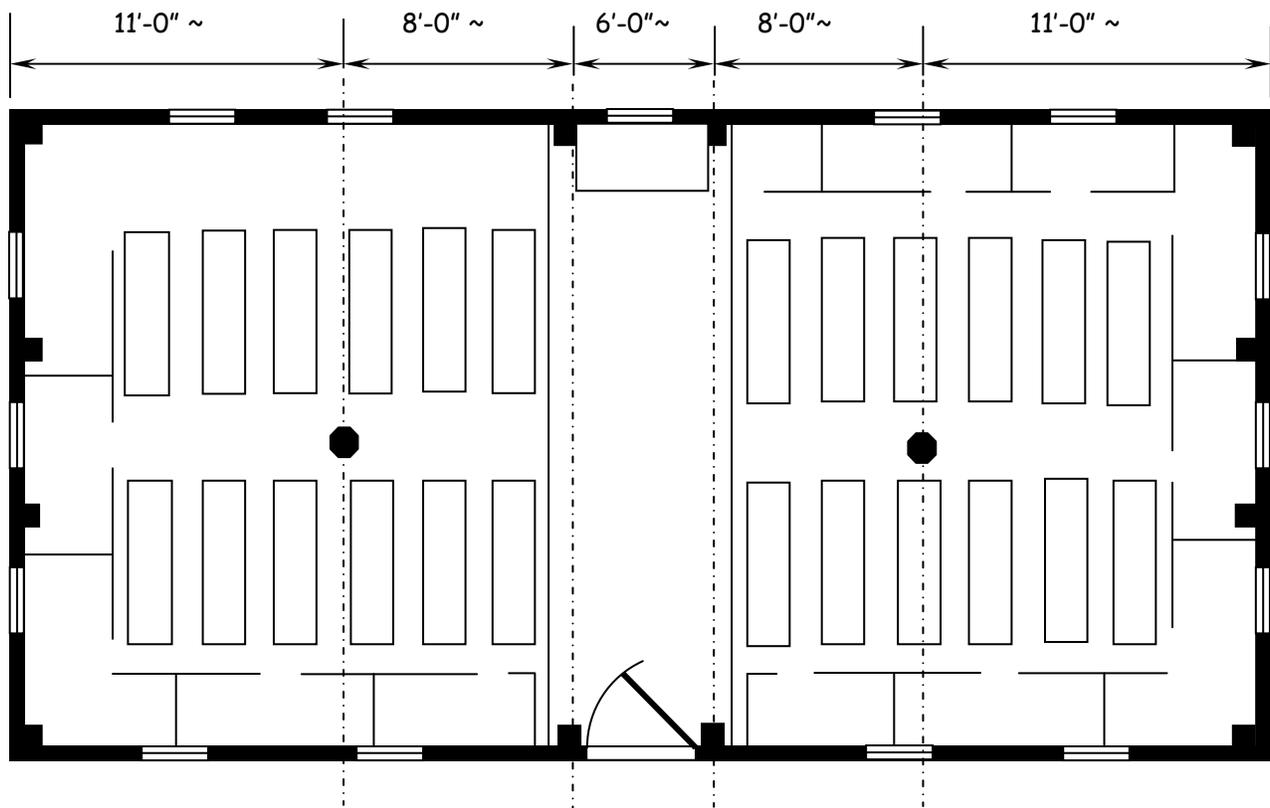
doorway across the depth of the building to the pulpit. On each side of this central aisle, the floor slopes gently upward to the two end walls of the building in the manner of the floors of galleries in two-story meeting houses, or of schoolhouses of the early nineteenth century. The floor framing plan of the building is shown below.

OLD ALLENSTOWN MEETING HOUSE
Floor and pew plan

A series of box pews begin at the doorway of the building and extend around the perimeter of the room to the pulpit, adjacent to the exterior walls. The building originally had twenty box pews; seventeen remain intact. The level floors of these enclosures step up from one to the next as the slanting floor rises. These privately-owned enclosures have paneled fronts, with raised panels but unmoulded stiles and rails. Above a lower range of panels, the stiles and rails of the pew walls and corresponding pew doors are left unfilled by panels. Unlike corresponding openings in more elaborate meeting houses, these areas are not filled with miniature turned balusters. Pew doors are hung on cast iron butt hinges with an adequate throw to allow the doors to be folded back against the pew walls without interference from simply moulded wooden caps that finish the tops of doors and

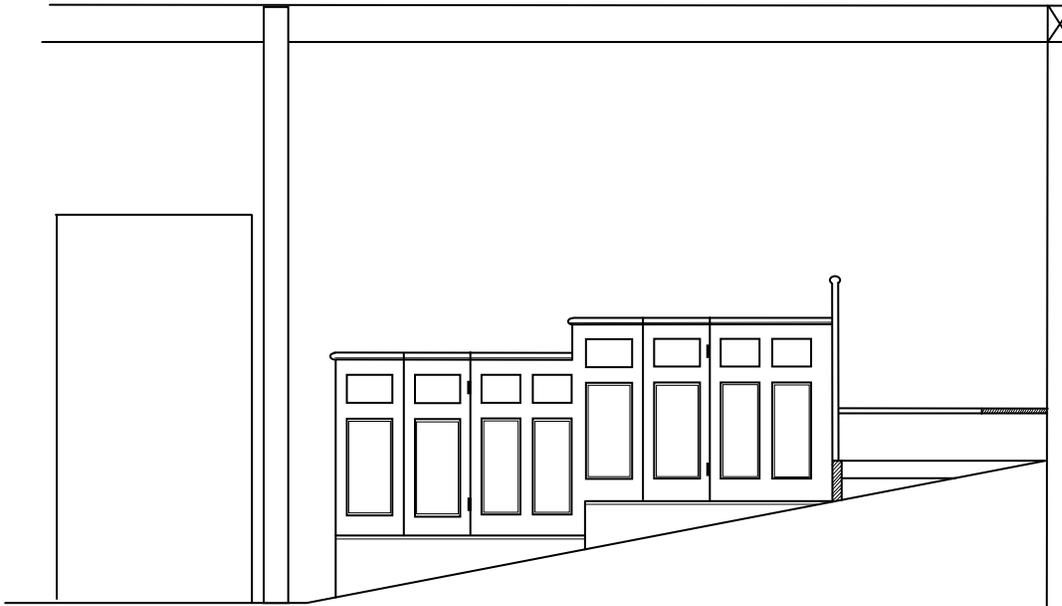
Elevation of box pews to the west of the front door

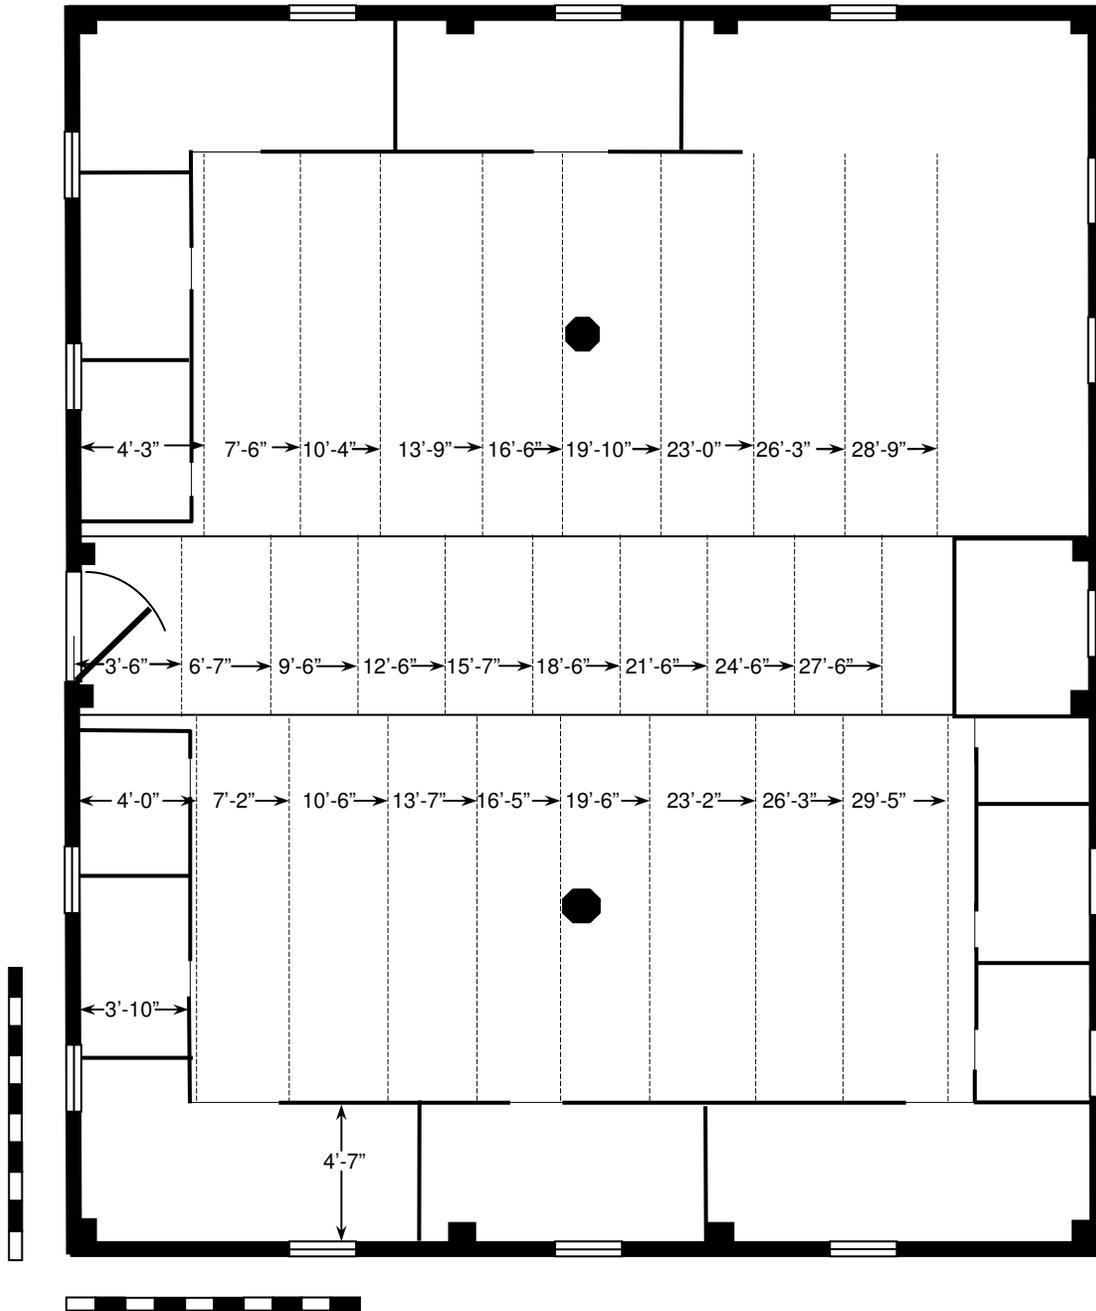
OLD ALLENSTOWN MEETING HOUSE
 Floor Framing Plan as Derived from Spacing of Rows of Nails

Condition of lower frame: As inspected and photographed on August 5, 2005, the framing of the lower walls and floors of the Allenstown Meeting House is in good condition. The timbers are skillfully hewn and smoothed with an adze. They were little affected by the fire of 1985 except at the northwestern rear corner where the fire started. A number of the floor joists and lengths of sill reveal the frass of powder post beetle activity, and it is recommended that all wood below the floor be treated with an insecticide to deter further powder post infestation (see below).

The slanted joists that support the floors on each side of the central aisle are supported at about mid-span by irregular blocks of wood or by wooden wedges that rest on lateral girders that run from front sill to rear sill. These timbers, in turn, are supported by wooden blocks or boulders placed at intervals beneath them. In some cases, especially on the eastern side of the building, the irregular blocks or wedges that are intended to support the slanted joists have fallen out of position. They should be replaced carefully in order to prevent the bending of the floor membrane when the building is fully occupied.

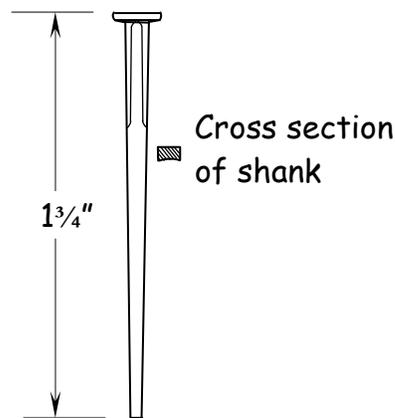
Each clapboard that was removed was found to be circular sawn. No clapboard had building paper under it. All clapboards were held by cut nails of the general pattern shown below. Although most of these nails were corroded by rust, they appear to conform to the most modern of several methods of fabrication that were employed between the advent of the cut nail in the 1790s and the decline of these nails a century later. Nails of this type have a long chamfer along the shank below the head, and burrs from shearing on the same side of the tapered shank. Research has dated the fabrication of such nails between circa 1835 and circa 1890, when the manufacture of cut nails diminished with the advent of the wire nail. Because of the wide possible date range for this type of nail, it is impossible to use the nails to ascertain a close date for the application of the clapboards. In general, however, it may be said that any wholesale re-clapboarding that might have been done in 1908, when Buntin Chapter restored the building, would most likely have utilized wire clapboard nails rather than cut nails. The wholesale use of cut nails implies that the clapboards were installed sometime in the latter nineteenth century rather than in the early twentieth century.

c. 1835 to c. 1890
Modern type of cut nail
