PUBLIC HAZARD

NEW HAMPSHIRE STREAM CROSSING INITIATIVE

Stream crossings – where the river meets the road

WILDLIFE AND SAFETY – A ROAD TO SUCCESS

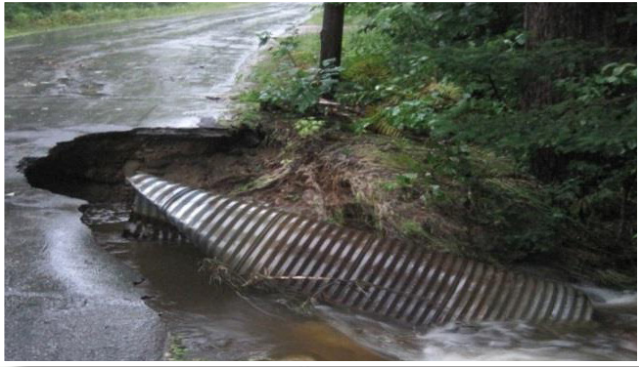
Road washout in Jackson, NH

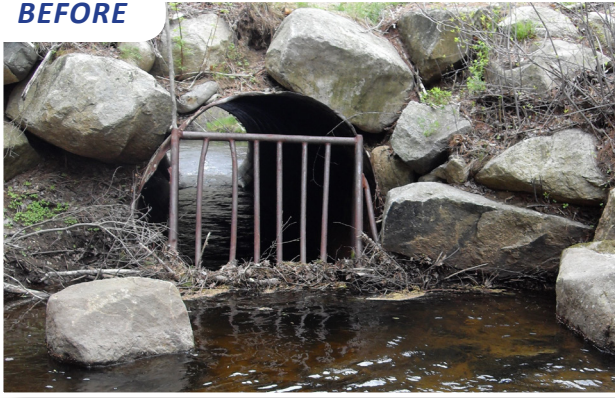
BEFORE

Improperly designed culverts create barriers to fish and other wildlife

- Under-sized culverts can increase water velocity and prevent a natural streambed from forming inside the structure. Fast-moving water and lack of natural eddies and protected areas can prevent passage for smaller aquatic animals.
- Elevated or perched culverts can prevent any animal passage – many local aquatic species need to move freely in a stream to complete their life cycles.

A six-foot corrugated metal culvert originally served as the crossing structure for Hale Road. It was identified as a priority replacement due to the amount of quality cold-water habitat within the stream reach and because it posed a potential hazard to the community during extreme storm events.

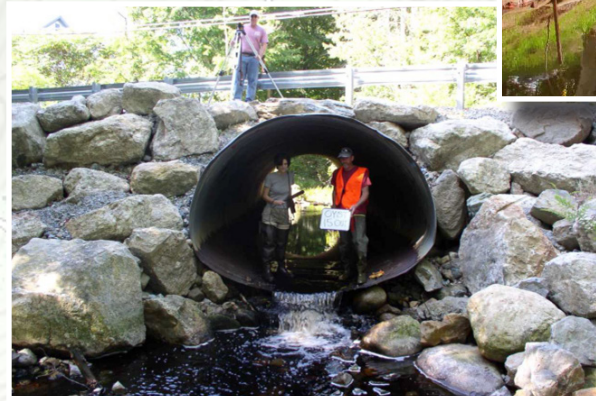
In 2016, the culvert was replaced with a 24-foot aluminum arch culvert, consistent with bankfull measurements. The streambed was restored and the downstream banks were planted with trees and vegetation to ensure stability.

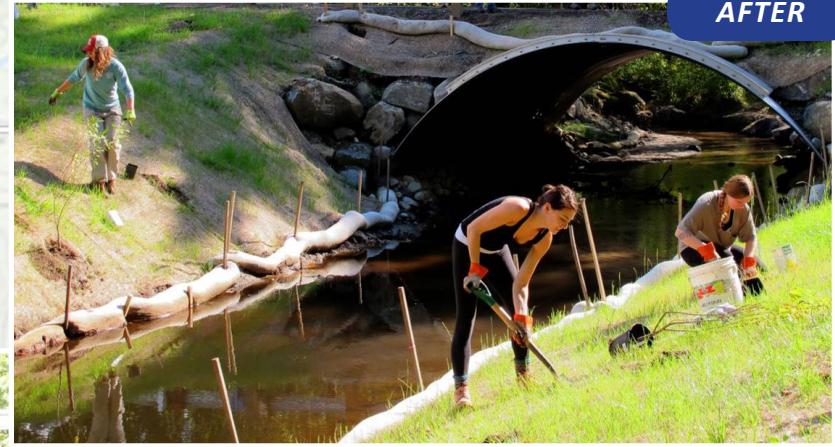
AFTER

Success Story – Falls Brook, Swanzey, NH
