Suncook River
Fluvial Geomorphology Assessment
Explanation Guide
Allenstown, Pembroke, and Epsom, NH

New Hampshire Geological Survey
New Hampshire Department of Environmental Services
Spring 2015

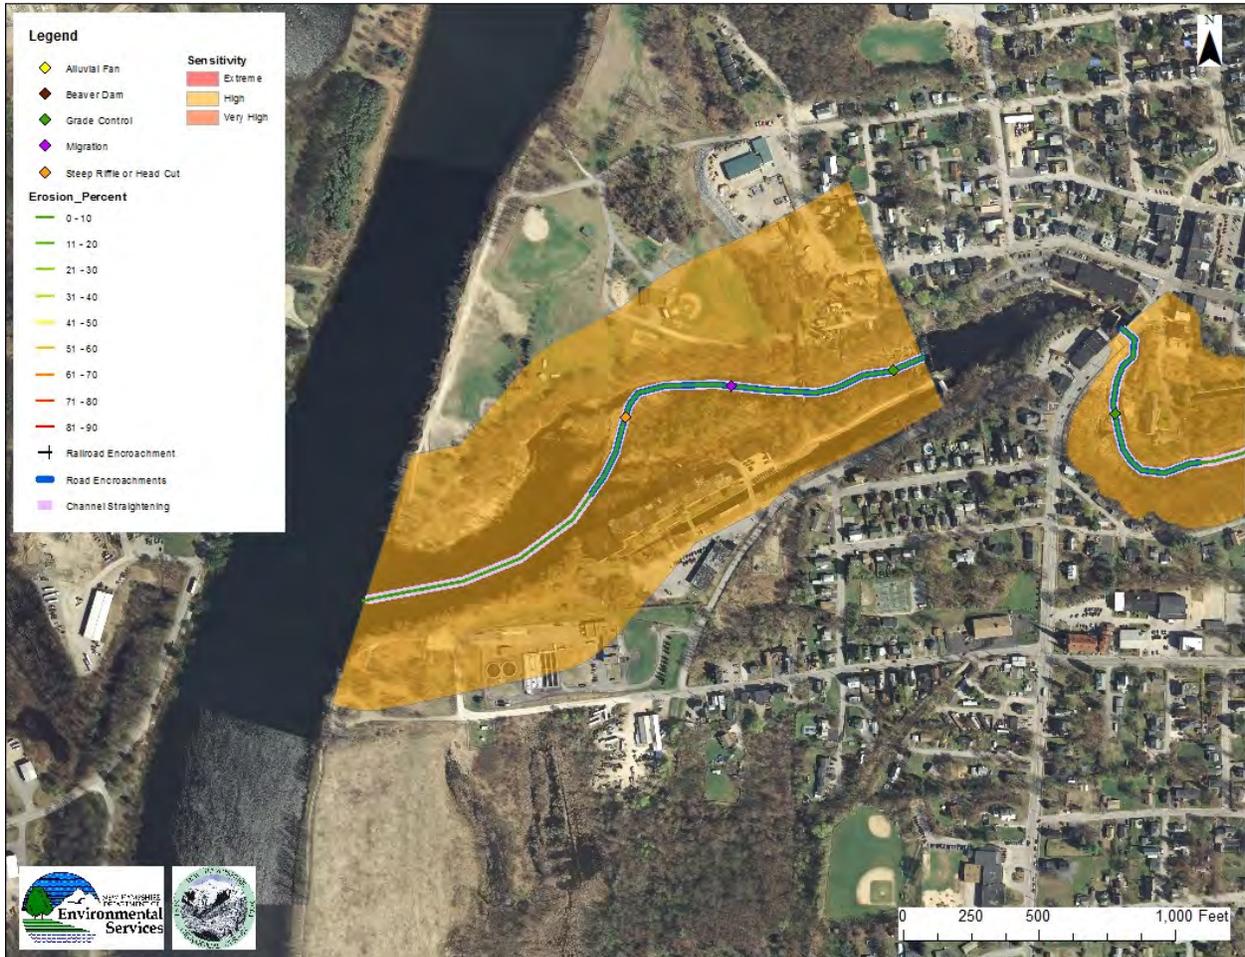
Map 1. Geomorphic features, reach sensitivity and fluvial erosion hazard meander belt for Reach 1.

Reach 1 typed as a B3 stream in the Rosgen classification system (described in Appendix A), and the geomorphic condition of the reach caused it to be assigned a condition rating of Fair, which translates to a reach with High sensitivity. Inputs to this scoring are as follows:

Category	Score
Channel Degradation	5
Channel Aggradation	13
Widening Channel	8
Change in Planform	13
Condition Rating	0.49

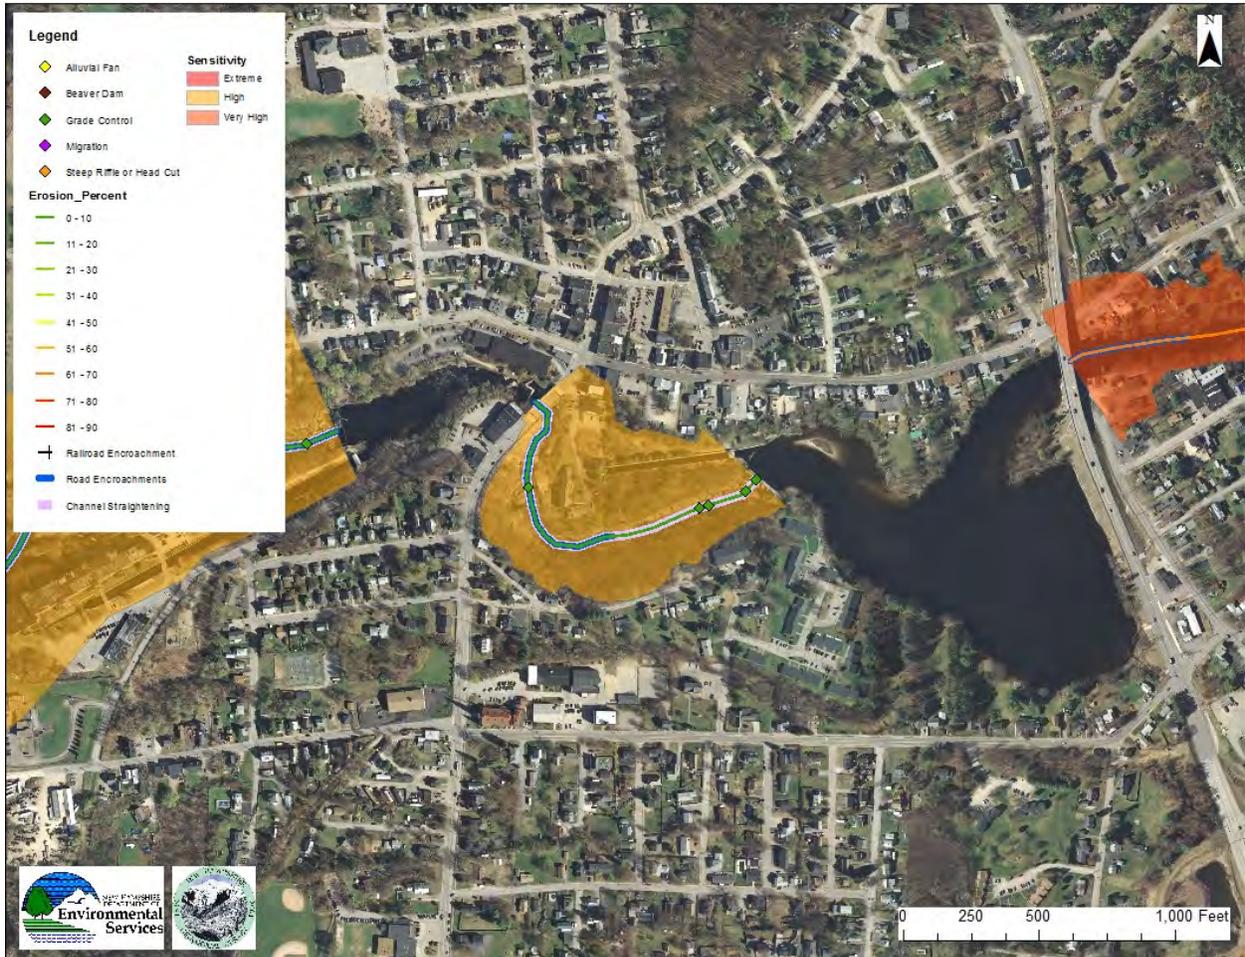
Map 3. Geomorphic features, reach sensitivity and fluvial erosion hazard meander belt for Reach 3.

The stream was classified as a B3, and with a Poor condition, produced a sensitivity of High. Inputs to this scoring are as follows:

Category	Score
Channel Degradation	2
Channel Aggradation	5
Widening Channel	3
Change in Planform	13
Condition Rating	0.29

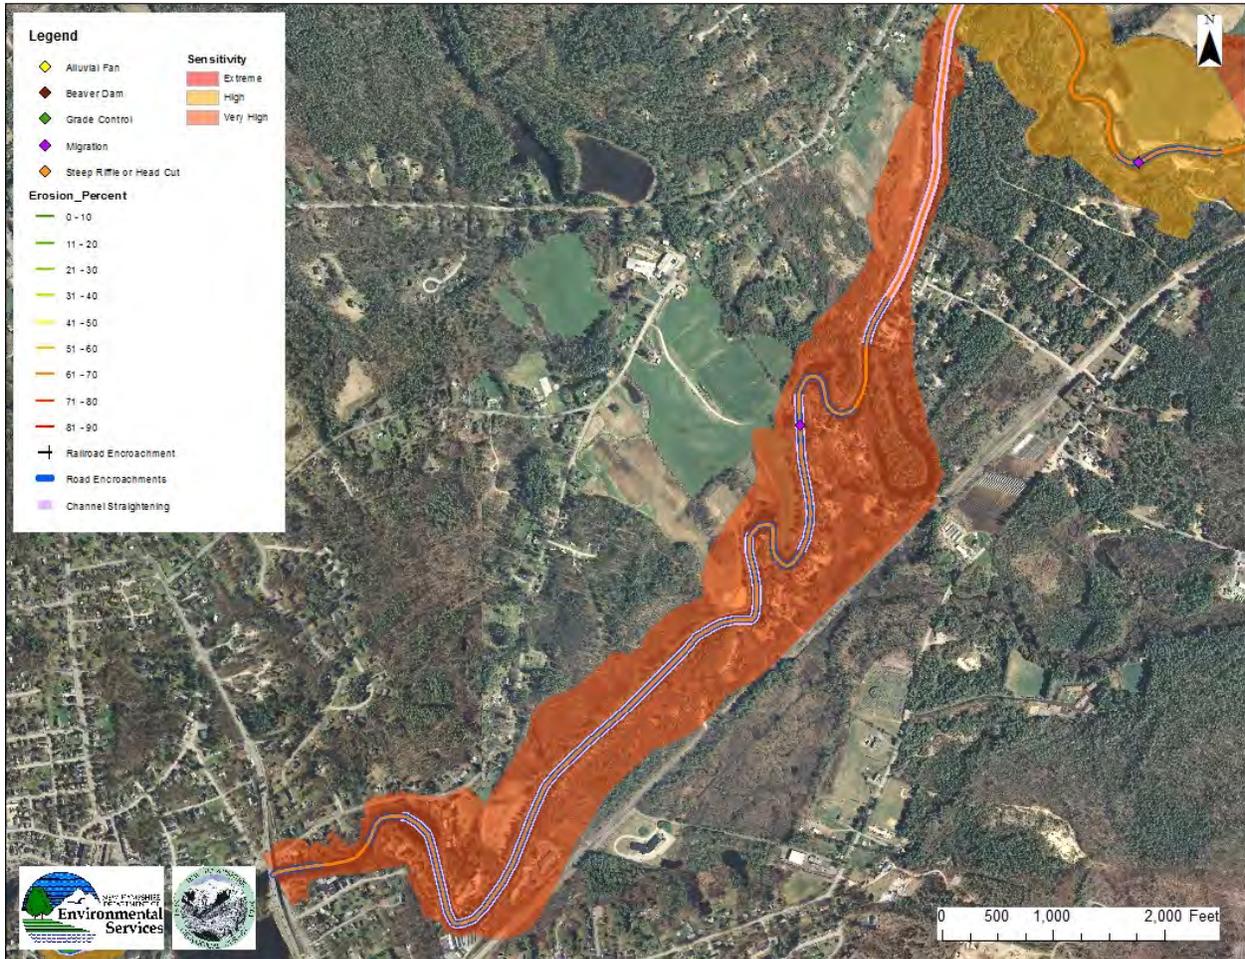
Map 5A. Geomorphic features, reach sensitivity and fluvial erosion hazard meander belt for Reach 5A.

The stream was classified as a C5, and with a Fair condition, produced a sensitivity of Very High. Inputs to this scoring are as follows:

Category	Score
Channel Degradation	11
Channel Aggradation	12
Widening Channel	10
Change in Planform	8
Condition Rating	0.51

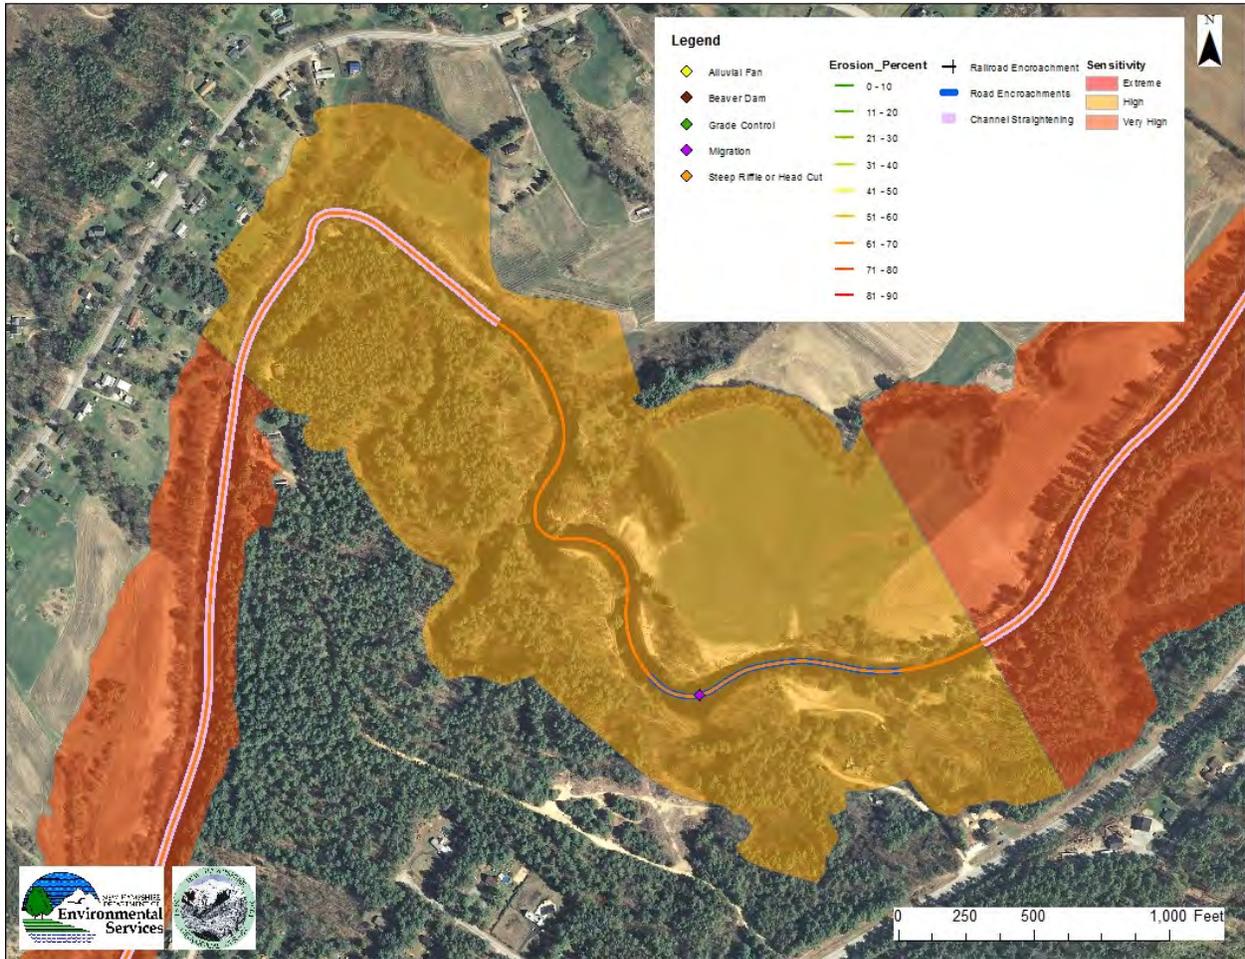
Map 5B. Geomorphic features, reach sensitivity and fluvial erosion hazard meander belt for Reach 5B.

The stream was classified as a C5, and with a Good condition, produced a sensitivity of High. Inputs to this scoring are as follows:

Category	Score
Channel Degradation	14
Channel Aggradation	12
Widening Channel	16
Change in Planform	10
<i>Condition Rating</i>	0.64

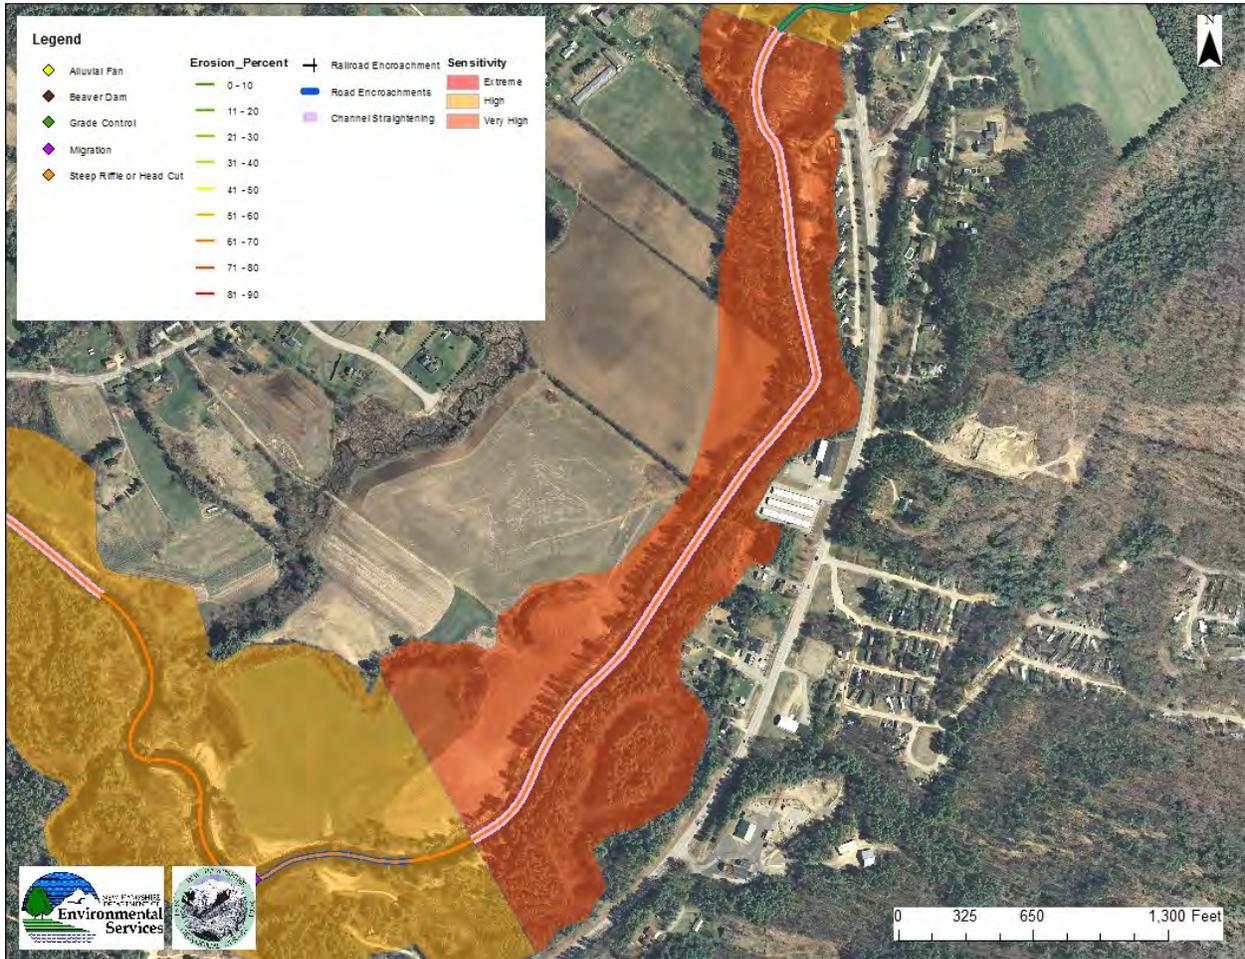
Map 5C. Geomorphic features, reach sensitivity and fluvial erosion hazard meander belt for Reach 5C.

The stream was classified as a C5, and with a Fair condition, produced a sensitivity of Very High. Inputs to this scoring are as follows:

Category	Score
Channel Degradation	4
Channel Aggradation	14
Widening Channel	5
Change in Planform	11
<i>Condition Rating</i>	0.425

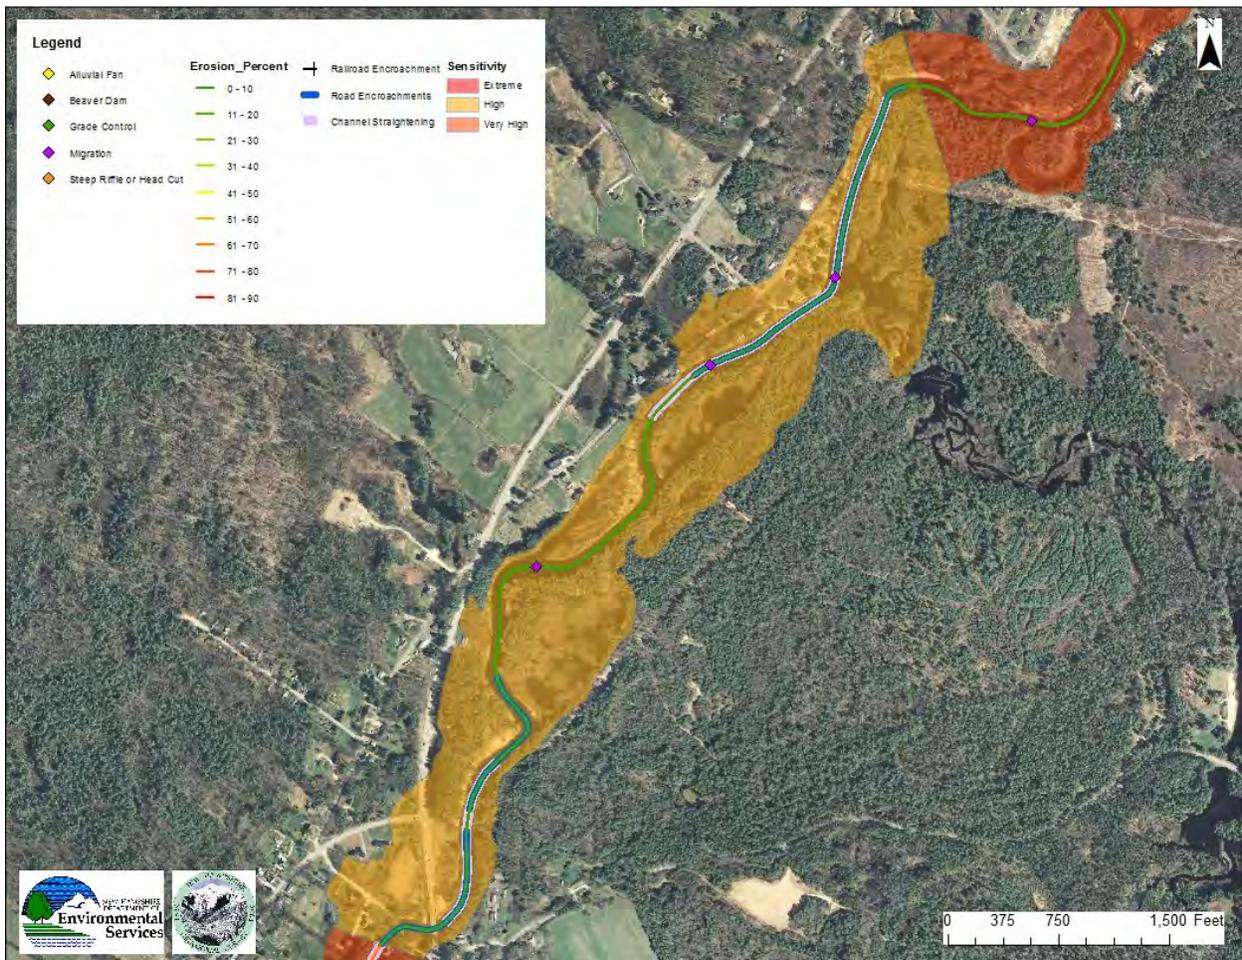
Map 6A. Geomorphic features, reach sensitivity and fluvial erosion hazard meander belt for Reach 6A.

The stream was classified as a B5, and with a Fair condition, produced a sensitivity of High. Inputs to this scoring are as follows:

Category	Score
Channel Degradation	9
Channel Aggradation	11
Widening Channel	10
Change in Planform	14
Condition Rating	0.55

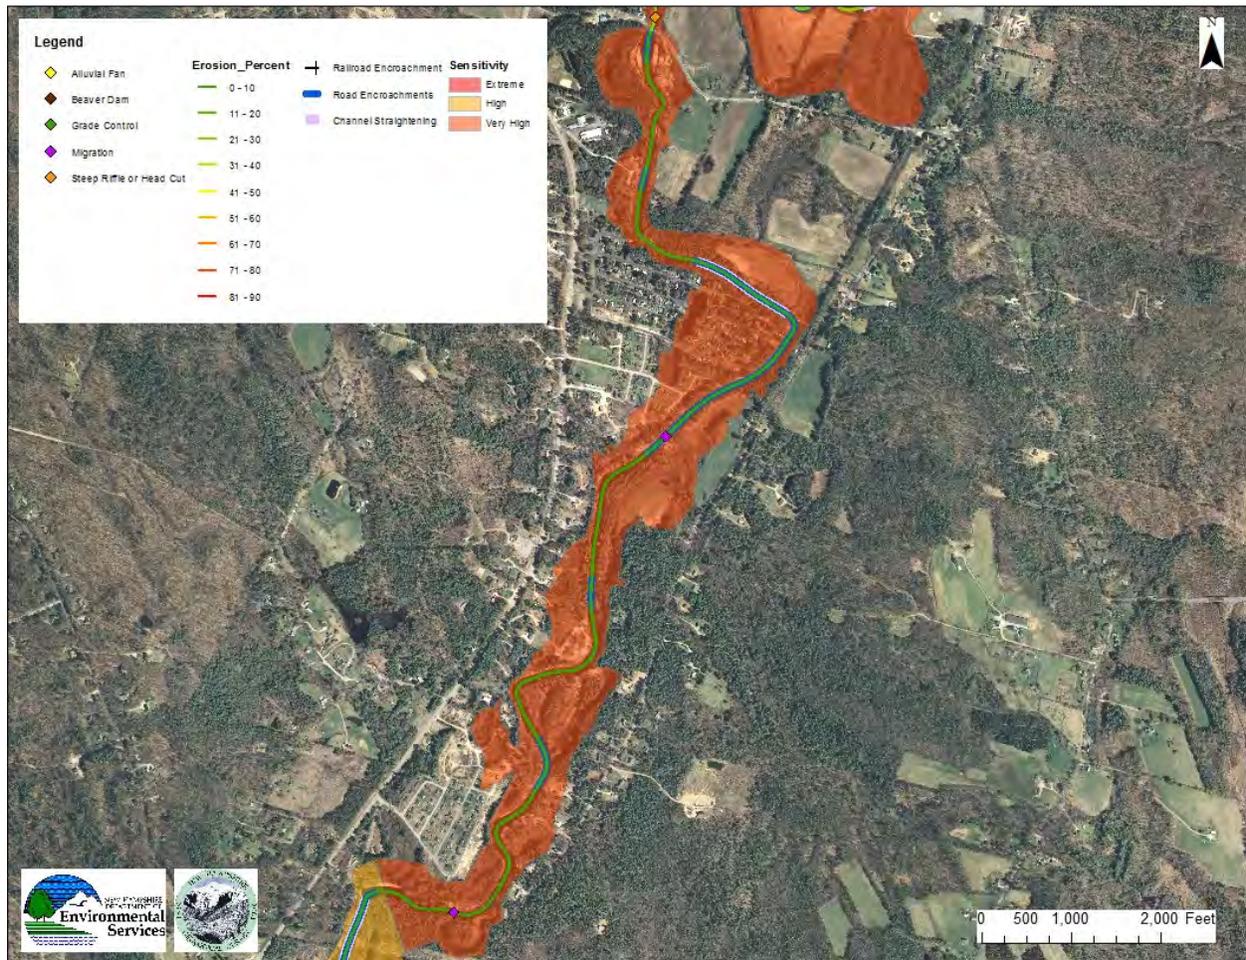
Map 6B. Geomorphic features, reach sensitivity and fluvial erosion hazard meander belt for Reach 6B.

The stream was classified as a F5, and with a Fair condition, produced a sensitivity of Very High. Inputs to this scoring are as follows:

Category	Score
Channel Degradation	5
Channel Aggradation	7
Widening Channel	9
Change in Planform	13

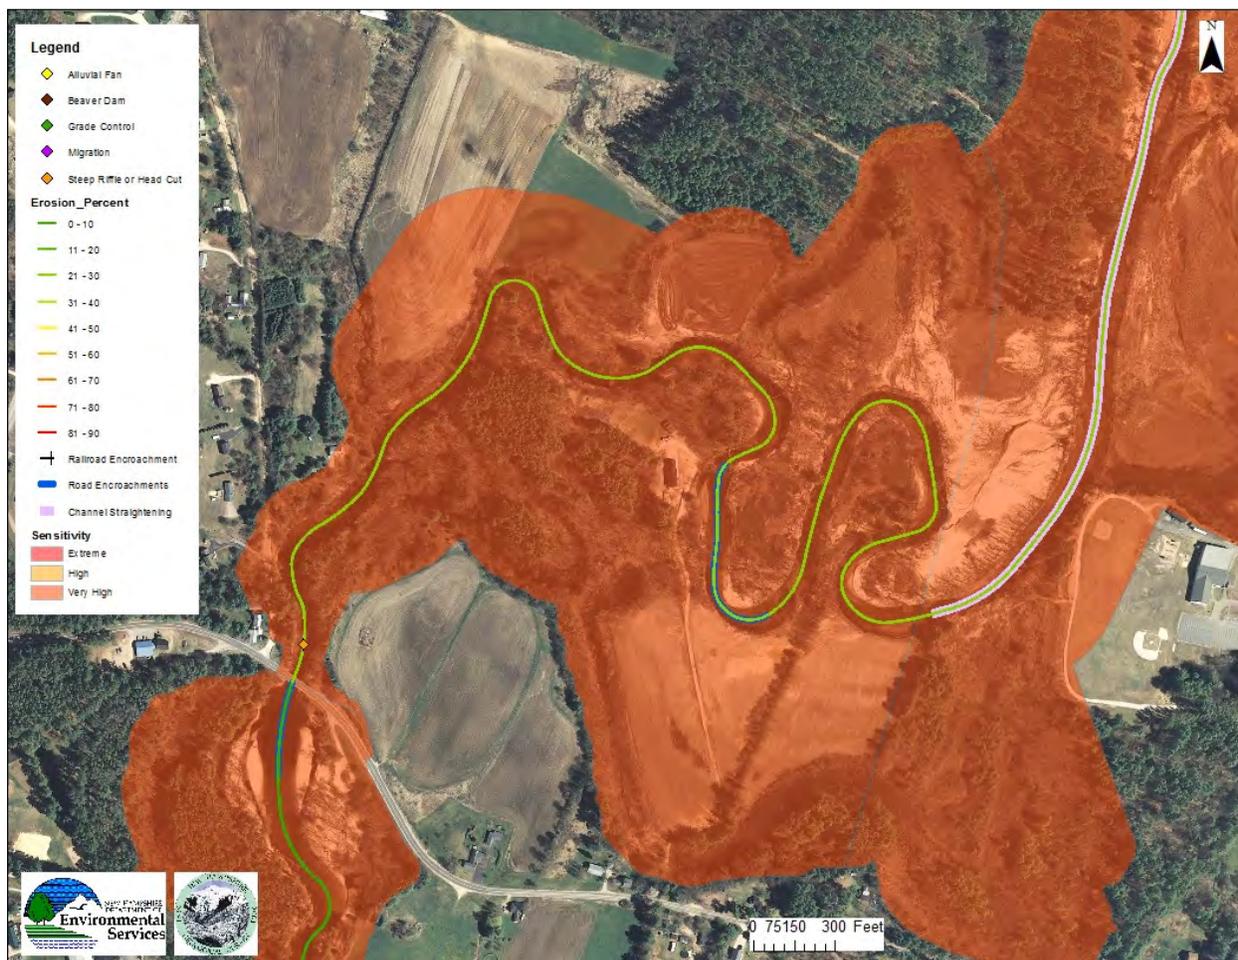
Map 7A. Geomorphic features, reach sensitivity and fluvial erosion hazard meander belt for Reach 7A.

The stream was classified as a F5, and with a Fair condition, produced a sensitivity of Very High. Inputs to this scoring are as follows:

Category	Score
Channel Degradation	5

Channel Aggradation	16
Widening Channel	11
Change in Planform	17
Condition Rating	0.61

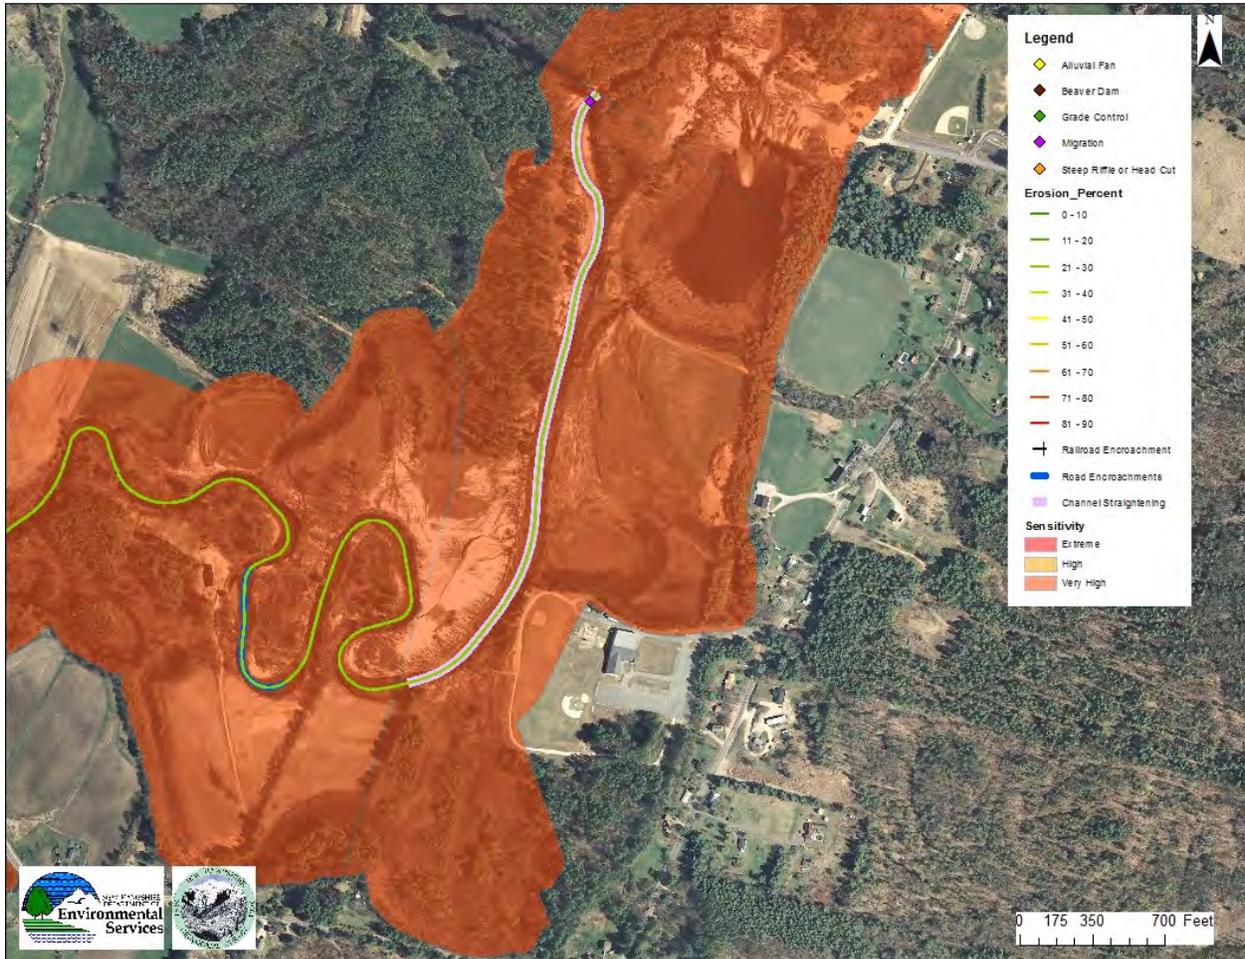
Map 7B. Geomorphic features, reach sensitivity and fluvial erosion hazard meander belt for Reach 7B.

The stream was classified as a C4, and with a Poor condition, produced a sensitivity of Very High. Inputs to this scoring are as follows:

Category	Score
Channel Degradation	5
Channel Aggradation	11
Widening Channel	4
Change in Planform	5
Condition Rating	0.31

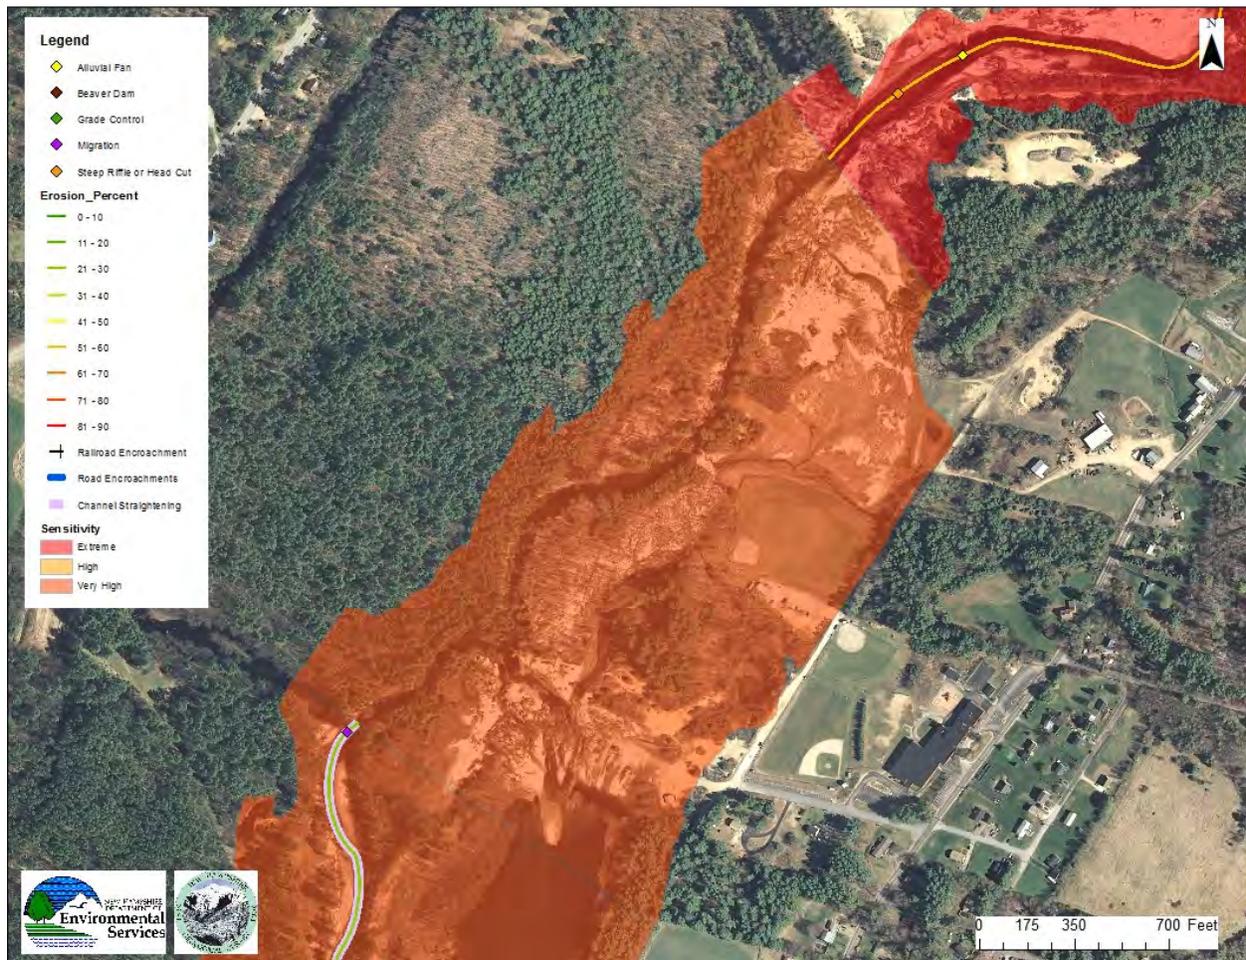
Map 8. Geomorphic features, reach sensitivity and fluvial erosion hazard meander belt for Reach 8.

The stream was classified as a C4, and with a Poor condition, produced a sensitivity of Very High. Inputs to this scoring are as follows:

Category	Score
Channel Degradation	10
Channel Aggradation	10
Widening Channel	3
Change in Planform	3
Condition Rating	0.325

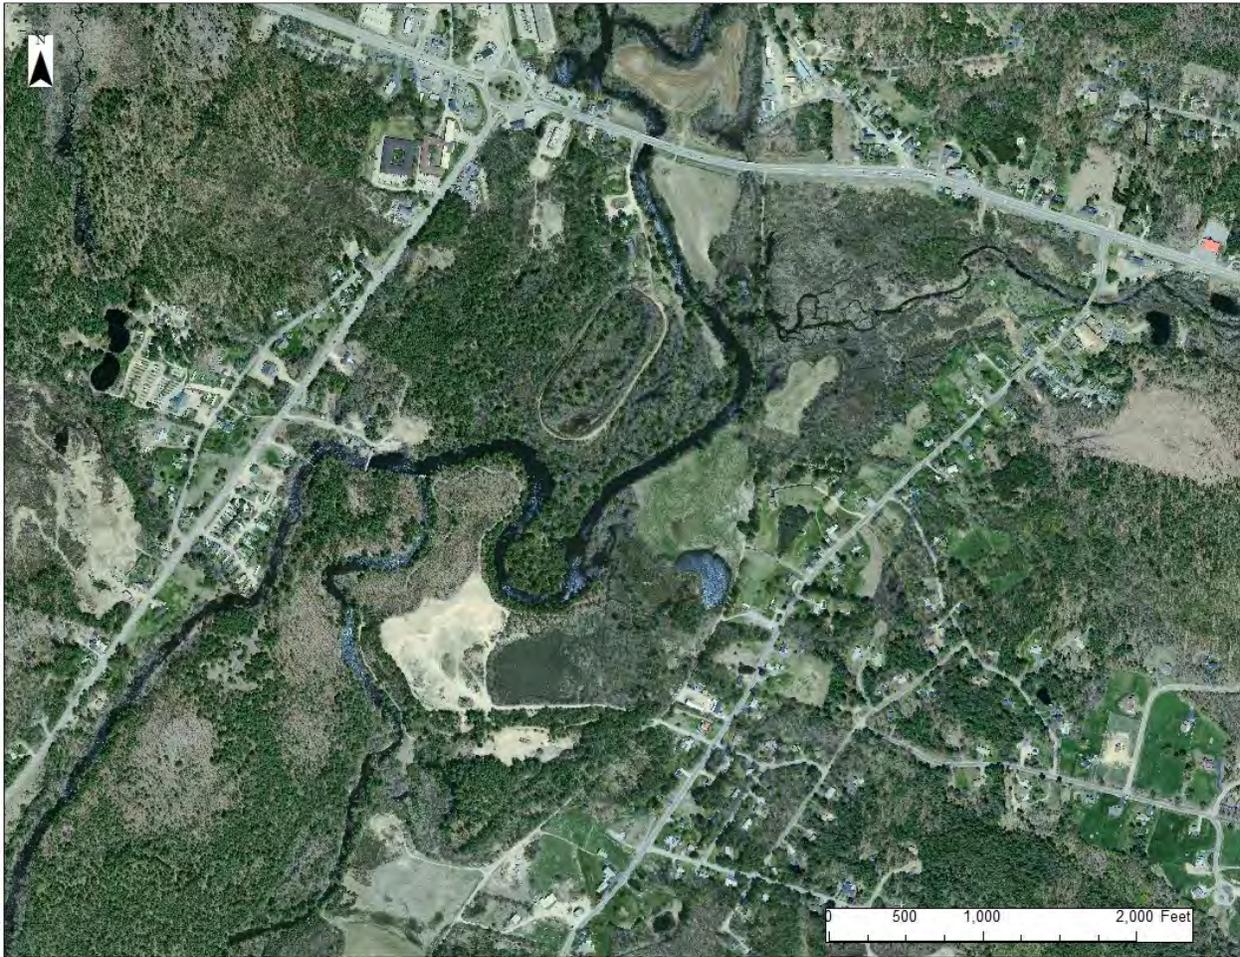
Figure 27. Aerial view of Suncook River in Epsom in 2005, prior to the avulsion.

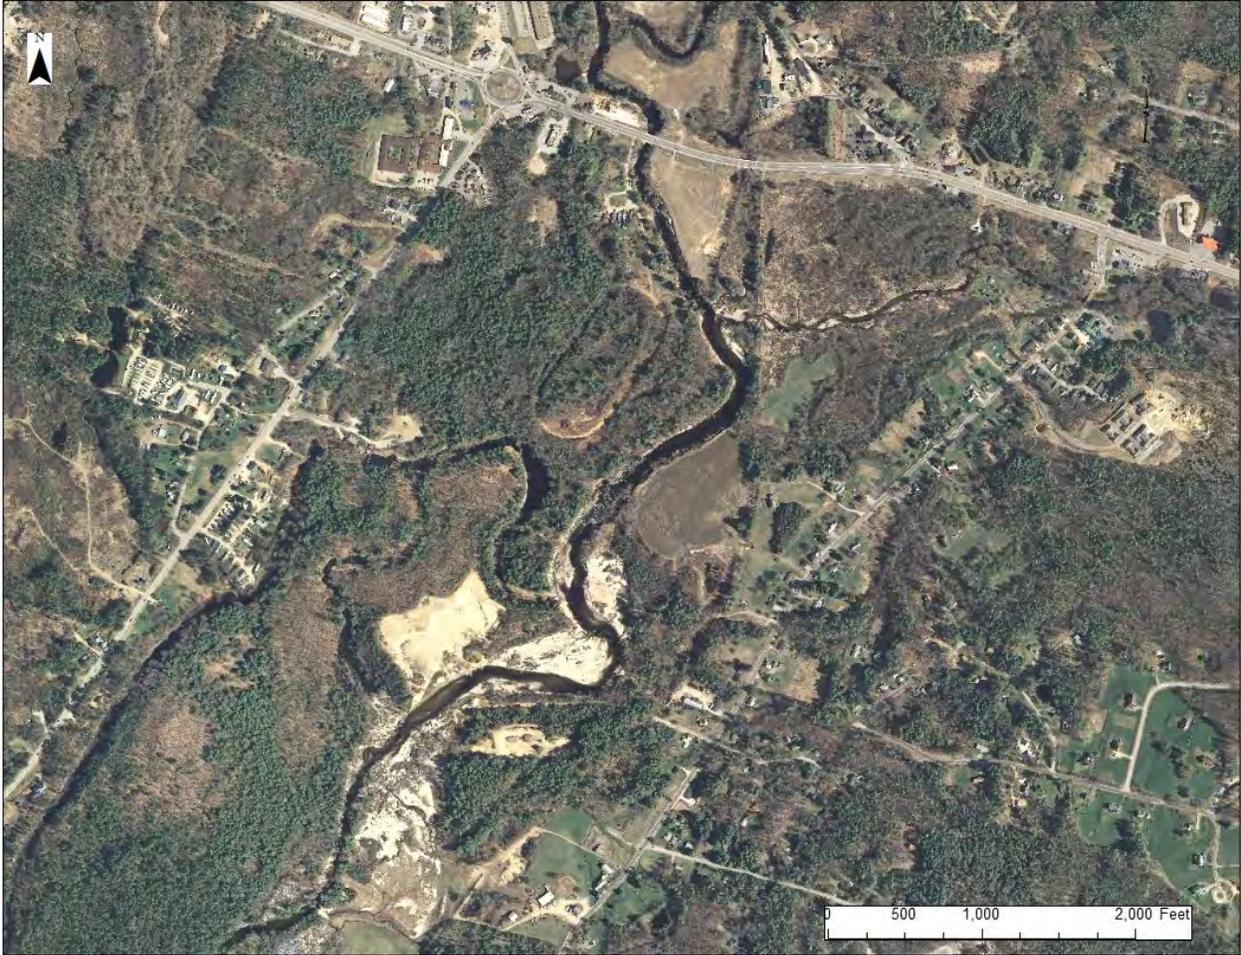
Figure 28. Aerial view of the Suncook River in Epsom, taken in 2011.

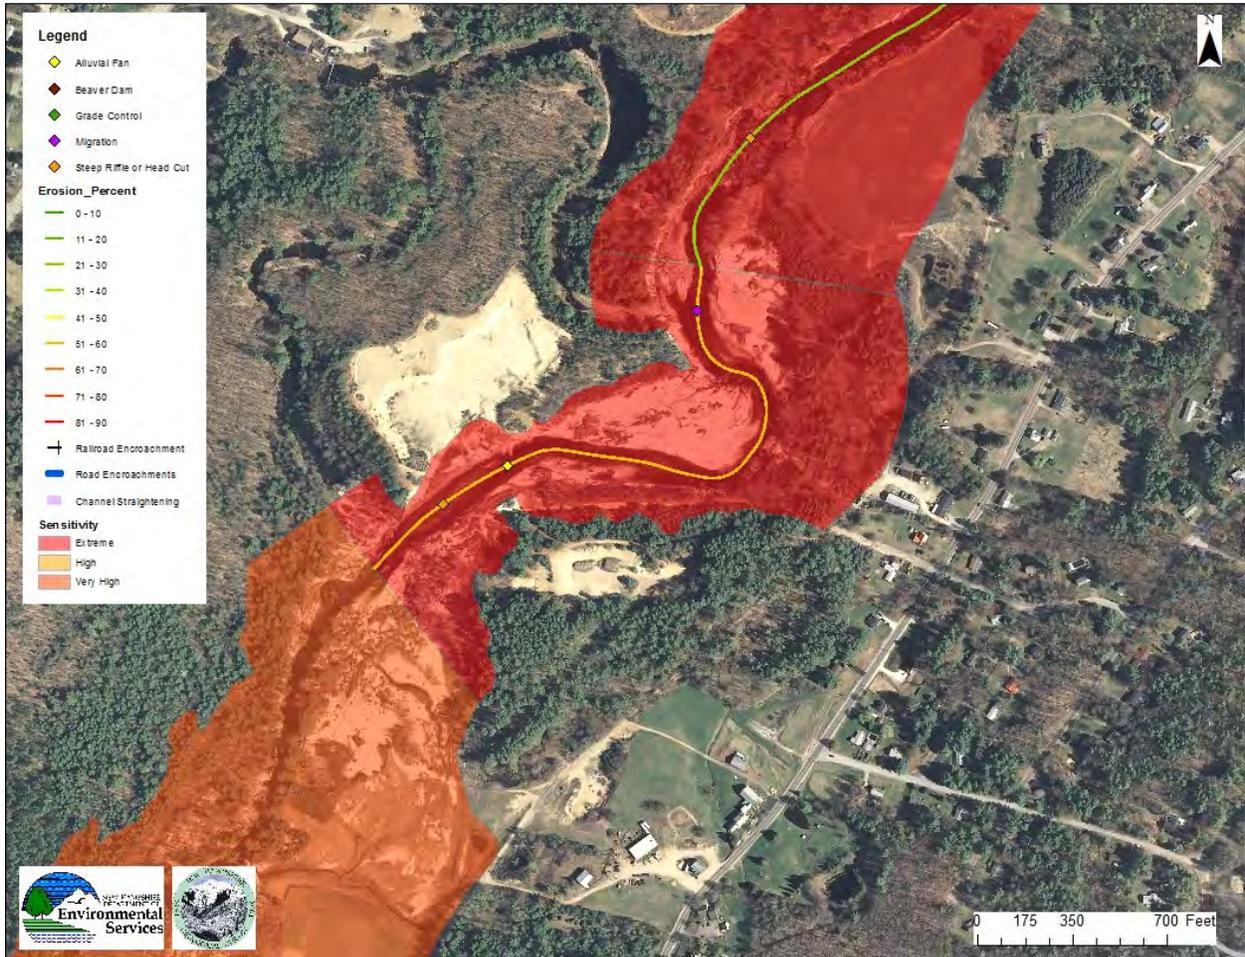
Map 9. Geomorphic features, reach sensitivity and fluvial erosion hazard meander belt for Reach 9.

The stream was classified as a F4, and with a Poor condition, produced a sensitivity of Extreme. Inputs to this scoring are as follows:

Category	Score
Channel Degradation	1
Channel Aggradation	11
Widening Channel	1
Change in Planform	3
Condition Rating	0.20

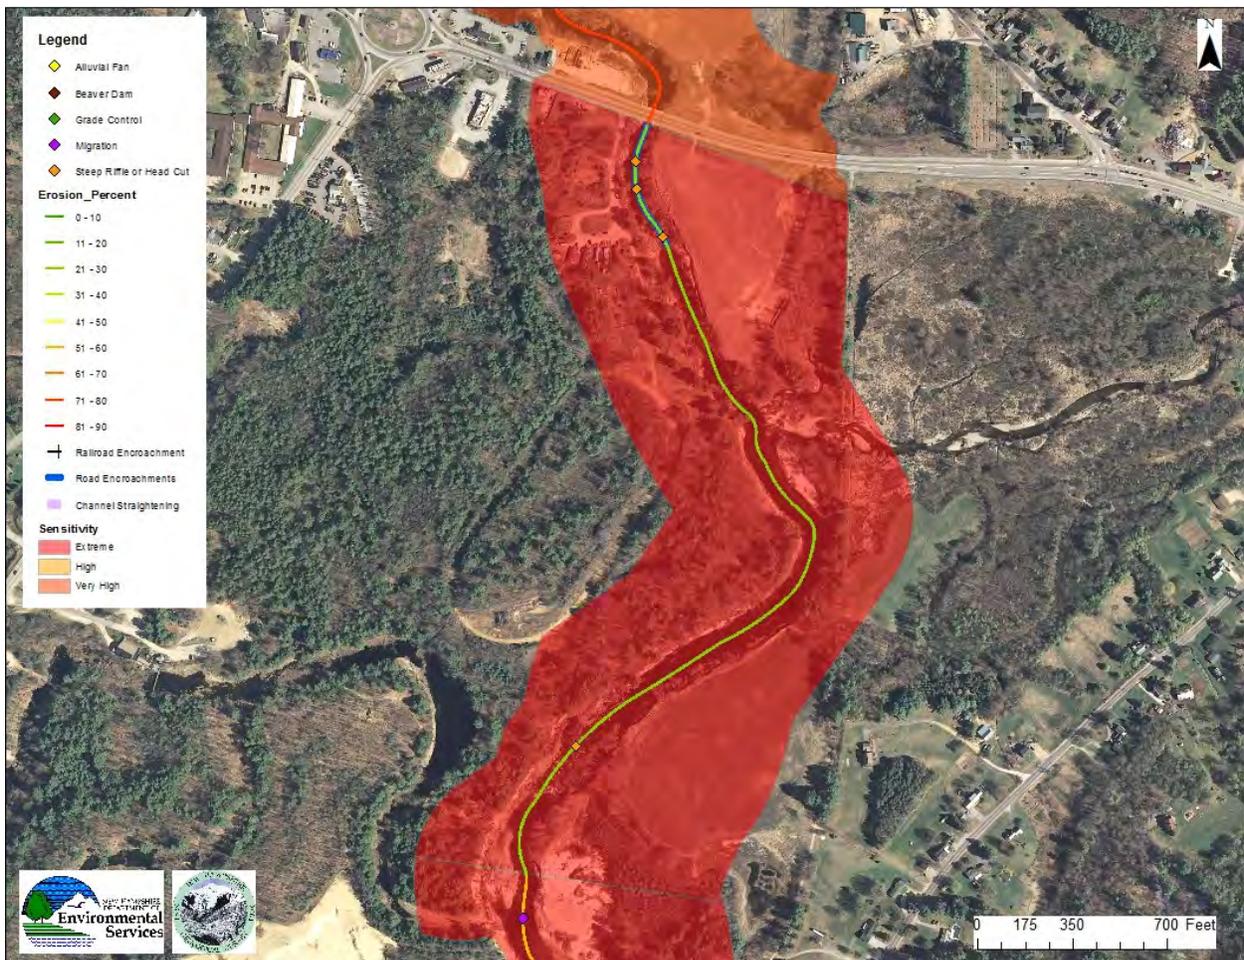
Map 10. Geomorphic features, reach sensitivity and fluvial erosion hazard meander belt for Reach 10.

The stream was classified as a F5, and with a Poor condition, produced a sensitivity of Extreme. Inputs to this scoring are as follows:

Category	Score
Channel Degradation	1
Channel Aggradation	15
Widening Channel	1
Change in Planform	8
Condition Rating	0.31

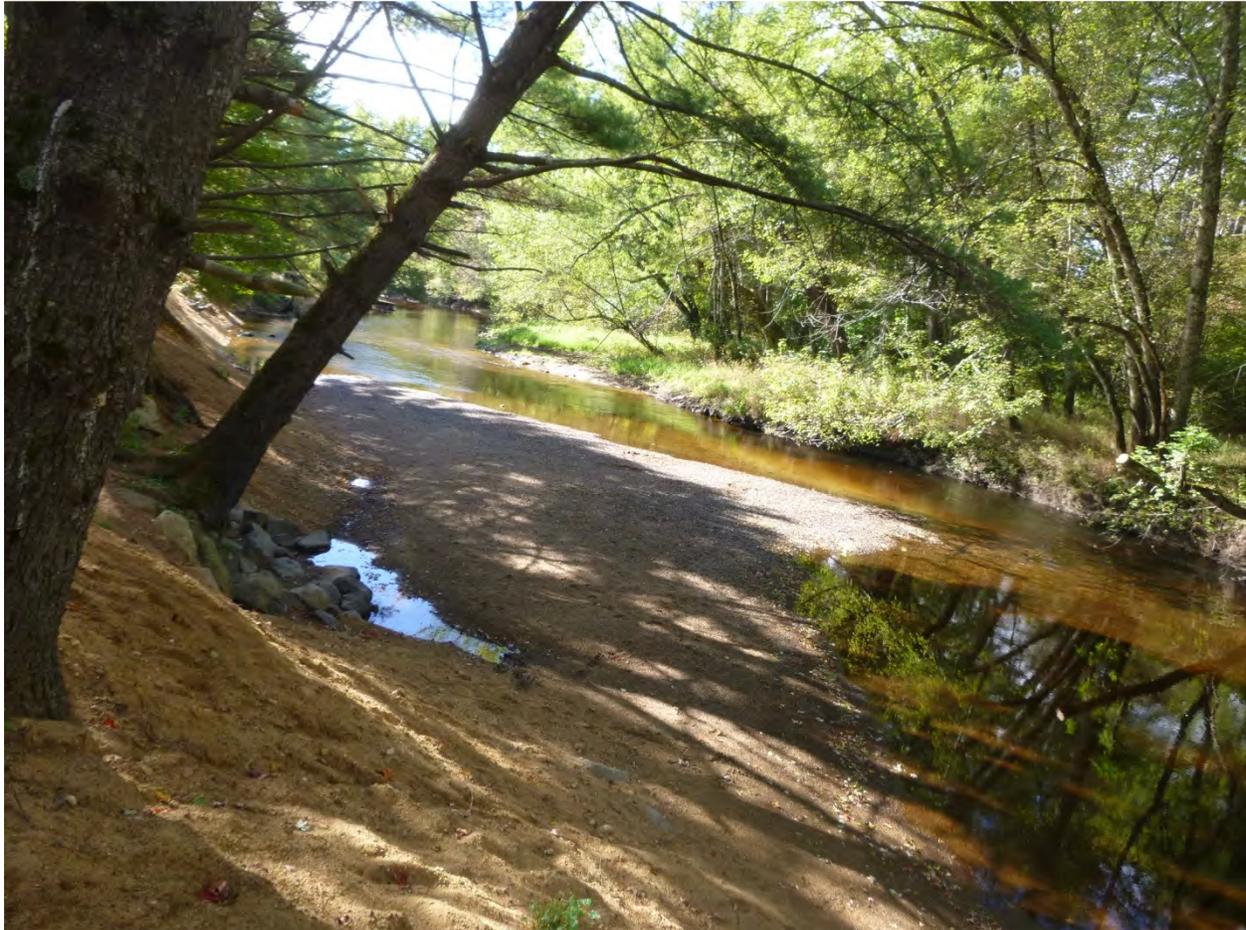
Figure 34. Example view of Suncook River, Reach 11.

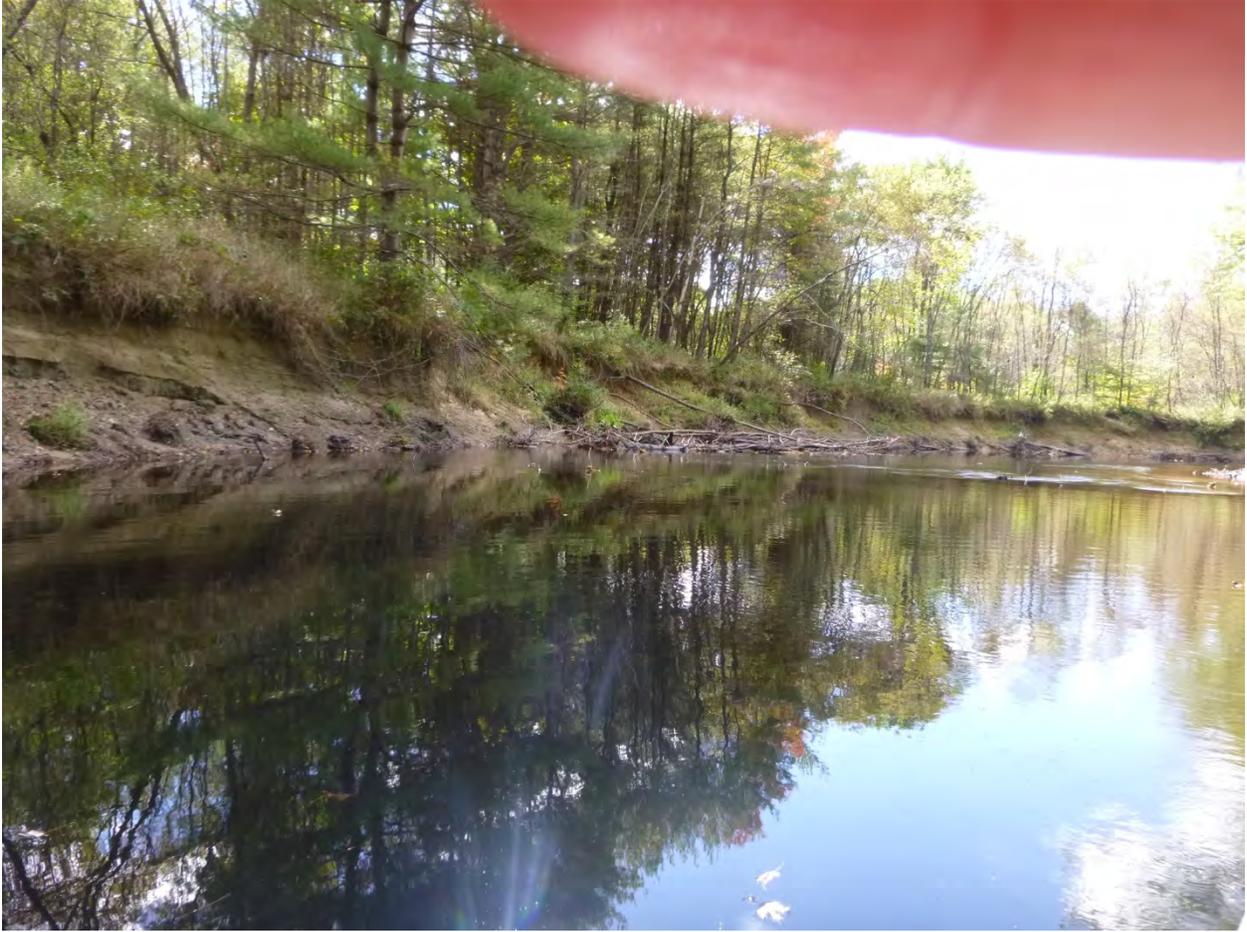
Figure 35. Example view of Suncook River, Reach 11.

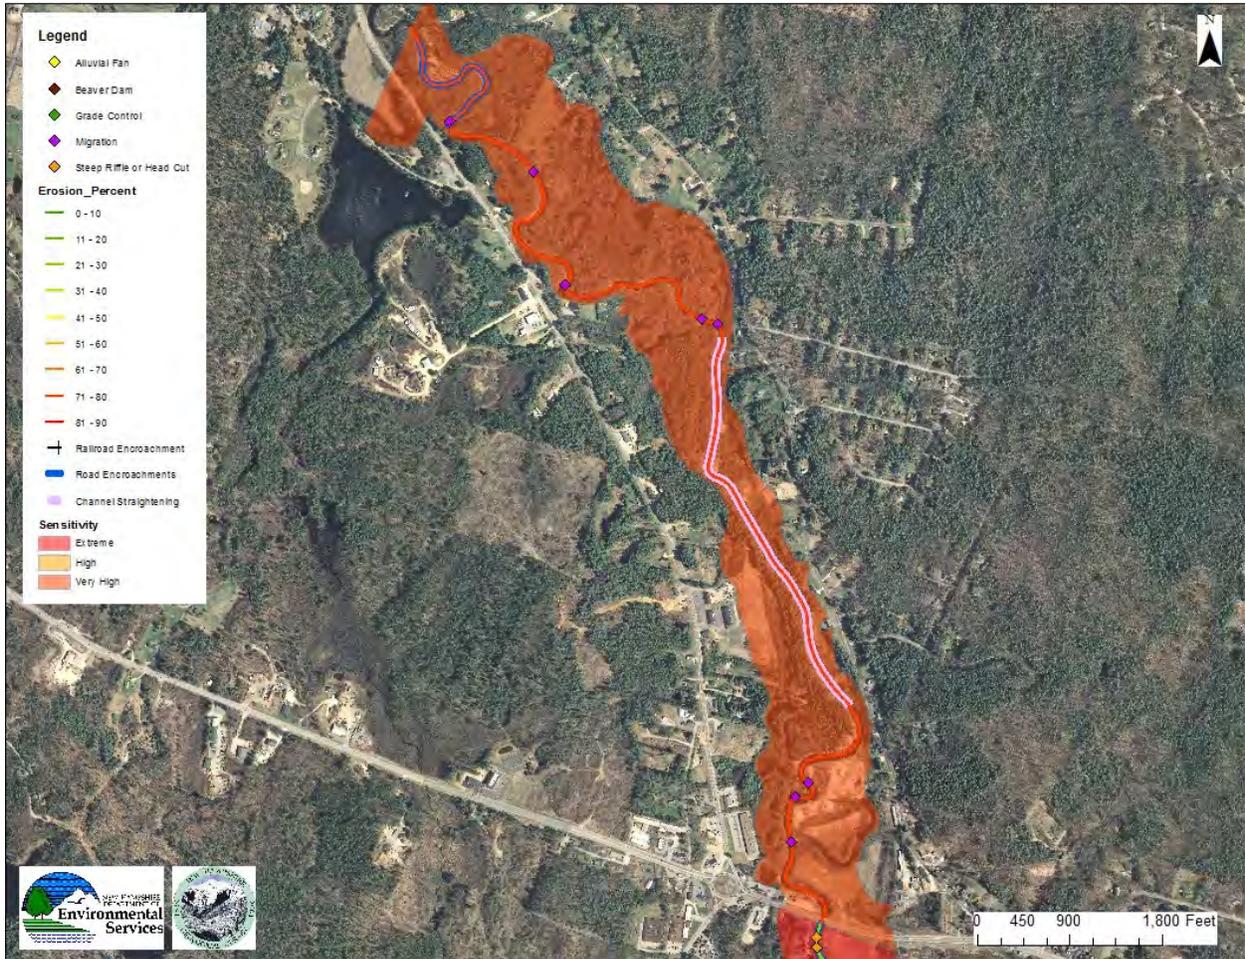
Map 11. Geomorphic features, reach sensitivity and fluvial erosion hazard meander belt for Reach 11.

The stream was classified as a C4, and with a Fair condition, produced a sensitivity of Very High. Inputs to this scoring are as follows:

Category	Score
Channel Degradation	10
Channel Aggradation	14

Widening Channel	11
Change in Planform	5
<i>Condition Rating</i>	0.50
