ALLENSTOWN SCHOOL DISTRICT
ARMAND R. DUPONT MIDDLE SCHOOL
Allenstown, NH 03275
PROJECT # 18345

March 11, 2019

FACILITY ANALYSIS

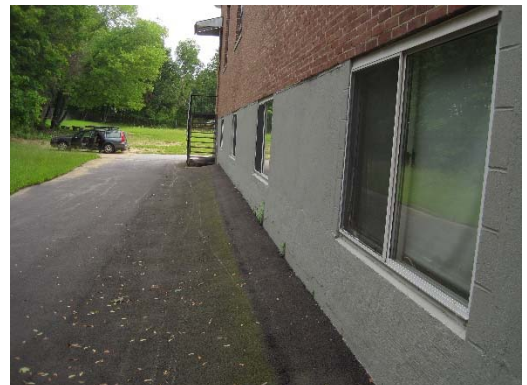
Pavement north of school (looking east)

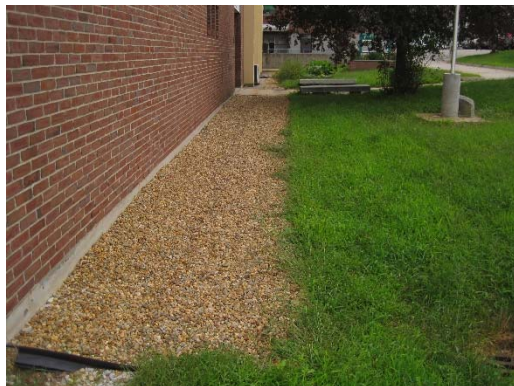
Perimeter drain along southern wall of western building

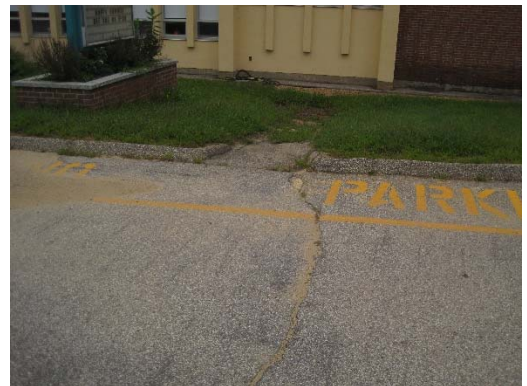
Curb cut that leads to catch basin

- Repair pavement within the school parking lot and access way from the school lot to the church parking lot;
- Repair the areas surrounding the two catch basins, including removing the overgrown vegetation and sediments from the area;
- Reconstruct pavement that conveys stormwater to the eastern catch basin;
- Control sediment build up that was observed throughout the paved surfaces;
- Repair existing surfaces around the western perimeter fence to cover exposed concrete post foundations;
- Coordinate for ADA parking spaces and pavement markings;
- Provide additional directional signage for drivers;
- Repaint the striping within the school parking lot; and
- Reseed the existing grassed areas along the eastern perimeter drive, including repairing the erosion rills within the area.

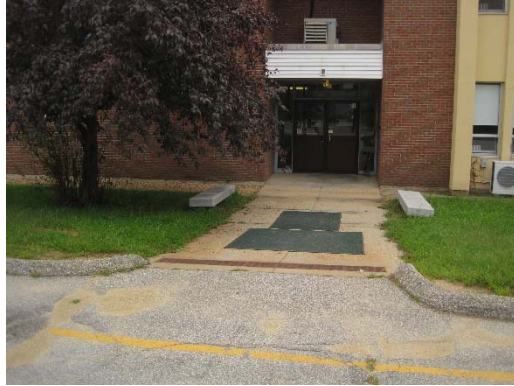
Trench drain at curb cut leading to entrance

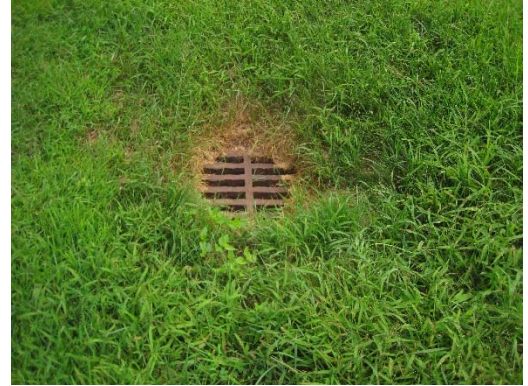
Catch basin within the vegetated area near building

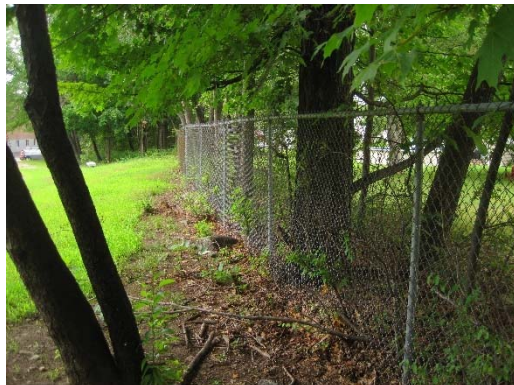
Northern perimeter fence in good condition

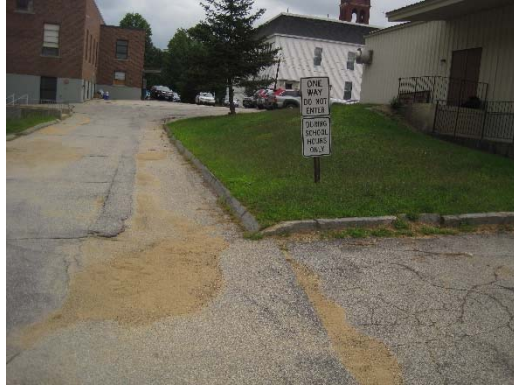
One-way signage heading eastbound on access way

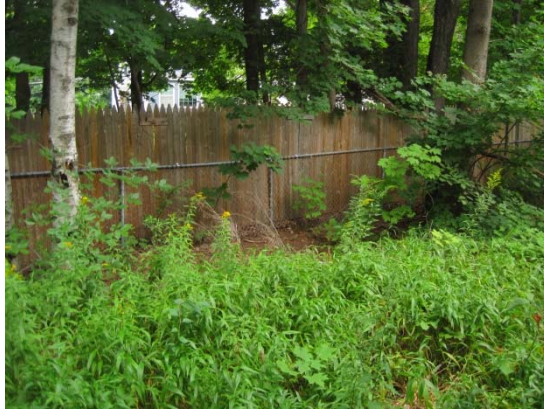
Space between corner of 1988 addition to residential area; approximately 20 feet

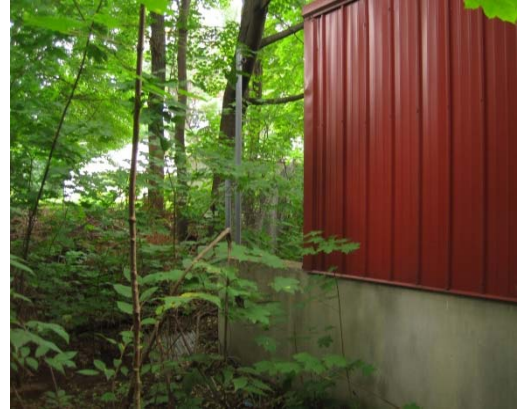
Red storage addition by connector reduces site access to less than 20 feet

Note: Site access along the rear of the two story classrooms is very limited. When designing a new school or renovation/additions to a school building, codes require access for fire apparatus. Local fire departments typically are very sensitive to accessing buildings in an event of a fire.

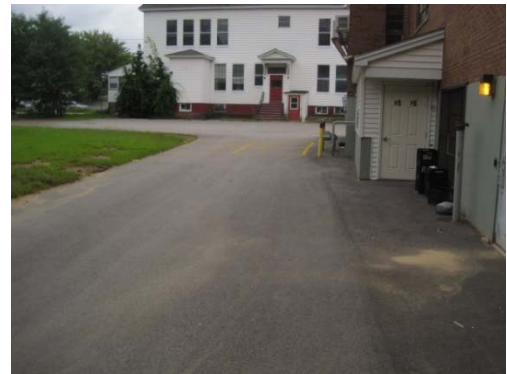
Paved accessed drive along east elevation

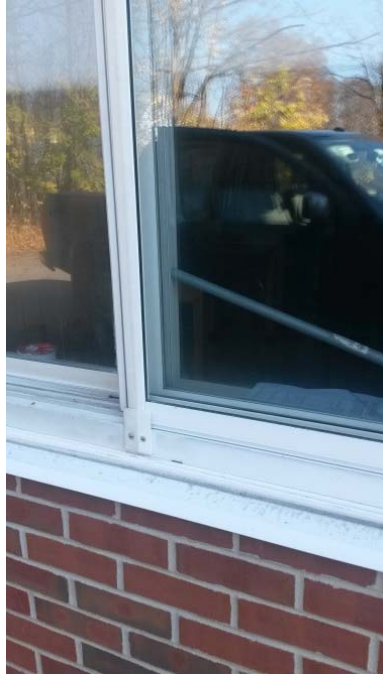
1988 Addition west elevation. Note wood dowel used to secure window due to latch not functioning.

Remove all windows other than recently replaced windows as noted above. Replace with new aluminum thermally broken with desired function and thermal pane glazing. Existing operable gymnasium windows should be reduced in size to lessen heat loss. Windows should be insulated glazing, low-E and argon filled for best performance. Also, replace window shades with clutch shades.

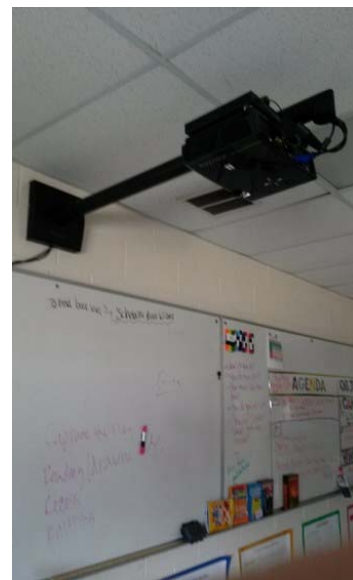
Wall mounted projector with marker board

Harriman recommends that when providing new interactive boards, marker and tack boards, to remove the old boards (if existing) prior to installation. The existing chalk boards should be tested for asbestos containing materials and abated prior to removal.

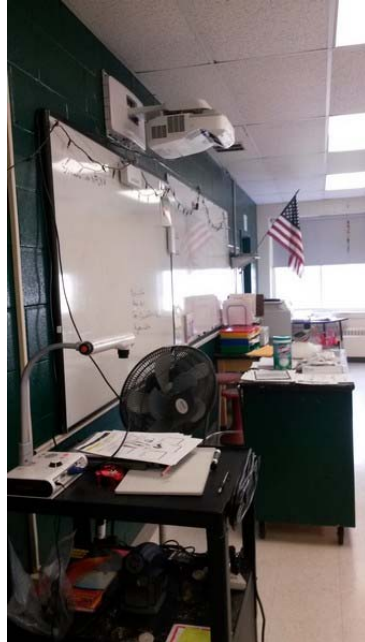
Wall mounted projector with marker board

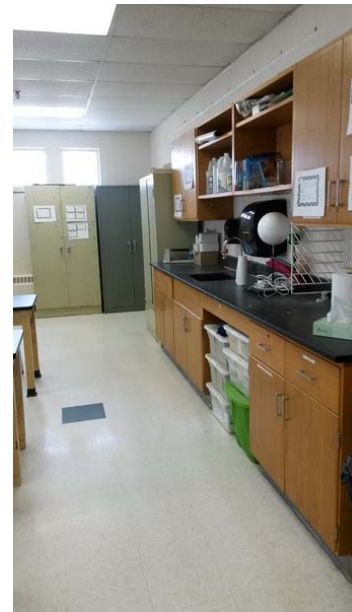
Art room extent of casework with one sink

- All casework to be replaced. Consider redesigning with a combination of open and closed cabinets/shelving. Provide all spaces to meet ADA requirements for accessibility.
- Most spaces need additional storage space.

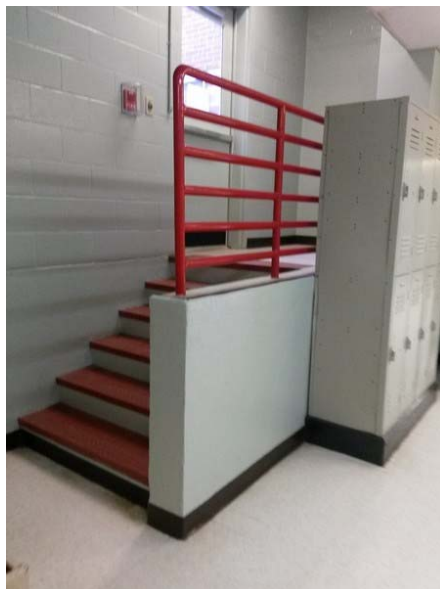
Stair C, needs handrails both sides of stair.

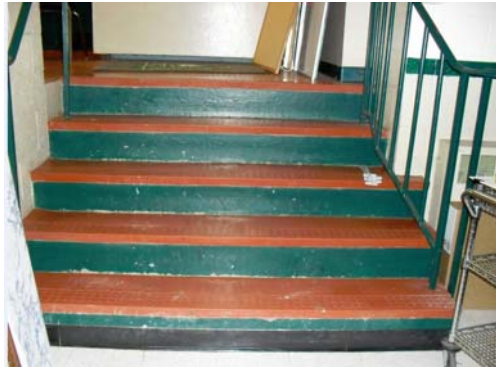
Stair F from Cafeteria #111 iron handrail, balusters and guardrail do not meet code.(Stair E similar)

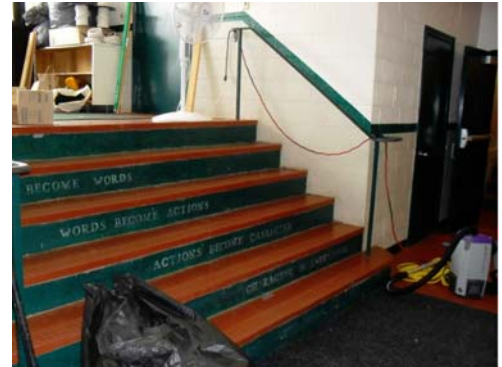
Stair G handrail height and extensions do not meet code.

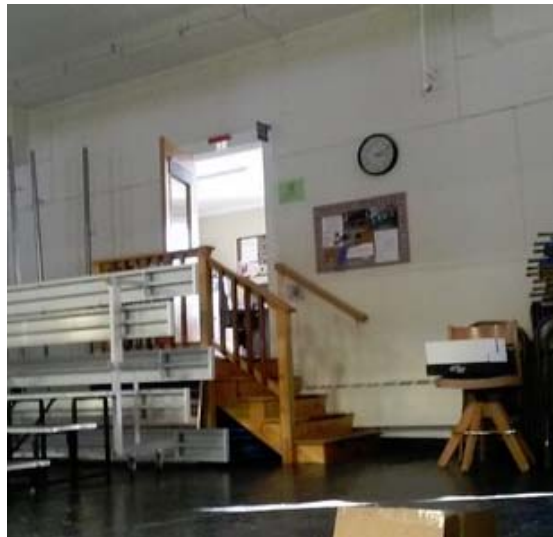
Stair L, wood stair handrail, balusters and guardrail do not meet code.

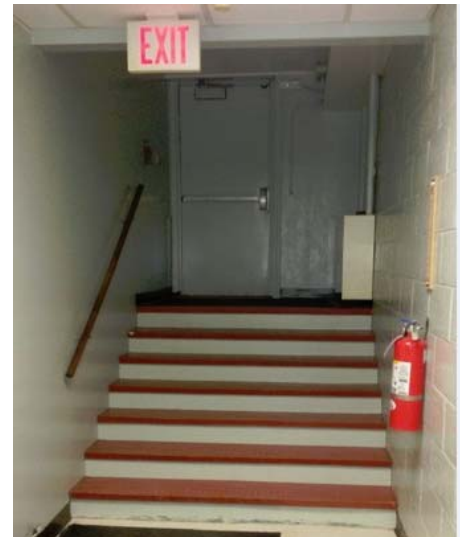
Stair D, needs handrail on right of stair. Note conflict with unit heater.

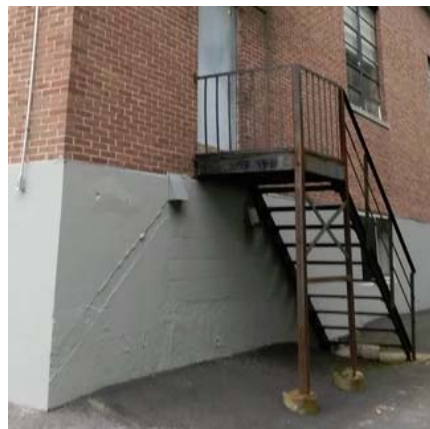
- Stair A and B - handrail extensions do not meet code.
- All stairs in 1954 do not meet many dimensional criteria.
- Exterior stairs K and M do not meet many dimensional criteria.

Exterior stair M need handrails both sides of stair and balusters and guardrail do not meet code.

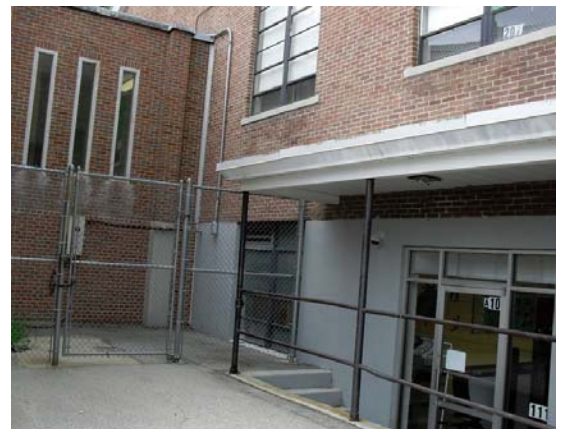
Exterior stairs K need handrails both sides of stair and balusters and guardrail do not meet code.

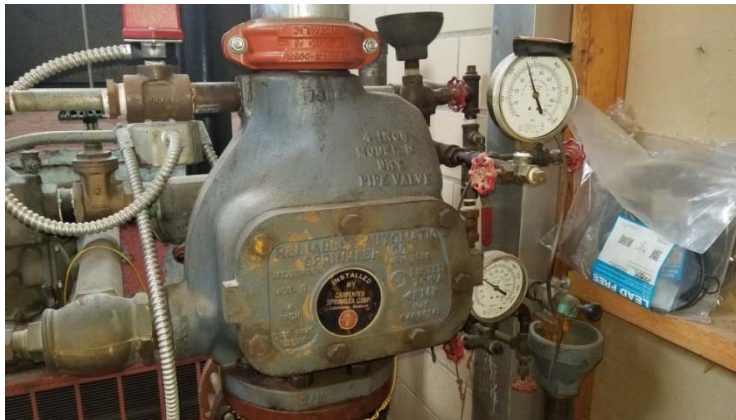
Dry Alarm Valve

The dry alarm valve is vintage 1988. It is unknown if the valve has required maintenance or repairs over the years. The floor mounted air compressor looks relatively new and is assumed to be in good operating condition. The compressor did not start during the survey, indicating that the system does not have any serious leaking of air.

- Dry piping is known to be more susceptible to interior corrosion than wet piping since any water remaining in the piping evaporates over time causing corrosion. The more times the piping is filled, the greater the possibility of interior corrosion. An interior inspection of the piping should be completed and documented. The internal inspection shall include the dry alarm valve, system riser, cross main and branch line.

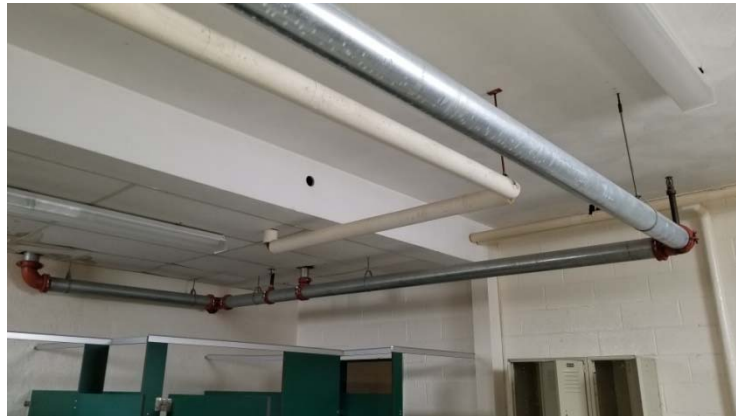
Galvanized Piping with Victaulic Couplings

The sprinkler consists of a black steel piping system throughout the building except in the girls' locker room. The exposed piping in the girls' locker room is galvanized steel piping. The piping system is joined with Victaulic couplings and threaded fittings. Threaded fittings connect piping 2"

and smaller while the Victaulic couplings connect piping 2-1/2" and larger. Sprinkler coverage meets current NFPA 13 requirements, although not every space and closet, etc. was surveyed for compliance. NFPA 25 requires piping to have an internal investigation at 5 year intervals. It is unknown if the piping has been inspected six times since it was installed in 1988.

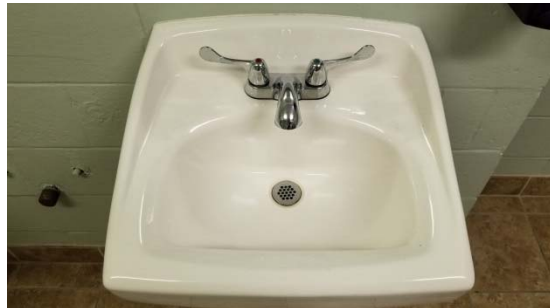
Second Floor Boys ADA Lav

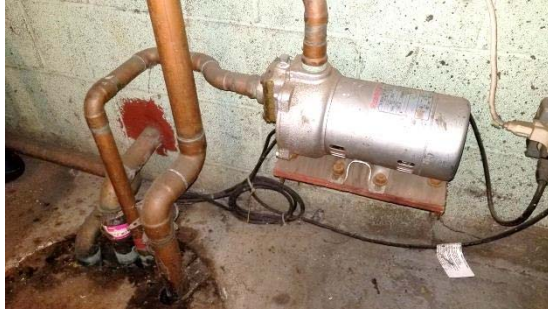
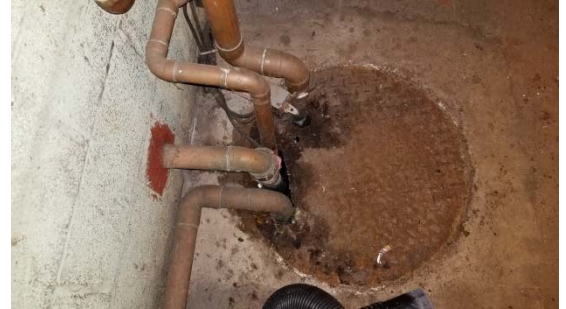
Sump Pump for Kitchen

The kitchen has an above floor grease interceptor. The grease interceptor serves the two wash bays of the three compartment sink. The kitchen pre-rinse sink, dishwasher, three bay sink and grease interceptor discharge into a sump pump recessed in the floor of the boiler room.

- Replaced all restroom plumbing fixtures with water conserving models with new flush valves and faucets.
- Replace the gas fired water heater with a unit with a high efficiency 80 gallon unit with 199,000 btuh input.
- Replace the domestic hot water thermostatic mixing valve with a unit of higher capacity.
- Replace the sump pump with similar equipment.

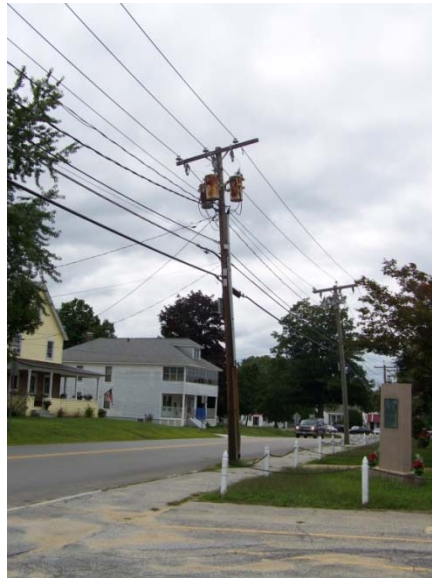
The electrical provider for this site is Eversource. The service entrance is served by three 25kVA, pole mounted transformers located on School Street. The transformers also serve St. John the Baptist Church located between the school and School Street. The 25kVA transformers have a full load rating of about 67.5kW @ .9pf (208 amps at 208 volt, three-phase). Information provided by Eversource indicates that the peak demand measured on April 16, 2018 was 47.8kW (about 133 amps @ 208 volt, three-phase).

Pole mounted transformers serving St. John the Baptist Church and Armand R. Dupont Middle School

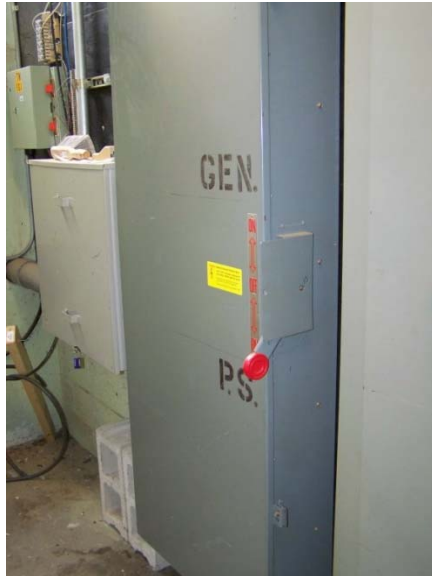
The service disconnect is a manual transfer switch for connection to a portable generator. This does not meet the National Electrical Code as the unprotected secondary conductors have no overcurrent protection until after the transfer switch. Overcurrent protection of the incoming service is the main circuit breaker of panelboard MP (400A circuit breaker). The manual transfer switch and main panel are located in a first floor electrical room adjacent to the girls' locker room.

Manual transfer switch (service disconnect) with CT cabinet and feeder from utility on the left, panelboard with overcurrent protection at right of transfer switch

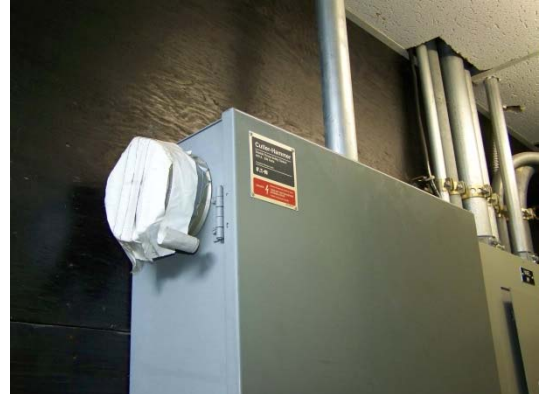
Knockout on transfer switch covered with tape

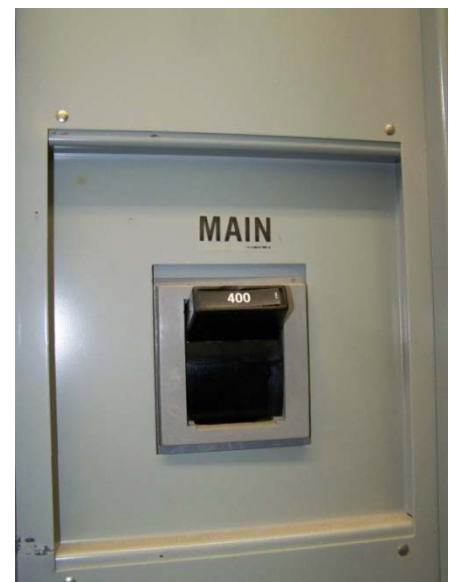
The meter is located on the building exterior. The main panelboard is located in the same first floor electrical room as the manual transfer switch (located to the right of the transfer switch). There appears to be additional circuit breakers tapped off ahead of the main panelboard. The main panelboard is 400amp, 208V, 3ph/4w panelboard with 400amp main circuit breaker. The main panelboard is a Siemens CDP-7 that appears to be in good shape; manufacturer date is 01/89.

Main panelboard MP main circuit breaker, first overcurrent protective device downstream of the manual transfer switch

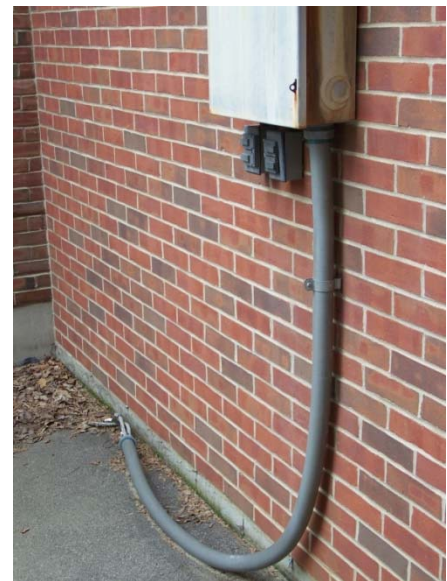
There is a generator connection box/disconnect located on the building exterior at the connector of the gymnasium and classroom portions of the building. The switch has a 400amp rating at 250V. Wiring connecting to an existing generator is still attached to the generator connection box/disconnect. The disconnect is padlocked in the “off” position.

Generator connection box/disconnect with generator umbilical still attached

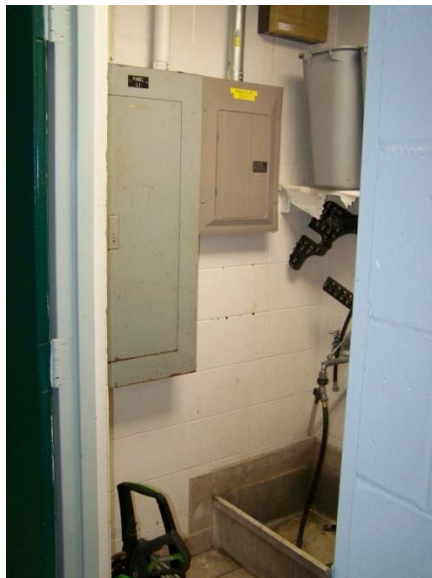
Panelboards downstream of the main panelboard are not located in electrical rooms. They are located in the kitchen, cafeteria, and janitor’s closets. One is located in a stair from the gymnasium adjacent to the music classroom. Many panelboards are single phase. Most panelboards are older

and beyond their expected useful life expectancy. Circuit breakers become difficult and sometimes impossible to find when needed.

Panelboards in typical janitors closet, code required working clearances do not exist

- Upgrade service throughout the building with additional circuit breakers and locate in spaces dedicated for electrical.
- Remove LPG from the Gymnasium egress stair.
- Panelboards that are 30 years old or older should be considered for replacement. Expected useful life expectancy is around 30 years.
- Circuits should be traced to update panelboard directories with accurate, legible, typed directory cards.

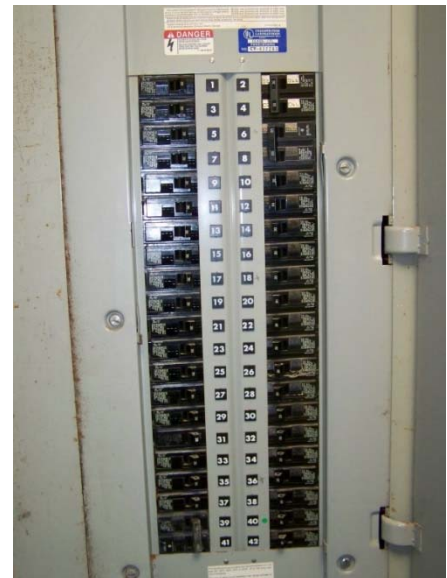
Panelboard L1 located in first floor janitors closet, single phase panelboard

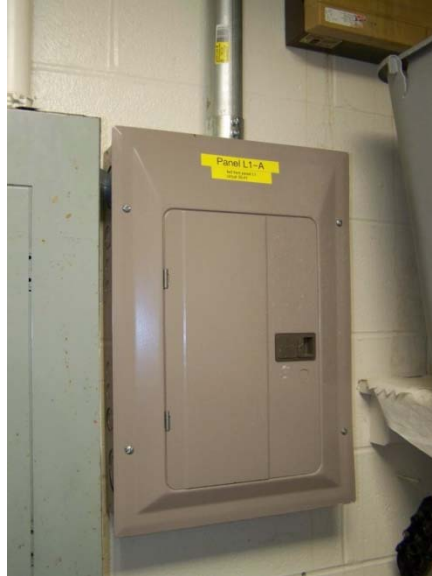
Panelboards have been added next to some panelboards for additional circuit breaker space, this panelboard is adjacent to panelboard L1 in first floor janitors closet

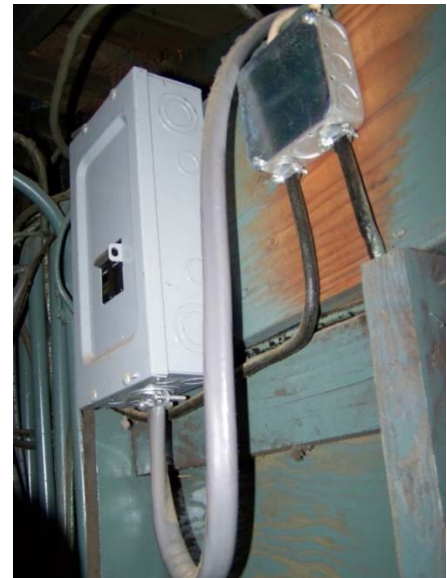
No panelboards were opened however, wiring with cloth insulation, non-metallic sheathed (Romex) and MC cable were observed above ceilings and "attic" space located above the stage.

Non-metallic sheathed cable serving circuit breaker, above stage

- All non-metallic sheathed cable should be replaced with MC.

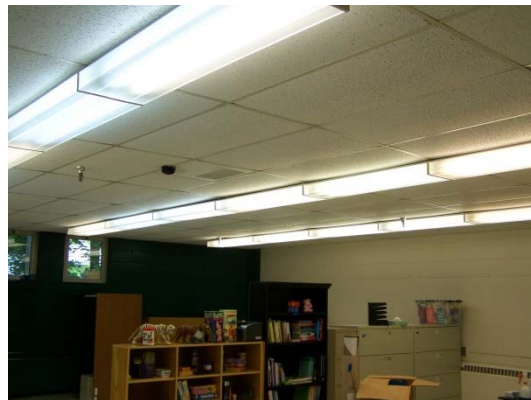
Typical classroom with surface mounted lighting

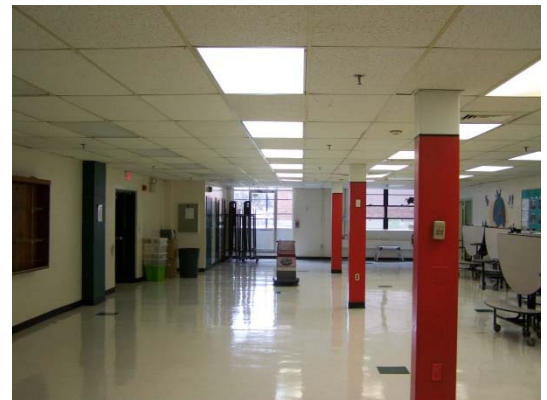
Recessed / flush lighting, cafeteria

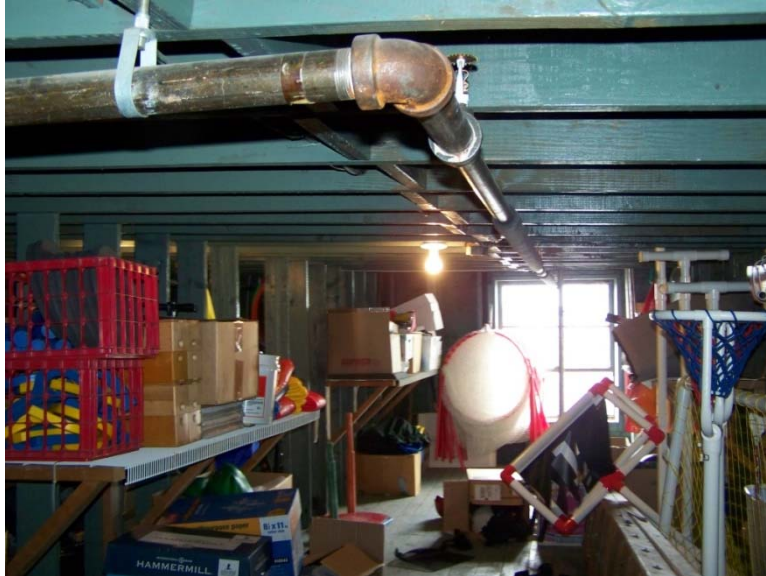
Incandescent lighting in attic space above stage

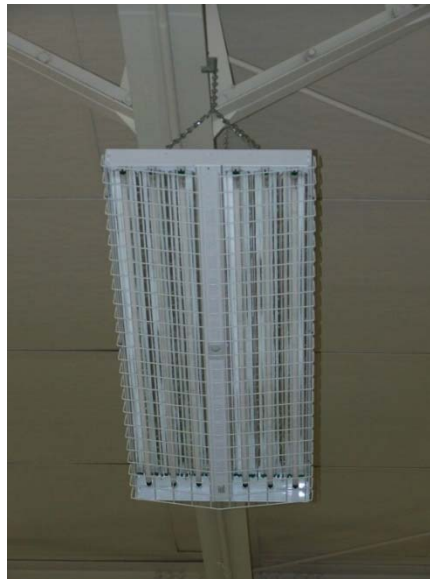
Lighting in the gymnasium/cafeteria is accomplished with six lamp fluorescent high bay fixtures.

Gymnasium lighting fixture

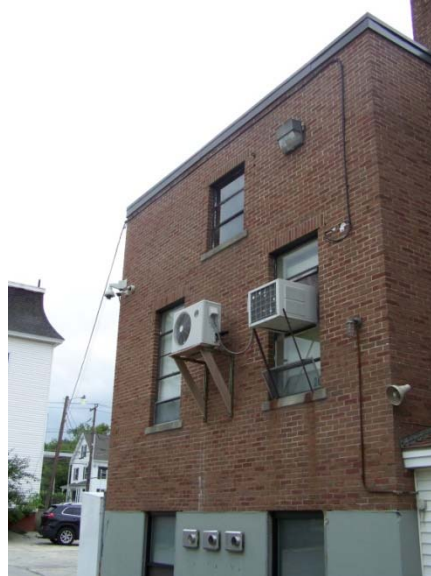
There is little exterior building mounted lighting and no pole mounted lighting. None of the lighting is cut off, so lighting spills above the horizon. There is little for security lighting around the building.

Building mounted lighting fixture

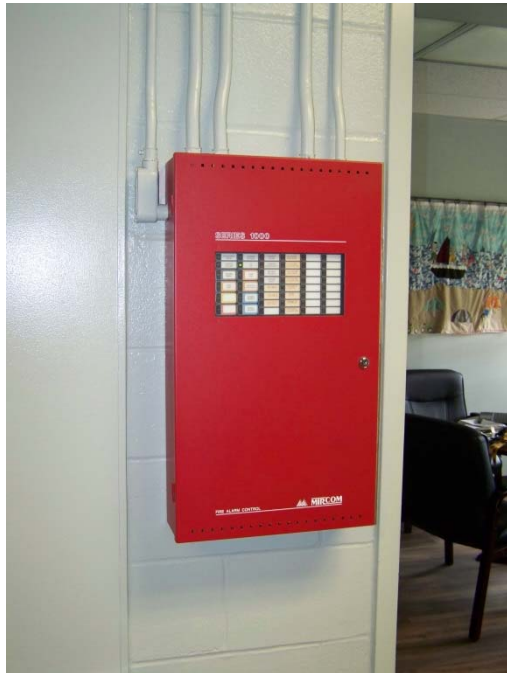
Fire alarm control panel located in gymnasium lobby

- Replace the existing fire alarm system with new system that provides voice evacuation throughout the building to comply with code.
- Provide notification in classrooms to comply with code.
- Provide smoke detection to comply with code.

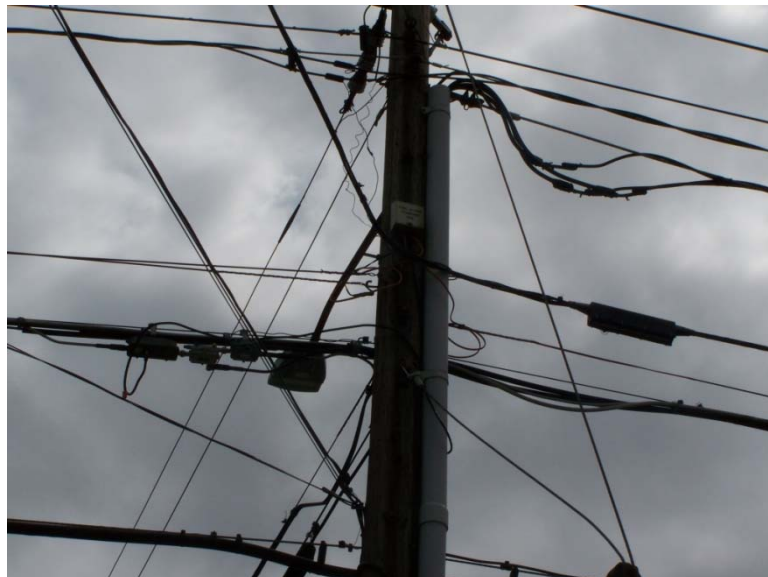
The fire alarm system reports to a city loop. Connection to the city loop is by aerial cable run to a utility pole located on School Street.

Building fire alarm connection to the city loop at School Street

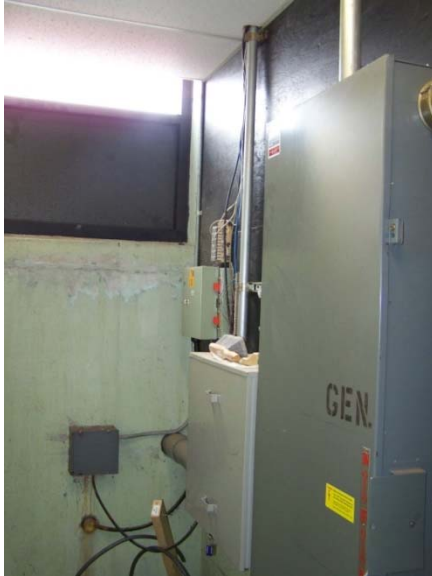
Demarcation in main electrical room

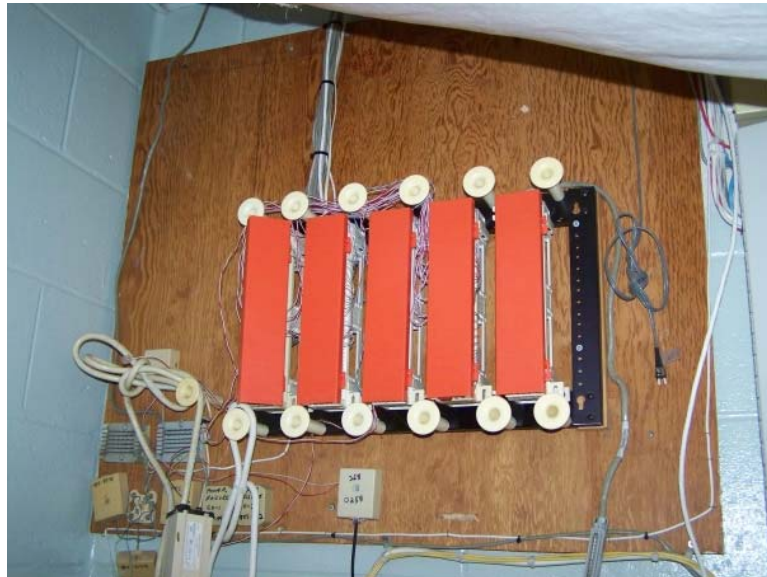
Backboard in administration with phone system punch down blocks

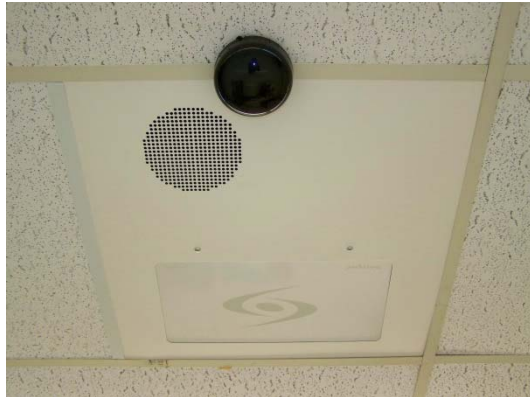
Classroom sounds reinforcement system

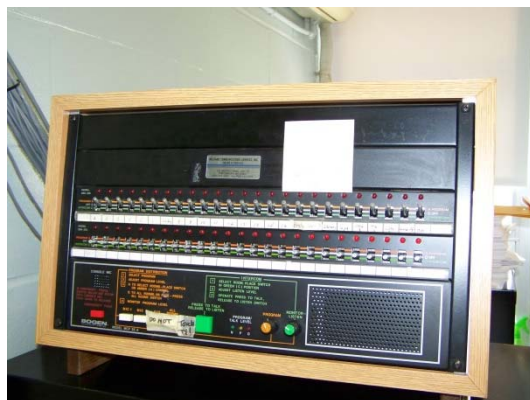
The public address system is by Bogen. It is a zoned system that requires each zone be hard wired back to the head end equipment. The head end equipment is located in the main office. The system appears to be in good shape with space to add approximately thirty additional zones.

Public address system head end equipment

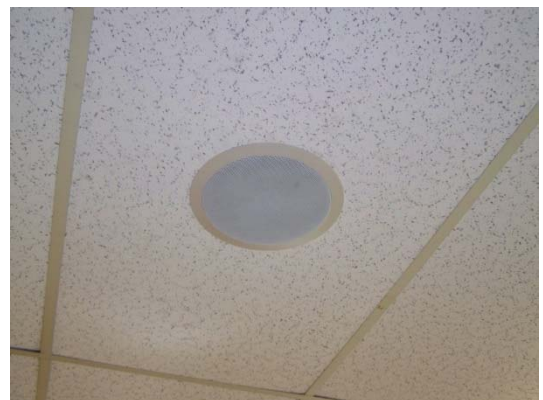
Typical recessed speaker, non-classroom locations
