ALLENSTOWN ELEMENTARY SCHOOL FEASIBILITY STUDY

Allentown, NH

FINAL REPORT

STUDY OVERVIEW

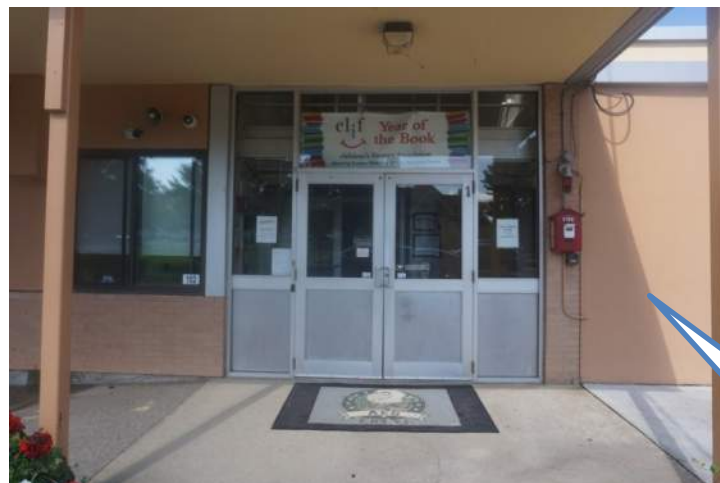
The one story area to the right of the main entrance is a masonry wall with exterior stucco insulated finish system. It is unknown if there is insulation in the walls other than the stucco insulated finish system. Based on the era of construction, little to no insulation was used in the walls on any of these masonry exterior walls.

1972 addition
with stucco

If a renovation is to take place the Energy Code (IEEC) will need to be adhered to. Harriman recommends furring out exterior walls with wood studs and filling the voids with spray foam insulation to seal the perimeter of the envelope and a layer of gypsum drywall. The cavity would allow for electrical and data wiring with devices.

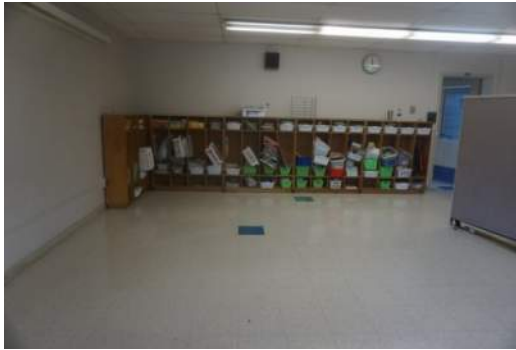
The predominant floor finish is vinyl tile. It is throughout the classrooms, SPED areas, Multipurpose, Offices, teacher's area, corridors and storage rooms. Classrooms in the 1998 addition are about one-third vinyl tile at cubbies, with the remaining area being carpet. Carpet was a miss-lot color run and needs to be replaced. Carpet is also installed at the Library and the SPED area by Multipurpose. The Boys and Girls toilet rooms are ceramic tile. There is quarry tile in the Kitchen.

Typical classroom

- Replace all carpeted areas with new carpet or alternative floor materials.
- Multipurpose to provide seamless sport floor.

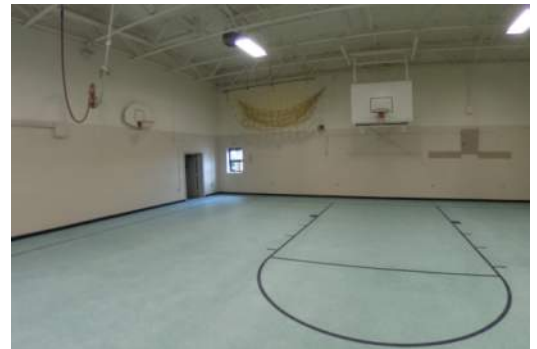
Multipurpose

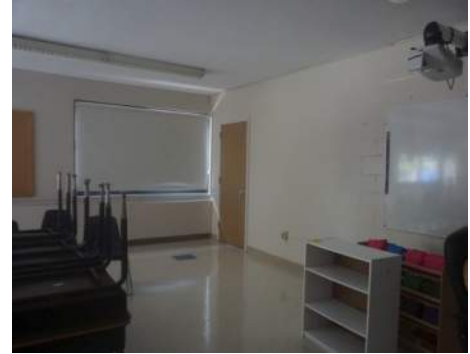
There is suspended acoustical ceiling tile throughout most areas of the building. A variety of conditions, from poor to good, were noted. Many ceiling tiles have been discolored and stained. Plaster ceilings are located at Rooms 112, 202, 203, 204, 205, and 206. The 1972 Multipurpose space is exposed painted acoustic metal decking.

Plaster ceiling

- Replace acoustical ceiling tiles.
- Add sound absorbing ceiling system at Multipurpose.

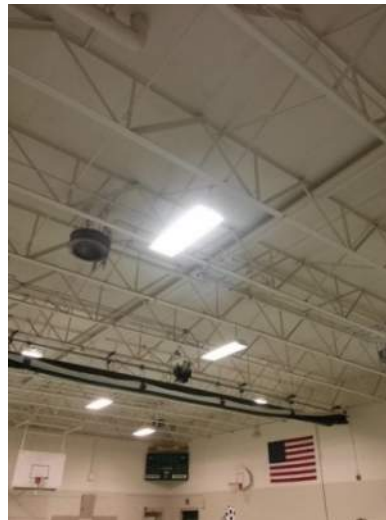
Exposed structure and deck

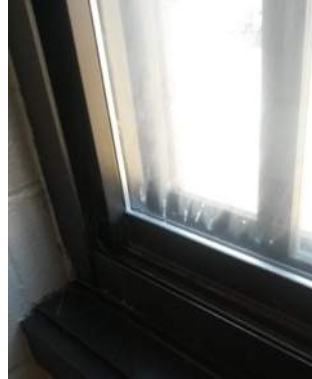
Exterior windows are generally aluminum sliding thermal pane that were replaced in two major window replacement projects. One series were a sliding window with one thermal pane glazing, which are in fair condition. The other series were light weight thermal pane glazing and a second single pane glazing similar to a storm window. They are very difficult to operate and in poor condition. Many of the thermal glazing have lost their seal, evidenced by condensation between the panes of glass. The SPED addition has residential windows.

Thermal pane glazing that lost seal

- Remove and replace all windows with commercial grade, thermally broken frames, exterior window system.
- System could be a combination of double hung windows or sliding style and fixed windows.
- Windows to be insulated glazing, low-E and argon filled for best performance.

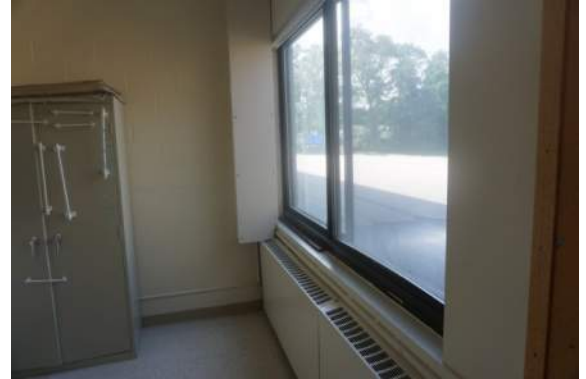
Typical sliding window

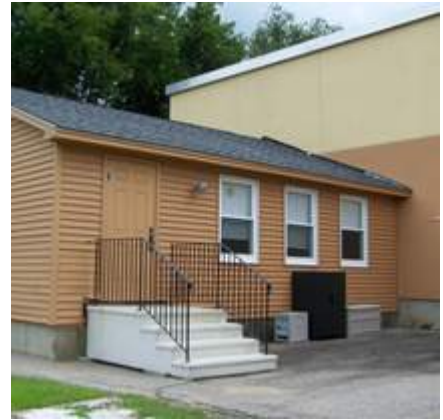
SPED addition - residential windows

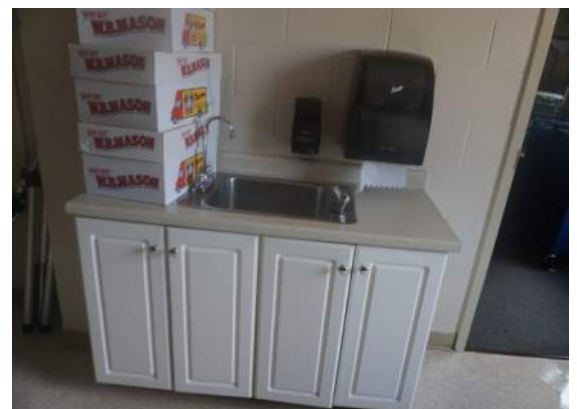
All built-in casework (cabinetry, cubbies, shelving, etc.) appears to be original to the respective portions of the building. Some of the casework has been modified or added too. Casework in the classrooms and Nurse are is residential grade. Much of the casework is missing parts. Many parts are outdated and no longer available including sinks, faucets and bubblers. Refer to plumbing section. The plastic laminate countertops show signs of significant delamination and have been reported to be repaired several times. A majority do not meet ADA standards.

Residential grade

- All casework to be removed.

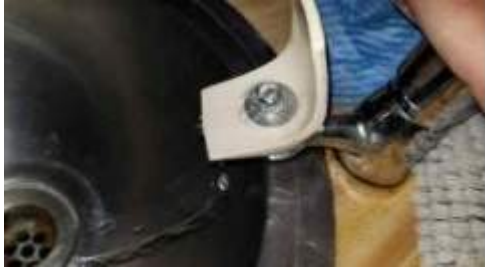
Bubbler not functioning

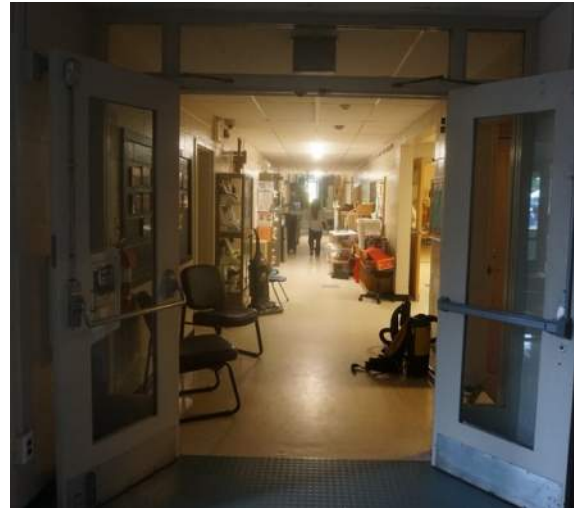
Doors vary from stained wood to painted hollow metal

- All exterior and interior doors to be replaced with new doors, frames, sidelights, transom, and hardware.
- Provide fire rating assemblies as required.
- Hollow metal frames in good condition can remain.

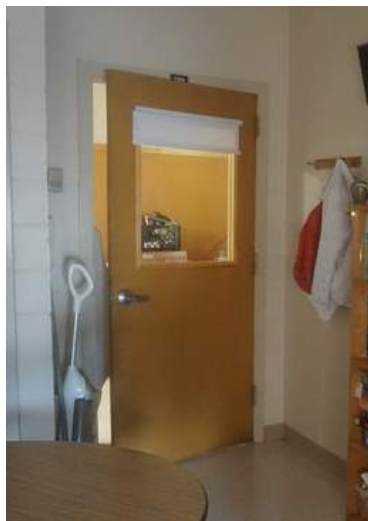
Typical wood door with half glass with knob

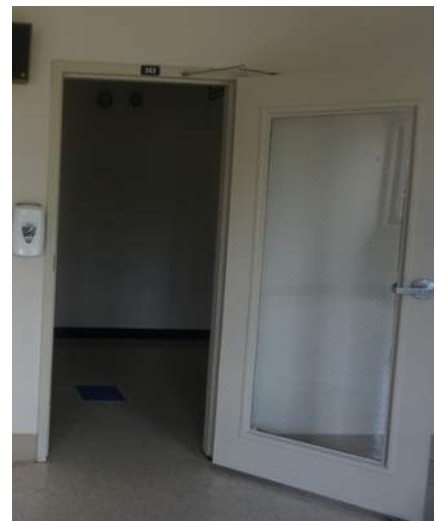
Typical hollow metal door with full glass

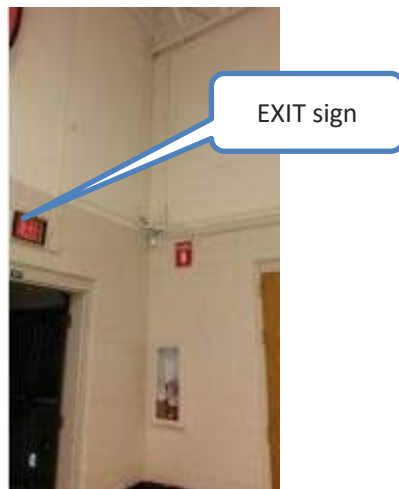
and exterior ramp view F. It is uncertain why double doors were removed; however this creates a rated and secured egress path from Multipurpose room to a public way. In its present condition this cannot be used as a means of egress. It appears this is the route to remove trash receptacles.

A - Double door viewed from Multipurpose room
Note EXIT sign above doors.

- Re-establish Vestibule as a rated egress path with door, frame and hardware. Verify fire rating of walls. No trash receptacles should be in the path of egress.
- Limits multipurpose room with 2 egresses. Review with local AHJ and post Maximum Occupancy allowed and remove EXIT sign.
- In both cases re-build ramp with code compliant landing and handrails both sides.

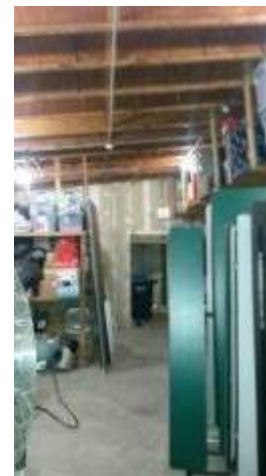
D - View from Storage 140 towards door to Stair D
Note wood frame construction.

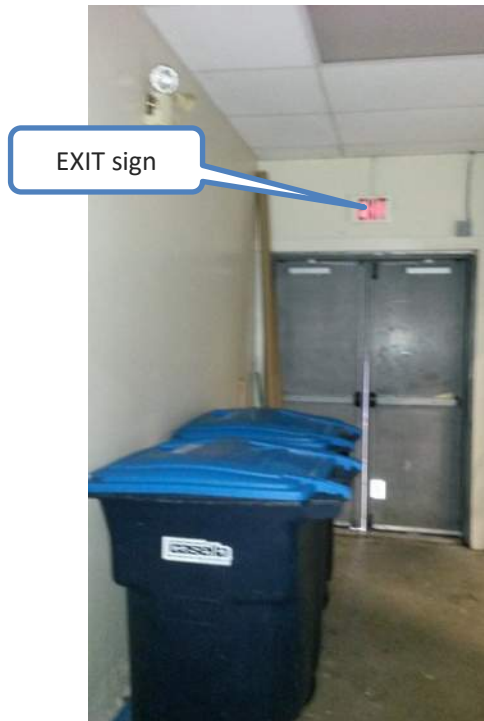
E - Double doors to exterior
Note EXIT sign above door.
