ALLENSTOWN SCHOOL DISTRICT
ARMAND R. DUPONT MIDDLE SCHOOL
Allenstown, NH 03275
PROJECT # 18345

March 11, 2019

FACILITY ANALYSIS

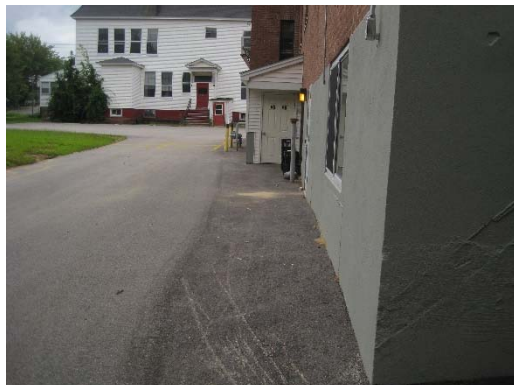
Pavement east of the school (looking south)

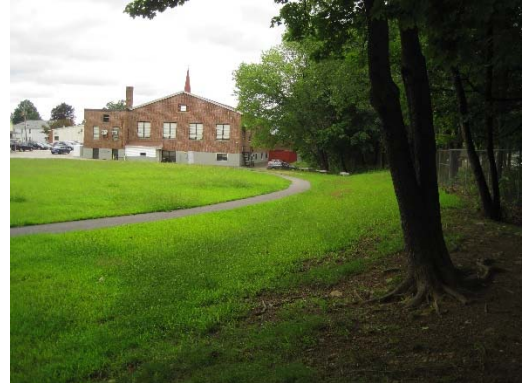
Vegetative area to the east of the building

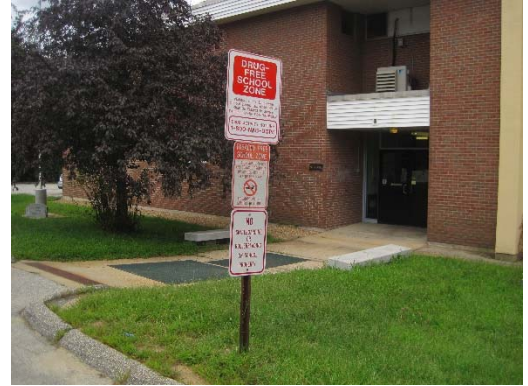
School signage in front of entrance to west building

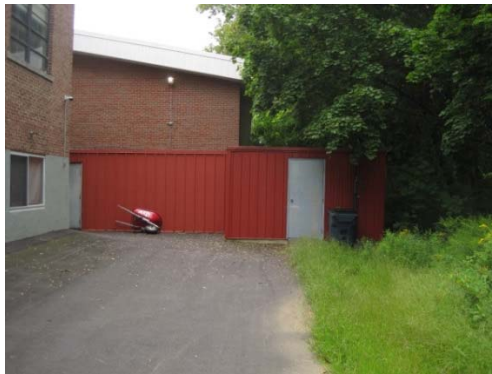
Red storage addition by connector

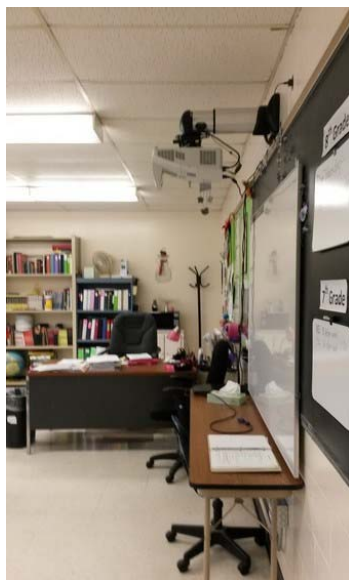
Projector with marker board mounted over existing chalk board

Harriman recommends that when providing new interactive boards, marker and tack boards, to remove the old boards (if existing) prior to installation. The existing chalk boards should be tested for asbestos containing materials and abated prior to removal.

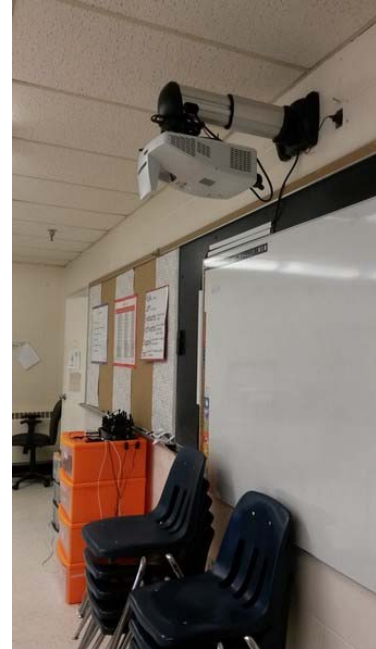
Projector with marker board mounted over existing chalk board

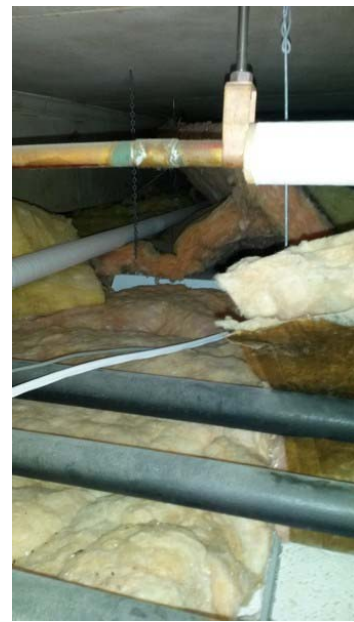
First floor ceiling

There is suspended acoustical ceiling (ATC) tile throughout most areas of the building. A variety of conditions, from very poor to good, were noted. Many ceiling tiles have been discolored and stained. Typically there is insulation above ATC. Shown below is fiberglass batt insulation with additional ATC above. This occurs in both the first and second floors. This was commonly done during the energy crisis in 1979. It is understood now that this can create an indoor air quality issue where moisture may condensate in the fiberglass insulation and ATC. Due to the amount of ceiling tile staining, it is suspected that some materials may be absorbing moisture.

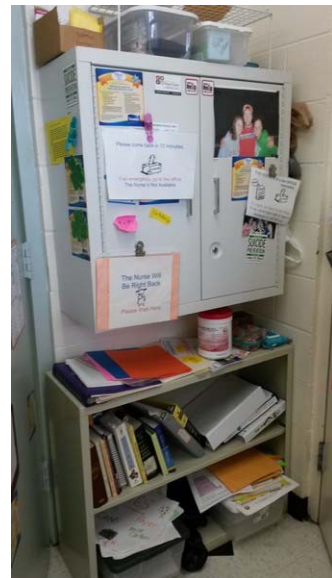
All built-in casework (cabinetry, counters, shelving, etc.) appears to be original to the respective portions of the building. Some of the casework has been modified or added too, similar to AES. Much of the casework is damaged and missing parts. Many parts are outdated and no longer available, including sinks and faucets. Science areas are original 1988, with one sink over 30 years old, and no longer meet current educational needs. The Art room has minimal counter space for student projects with one sink and no longer meets current educational needs. The majority of casework does not meet ADA standards. Refer to Plumbing section for additional information.

Various cabinets and book shelving

- All casework to be replaced. Consider redesigning with a combination of open and closed cabinets/shelving. Provide all spaces to meet ADA requirements for accessibility.
- Most spaces need additional storage space.

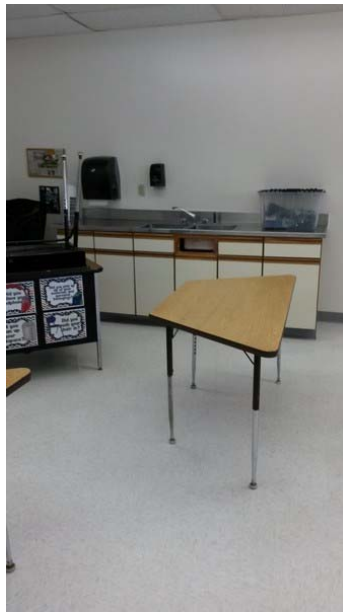
Residential style casework

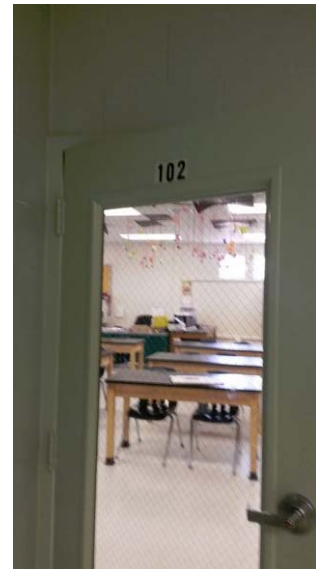
Science room door with full glass and lever handle

- All interior classroom and teaching space doors to be replaced with new doors with partial glass, upper viewing glass panel.
- All doors with knob sets to be replaced with lever handles. Provide fire rating assemblies as required.

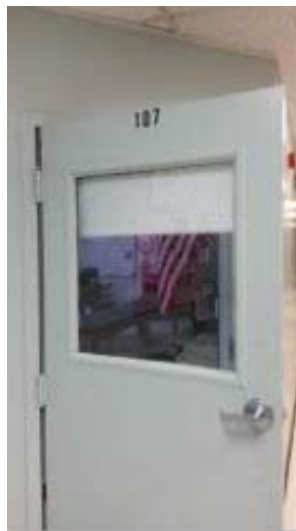
Typical door with half glass

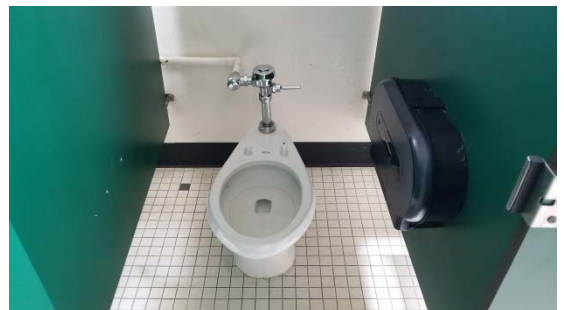
Plumbing fixtures appear to be in good condition. The toilet fixtures are modern design, but do not appear to be water conserving models. Water conserving models have been a requirement since 1991. Water conserving models use 1.6 gallons or less per flush. The existing fixtures use 3.5 gallons per flush. The lavatories are modern design with single lever faucets. The urinals are a wall hung modern design and use 1 gallon per flush. Fixtures on the second floor are more up to date and in better condition.

Boys Locker Typical Stall (no seat)

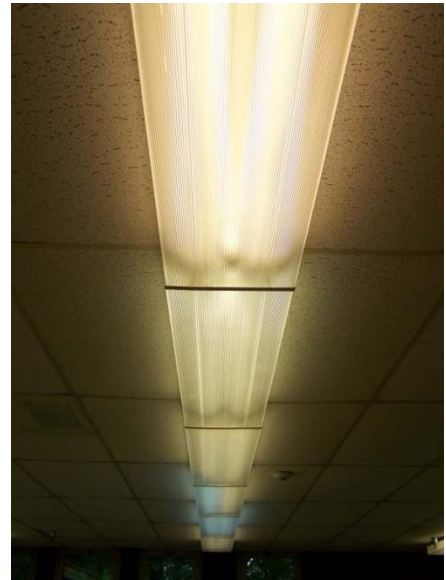
Lamp color varies

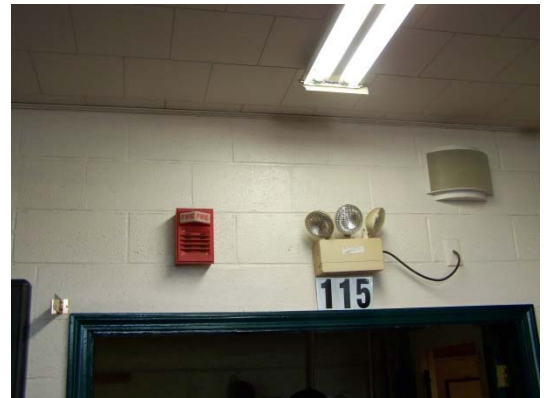
2. Many of the notification appliances are lights and do not provide the required candela (cd) level to meet code.
3. There is no voice evacuation in the building.
4. Smoke detectors are not located within five feet of doors on hold opens.

Fire alarm system light

- Replace the existing fire alarm system with new system that provides voice evacuation throughout the building to comply with code.
- Provide notification in classrooms to comply with code.
- Provide smoke detection to comply with code.

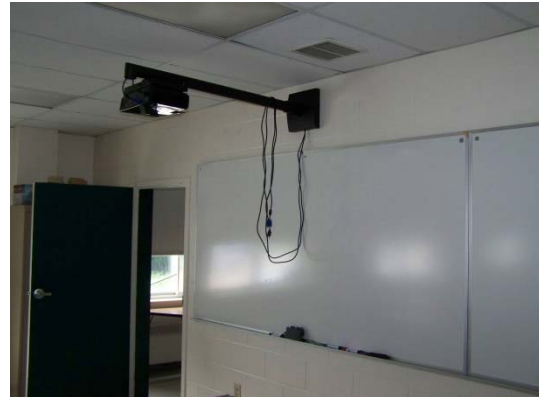
Classroom interactive projector/ board

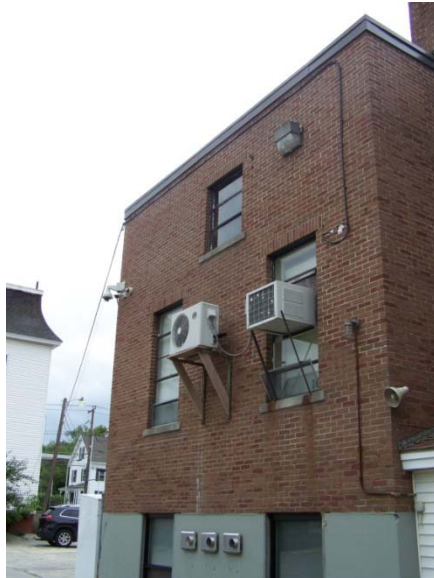
Exterior camera

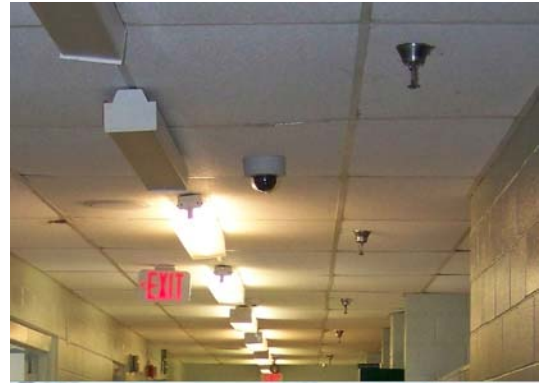
Typical interior camera

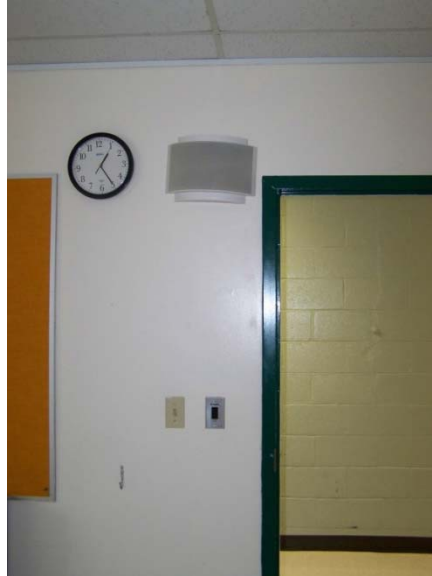
Typical classroom speaker and call button
